Church of Panagia, Koimisis tis Theotokou

İnci Türkoğlu, Ioannis Papachristou

District of Marmara, Ekinlik Neighbourhood	Construction period/date: 1845-1848
	Current status: Ruinous
GPS: 40°32'46.1"N 27°29'07.6"E	Ownership: Unknown
Registration date and number: Bursa KTVKKBK 18.04.1990 - 1297

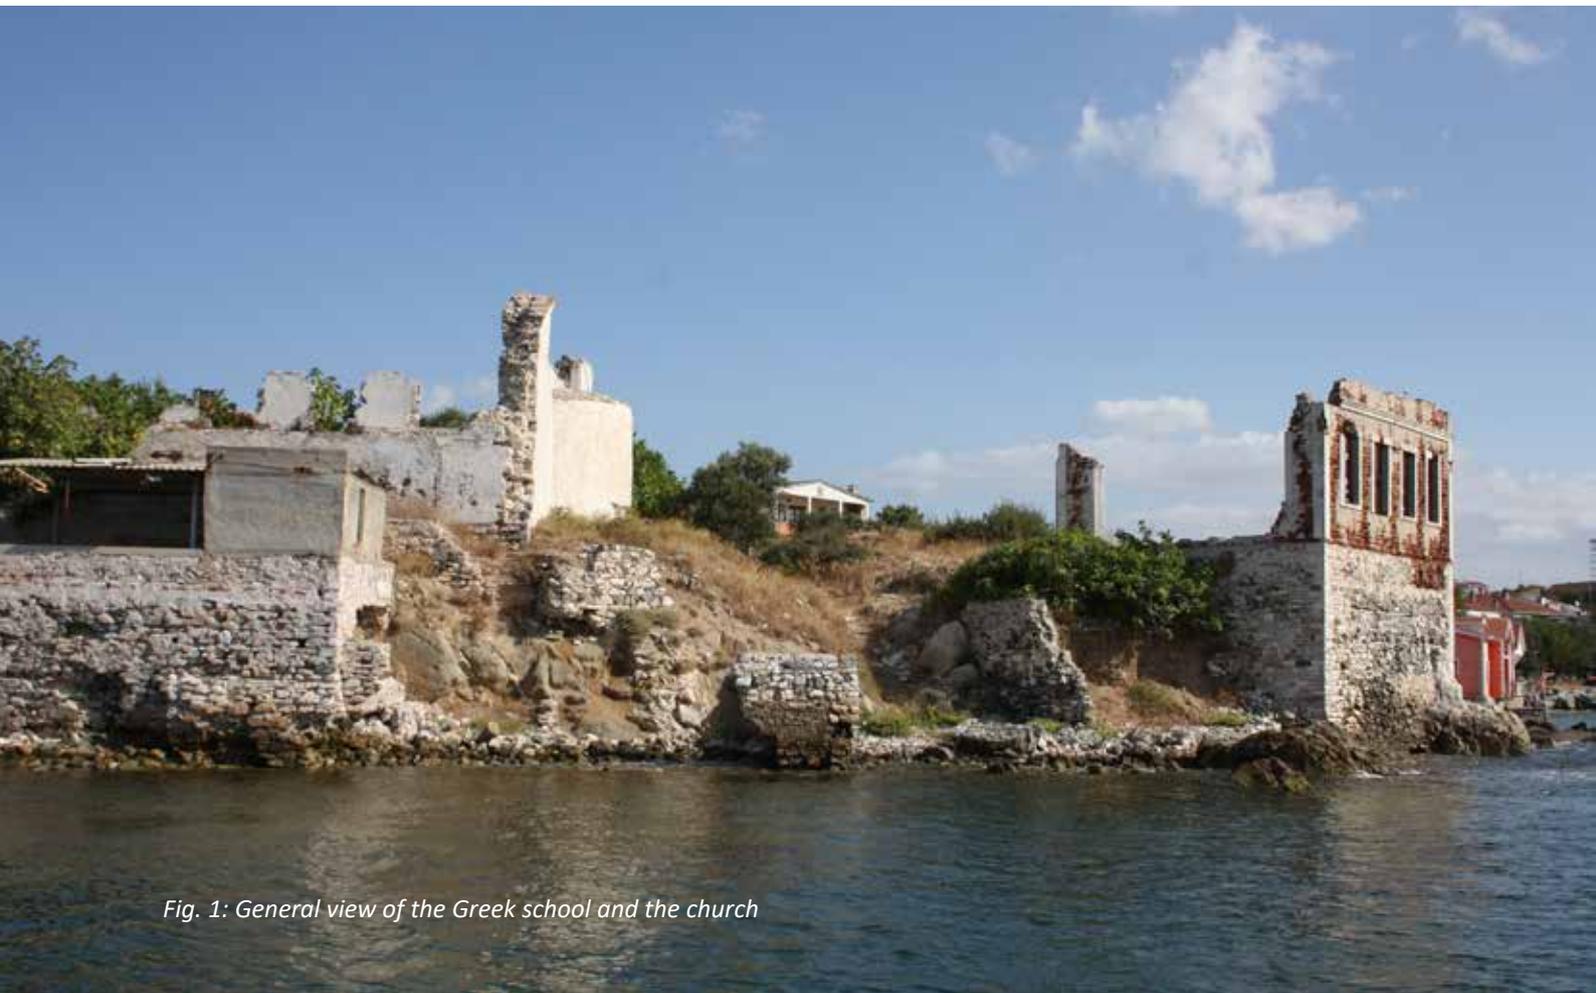
Fig. 1: General view of the Greek school and the church

The church is located to the northwest of the Greek school, rising on top of a rocky outcrop to the west of the harbour. The white-washed eastern façade of the church stands next to the school, which creates a majestic view of this prominent position in the island's landscape from the sea. (Fig. 1). From land, it seems as if the church stands alone, however, there are some wall remains at a lower level to its south. To the west of the church lies the terminus of a dead-end street and to its north is a path separating it from neighbouring houses.

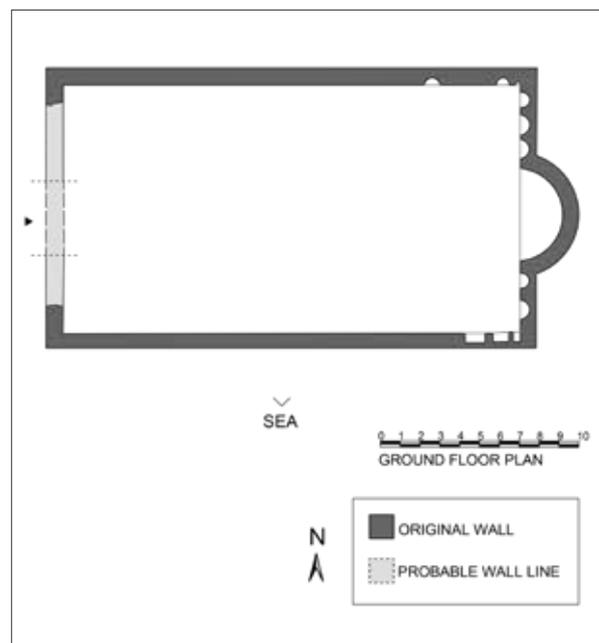
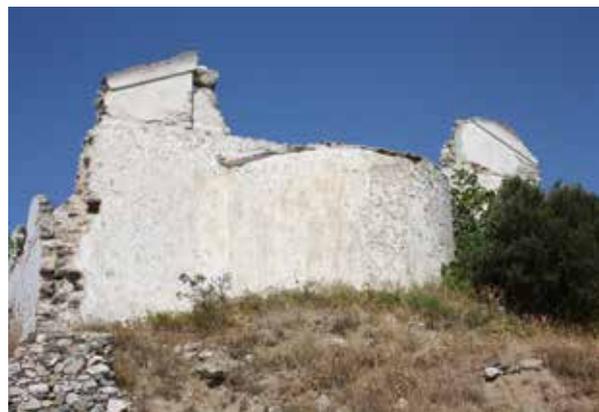
Fig. 2: General view of the eastern wall

being in better condition than the other two (Fig. 2); however, the western wall where the entrance was located cannot even be traced. Observation of the remains revealed that the walls were built using rubble, brick fragments, and lime mortar, then coated with lime plaster. Some of the timber bands in the walls are still in place.

The eastern façade features a single round protrusion in the middle that housed the apse (Fig. 2). This is covered by a very shallow, conical, and tiled roof. A triangular gable evidently connected the eastern wall to the roof; this suggests a pitched timber roof structure covered by tiles. Only the northern and southern ends of the gable survive today. It is likely that its dilapidated center portion had windows. The southern and northern façades of

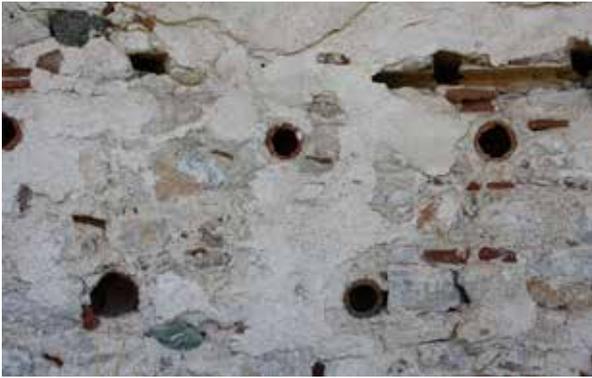
Fig. 3: Detail from the apse wall

The narthex is not discernible due to extensive foliage. The team had to clear a path to reach the eastern façade. The erect semi-circular apse features baked clay jars embedded in the wall to improve acoustics, some of which are now exposed (Fig. 3). The apse is flanked by three niches to the north (Fig. 4) and two niches to the south (Fig. 5). Of the former three, the middle niche is the taller than the other two. All five niches are semi-circular, topped with round, brick arches. The eastern end of the southern wall features two rectangular niches also topped with round, brick arches, while the northern wall has two semi-circular niches.

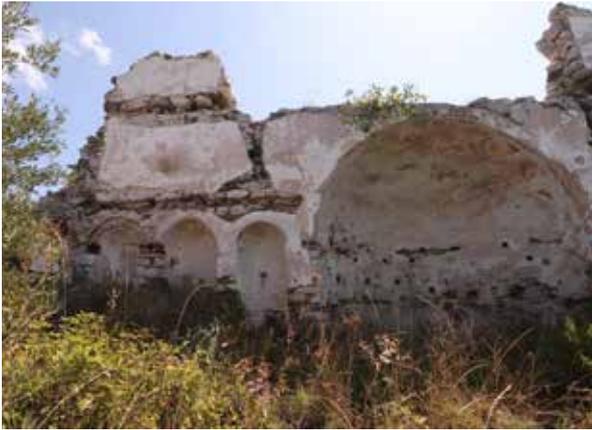
Fig. 4: Apse and northern niches

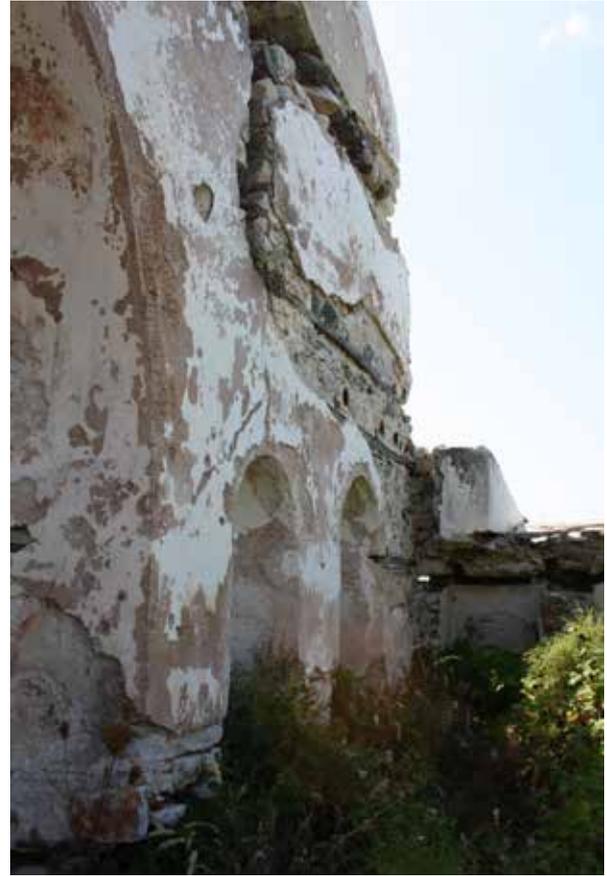
Fig. 5: Niches in the south
