Church of Taxiarches

Emre Kishali, Ioannis Papachristou

District of Marmara, Merkez Neighbourhood	Construction period/date: 1884-1889
	Current status: Abandoned
GPS: 40°35'10.7" N 27°33'25.8" E	Ownership status: Private ownership
Registration date and number: Bursa KTVKKBK 15.1.1996 - 4904, 28.11.2015 - 5175 KGB-1

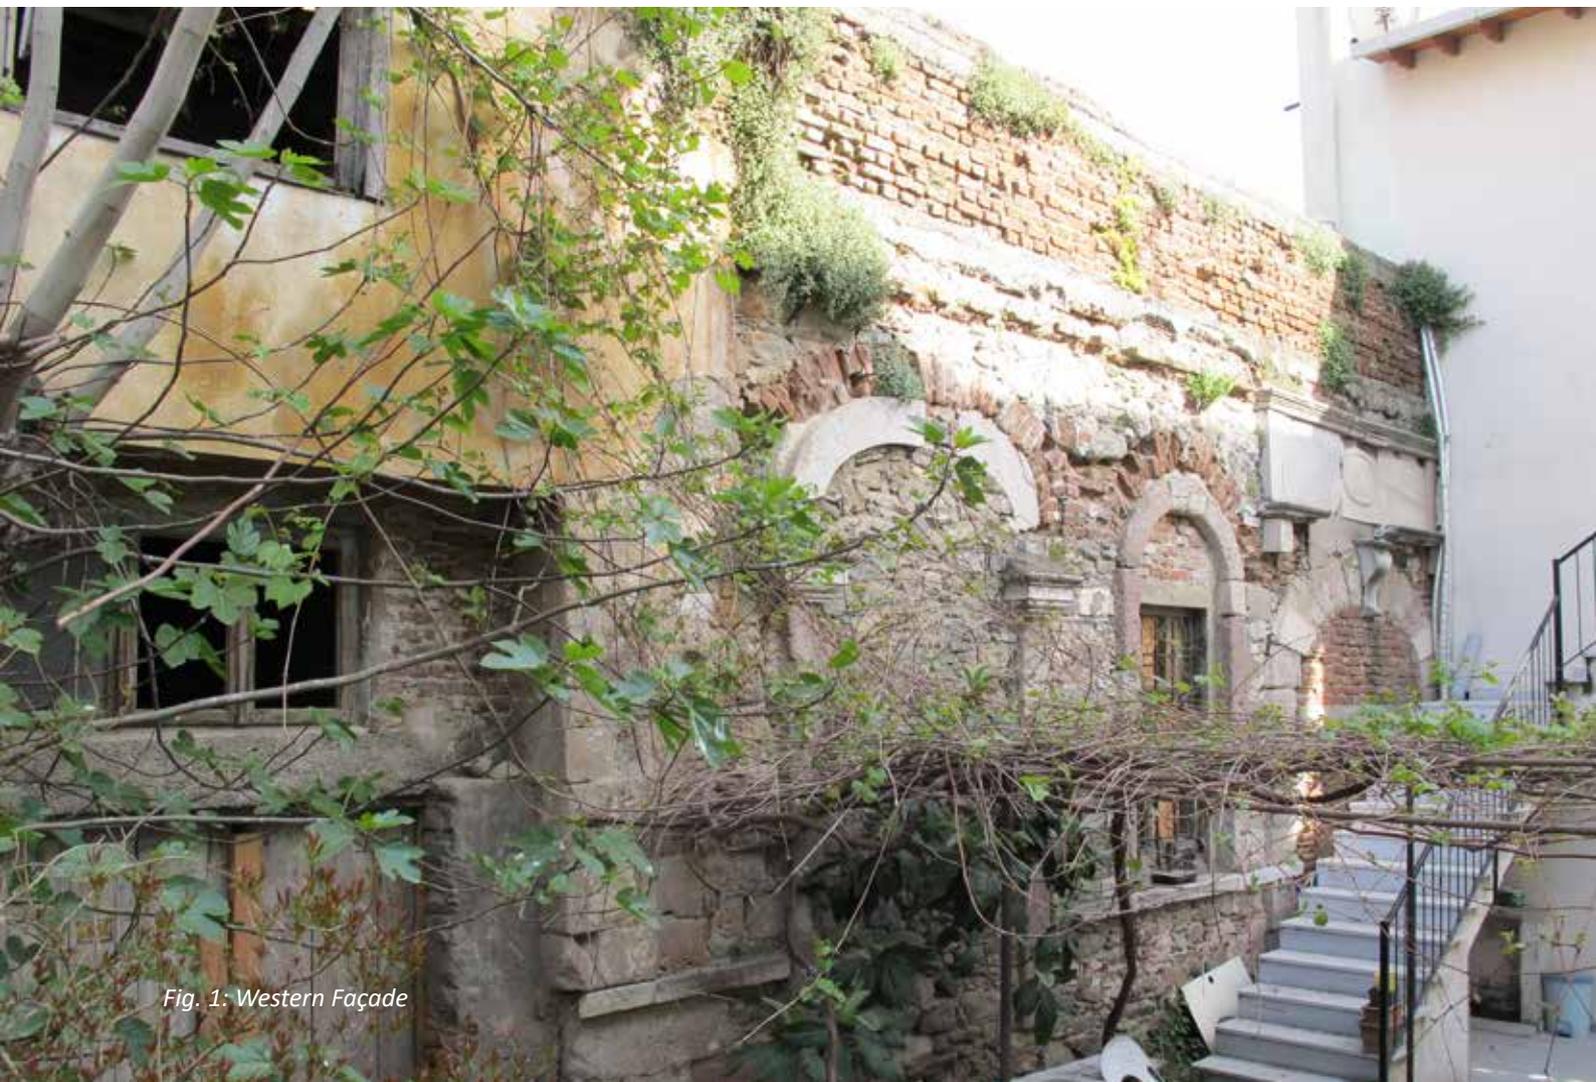
Fig. 1: Western Façade

The building's south façade was damaged due to the adjacent hotel structure. There is an annex close to the north corner of the western façade (Fig. 1). The annex has a timber double-winged door with a top window, as well as a timber window on the upper floor. The older sections of the façade contain door and window openings that were later closed. Since the walls are not plastered, the building materials are visible. Different building elements such as rubble, lime mortar with brick powder (*khōrasan*), brick, marble and a reinforced concrete beam were observed on the western façade. The marble inscription panel, which denotes the construction date of the building, is in the southern part of this façade (Fig. 2). The arched opening under the inscription panel was closed off. The marble moulding in this section of the eave provides clues about the original entrance of the building. The arched

opening between the two engaged columns with Doric capitals near the modern annex on the western façade was also later closed off. Ornamented marble pieces were used as spolia in the masonry. There are two levels of reinforced concrete bands at the roof level and approximately 1m below it.

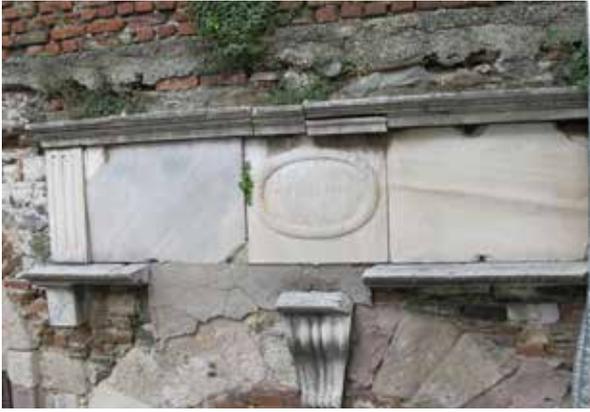
There was a fire in the town of Marmara on 20 July 1884. The flames began in the Taxiarches neighbourhood and damaged part of the Ottoman quarter to the east and west of this area. The church was also destroyed. According to the extant inscription above the main entrance of the church: 'The Church of Taxiarches burnt down in 1884 and was reconstructed in 1889' ('Ο ἐν ἔτει 1884 ἀποτεφρωθεὶς ναὸς τῶν Ταξιαρχῶν ἀνωκοδομήθη τῷ 1889'). The church had three aisles separated by two colonnades. There was no belfry; the church bell hung from the tree next to the entrance. Two priests were appointed to Taxiarches.

Fig. 2: Inscription on the western façade

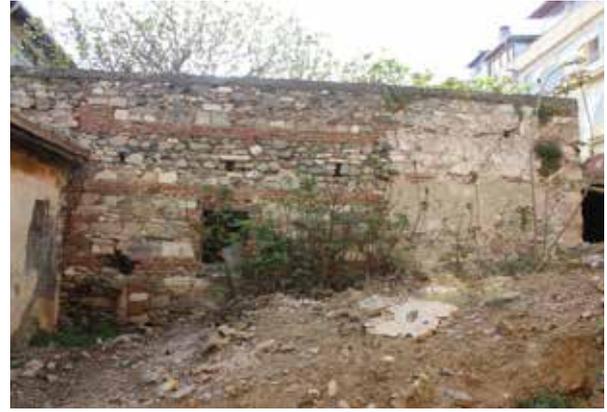
Fig. 3: Eastern Façade

Traces of the apse, which was cut and flattened, are still visible on the original main wall of the eastern façade (Fig. 3). There is also a square window in this section. The façade has alternating rows of brick and stone. The pattern of three rows of brick between rubble masonry changes in the apse. Spolia marble is used in this wall, similar to the style of those in the western wall. There is also an adjacent, single-story building in the southern part of the facade.

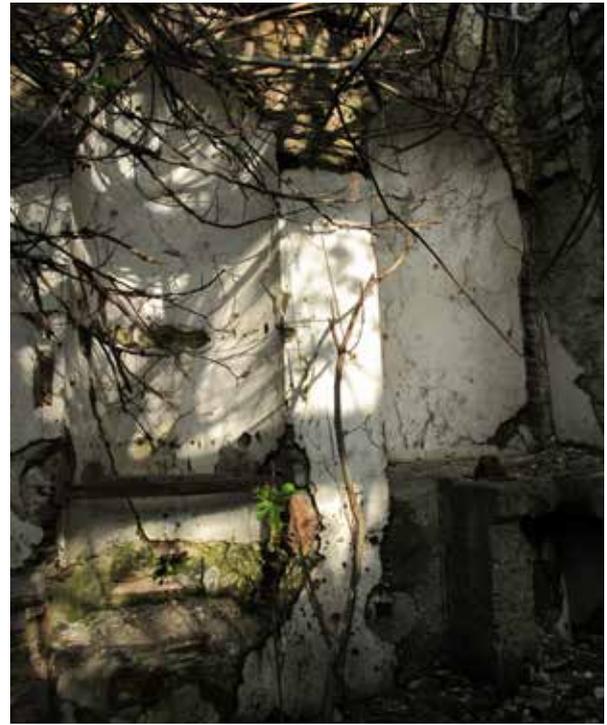
Fig. 4: The niches in the eastern wall of the church
