Church of Agios Nikolaos

Umut Almaç, Emre Kishalı, Ioannis Papachristou

District of Marmara, Abroz Neighbourhood, Yana Locality	Construction period/date: repaired in the 19th century
GPS: 40°38'56.5"N 27°42'10.2"E	Current status: Abandoned
	Ownership status: Unknown
Registration date and number: Bursa KTVKBK 18.08.1990 - 1293

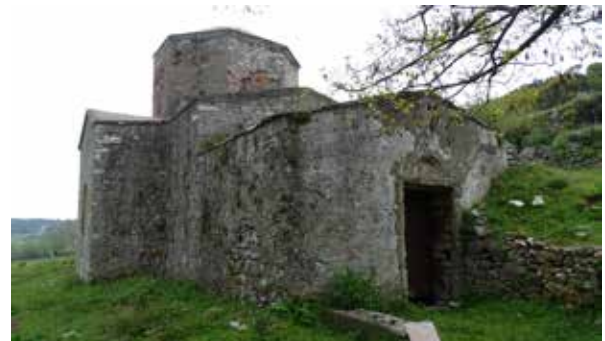
Fig. 3: General view from the northwest

covering these sections at +5.00 m, and the narthex and apse sections rising up to +4.00 m are seen from the outside (Figs. 2, 3). Three different sections of the building are perceptible on the western façade (Fig. 3). At the foremost is the narthex section, which is plastered over, with the entranceway in the centre and crowned by a triangular pediment. Further behind is the gable that rises from the superstructure of the narthex and separates it from the western arm of the church. In the middle of this gable is a concrete panel added after the 1954 repairs. The octagonal drum of the dome covering the main space is seen at the back. The northern facade includes the narthex, the western arm of the cruciform, the transept, the bema and the apse (Fig. 2). The northern façade does not have any openings except the transept’s arched window, which was later closed. On the eastern façade are the semi-circular apse wall, the gable of the bema wall, the protruding northern and southern transepts, and the dome’s drum visible (Figs. 1-2). The apse wall has a circular window, which

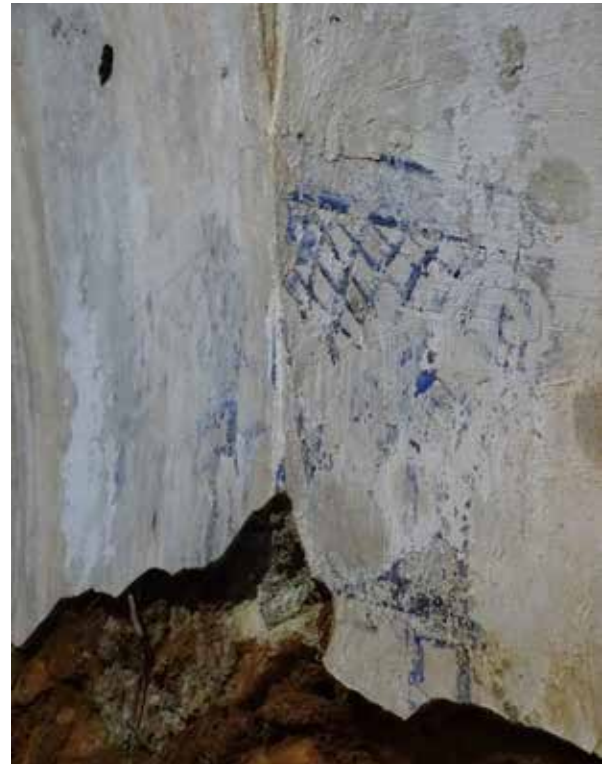
Today, only a few paintings are visible on the walls of the church, like the head of an angel

above the western window and sketches of (Corinthian) columns to the south of the apse (Figs. 5-6). It is likely that there were graves inside the walls of the monastery, in the area between the church and the sea.

Fig. 5: Naos, traces of wall paintings

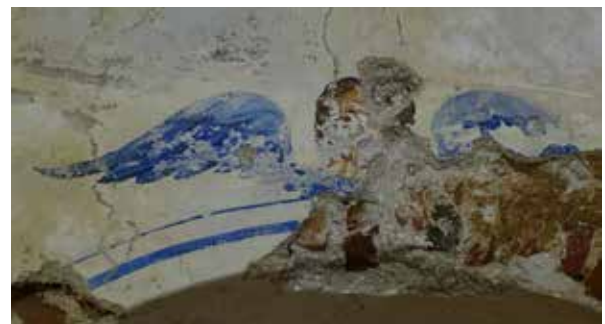
Fig. 6: Naos, traces of wall paintings
