Koyun Island Chapel

Emre Kishalı, Ioannis Papachristou

District of Erdek, Paşalimanı Neighbourhood, Koyun Adası Locality	Construction period/date: 18th century
	Current status: Ruinous
GPS: 40°29'48.5"N 27°34'29.2"E	Ownership status: Private ownership
Registration date and number: Unregistered.

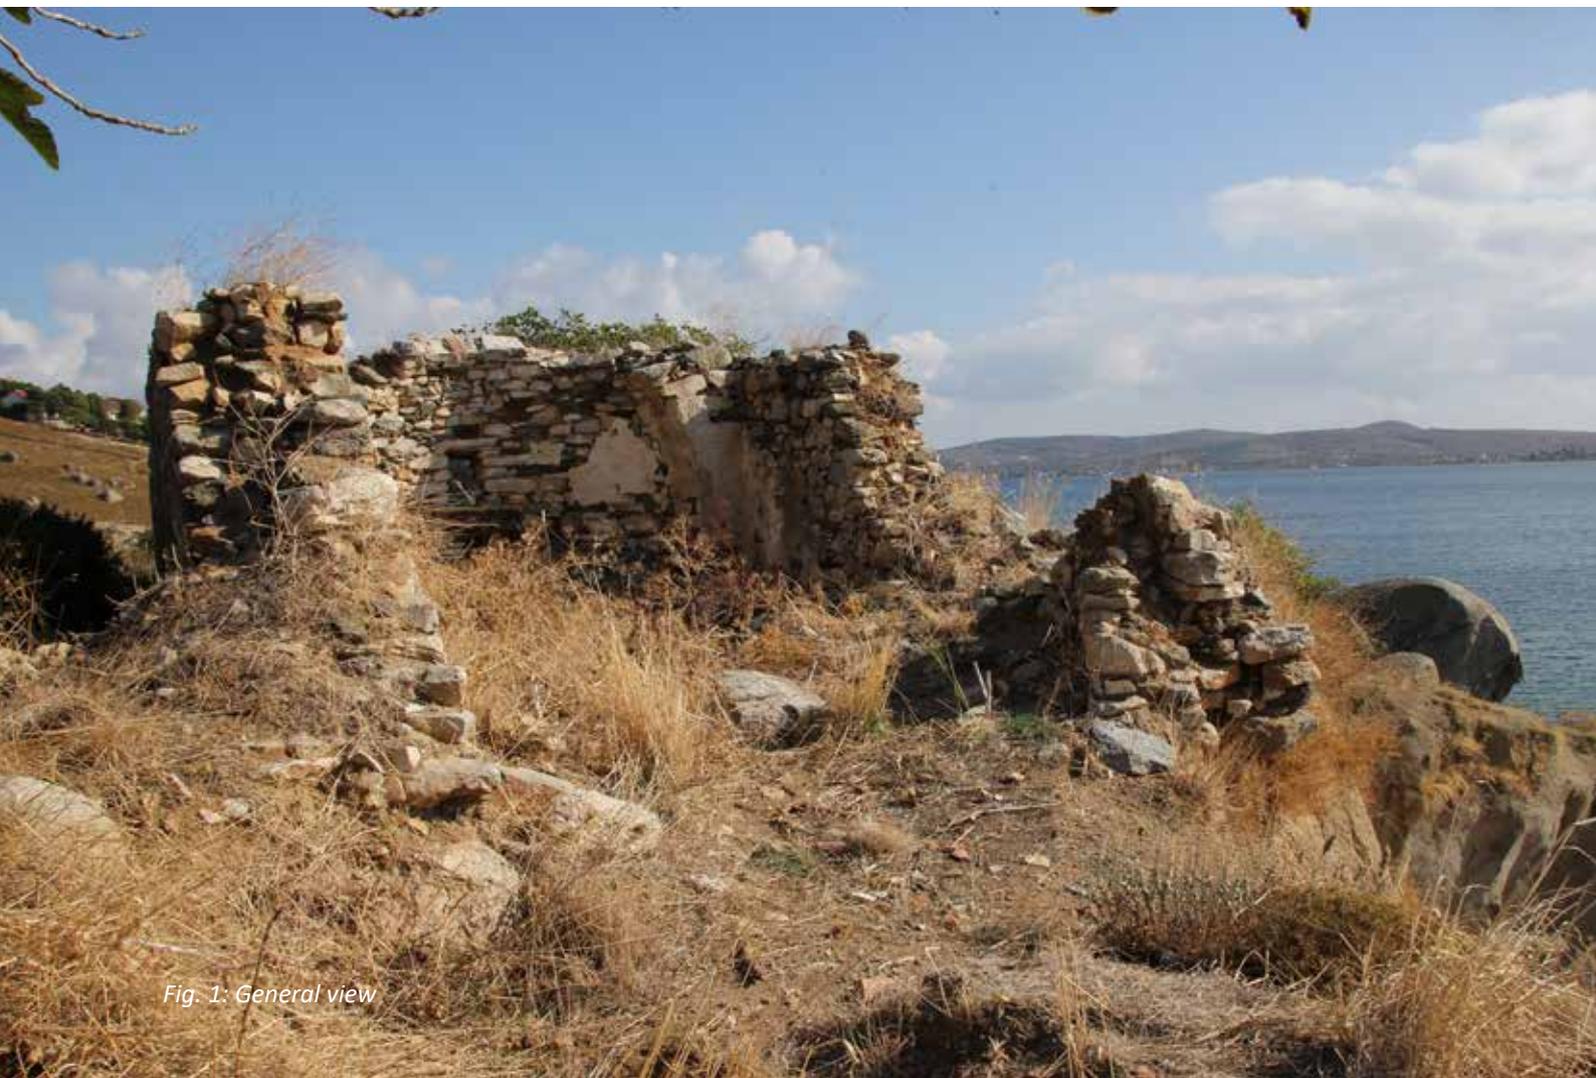
Fig. 1: General view

Although the plan organization of the building can be identified, its spatial properties cannot be estimated (Fig. 1). The eastern part of the building, which is located on an area descending westward, remains concealed up to a certain level (Fig. 2). The building is currently accessed through the collapsed western wall. There are not any traces of the superstructure of the building. The northern wall of the chapel is 7.55 m long, while the length of the southern wall is 6.05 m. The curvilinear wall on the eastern façade, where the apse is located, is 5.58 m long. There are wall remains of about 2.50x3.00 m adjacent to the southern wall of the building, which must be related to the chapel. The

The walls of rubble masonry with brick fragments resting on rubble foundations constitute the overall construction technique. The inner cavity of the double-faced rubble masonry is filled with stone and earth (Fig. 1). The wall thickness is measured 78-81 cm at upper levels that could be reached. Spolia materials are noted in the wall. Earth and adobe were used as the binding material. Traces of both rough and fine lime-based plaster were found on the interior surfaces of the main walls.

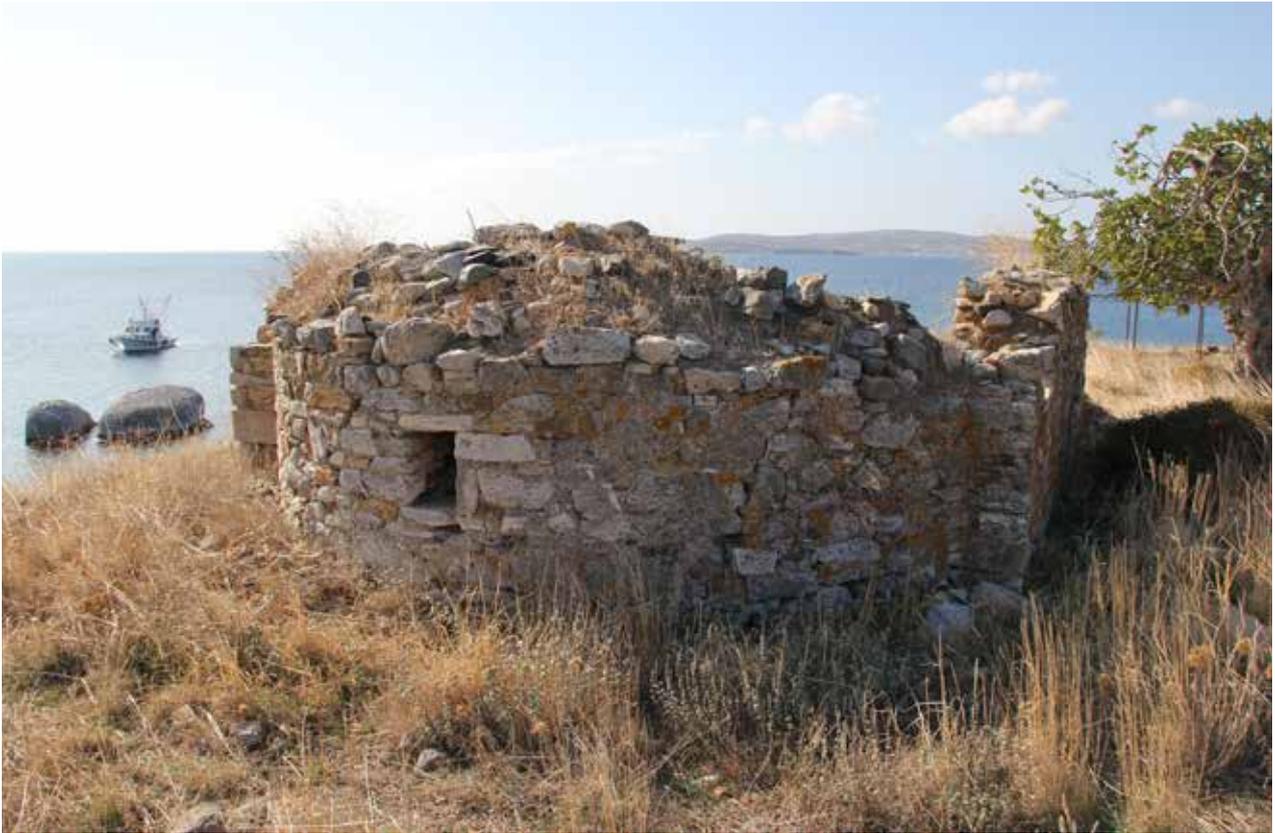
Fig. 2: Eastern façade

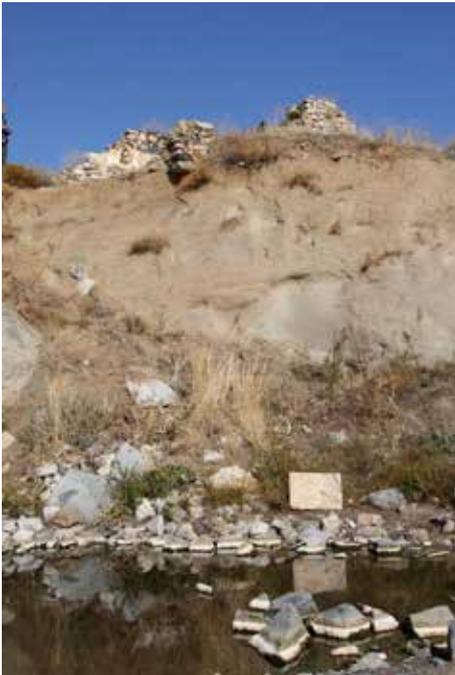
Fig. 3: The area destroyed by dynamite

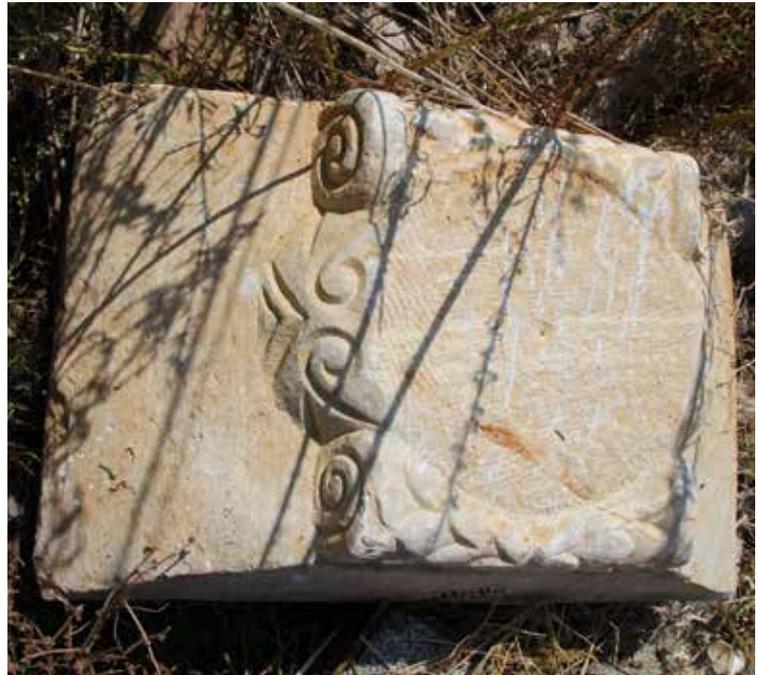
The entire western wall of the building, certain sections of its northern and southern walls, and its superstructure have been lost. While the eastern façade still stands, the other masonry walls have largely collapsed. Loss of materials, vegetation, and surface deterioration are noted on the southern and northern façades. Access to the building is not controlled and there is no information panel on the site. During the fieldwork, it was observed that the area to the south had been recently destroyed by dynamite (Fig. 3). It was discovered that this destruction was deliberate in order to procure stones for the construction of Yiğitler Port. The inscription panel and column capital seen in the historical photographs, which were located in the west of the chapel, are currently found in the area destroyed by dynamite (Fig. 4). Moreover, traces of damage caused by illicit digging were found within the building.

Fig. 4: Ion-impost column capital
