Marmara Island Synagogue

Umut Almaç, Mustafa Akçaöz

District of Marmara, Merkez Neighbourhood	Construction period/date: 1893-1908
	Current status: Abandoned
GPS: 40°35'10.9"N 27°33'14.3"E	Ownership status: Private ownership
Registration date and number: Bursa KTVKBK 15.01.1996 - 4904

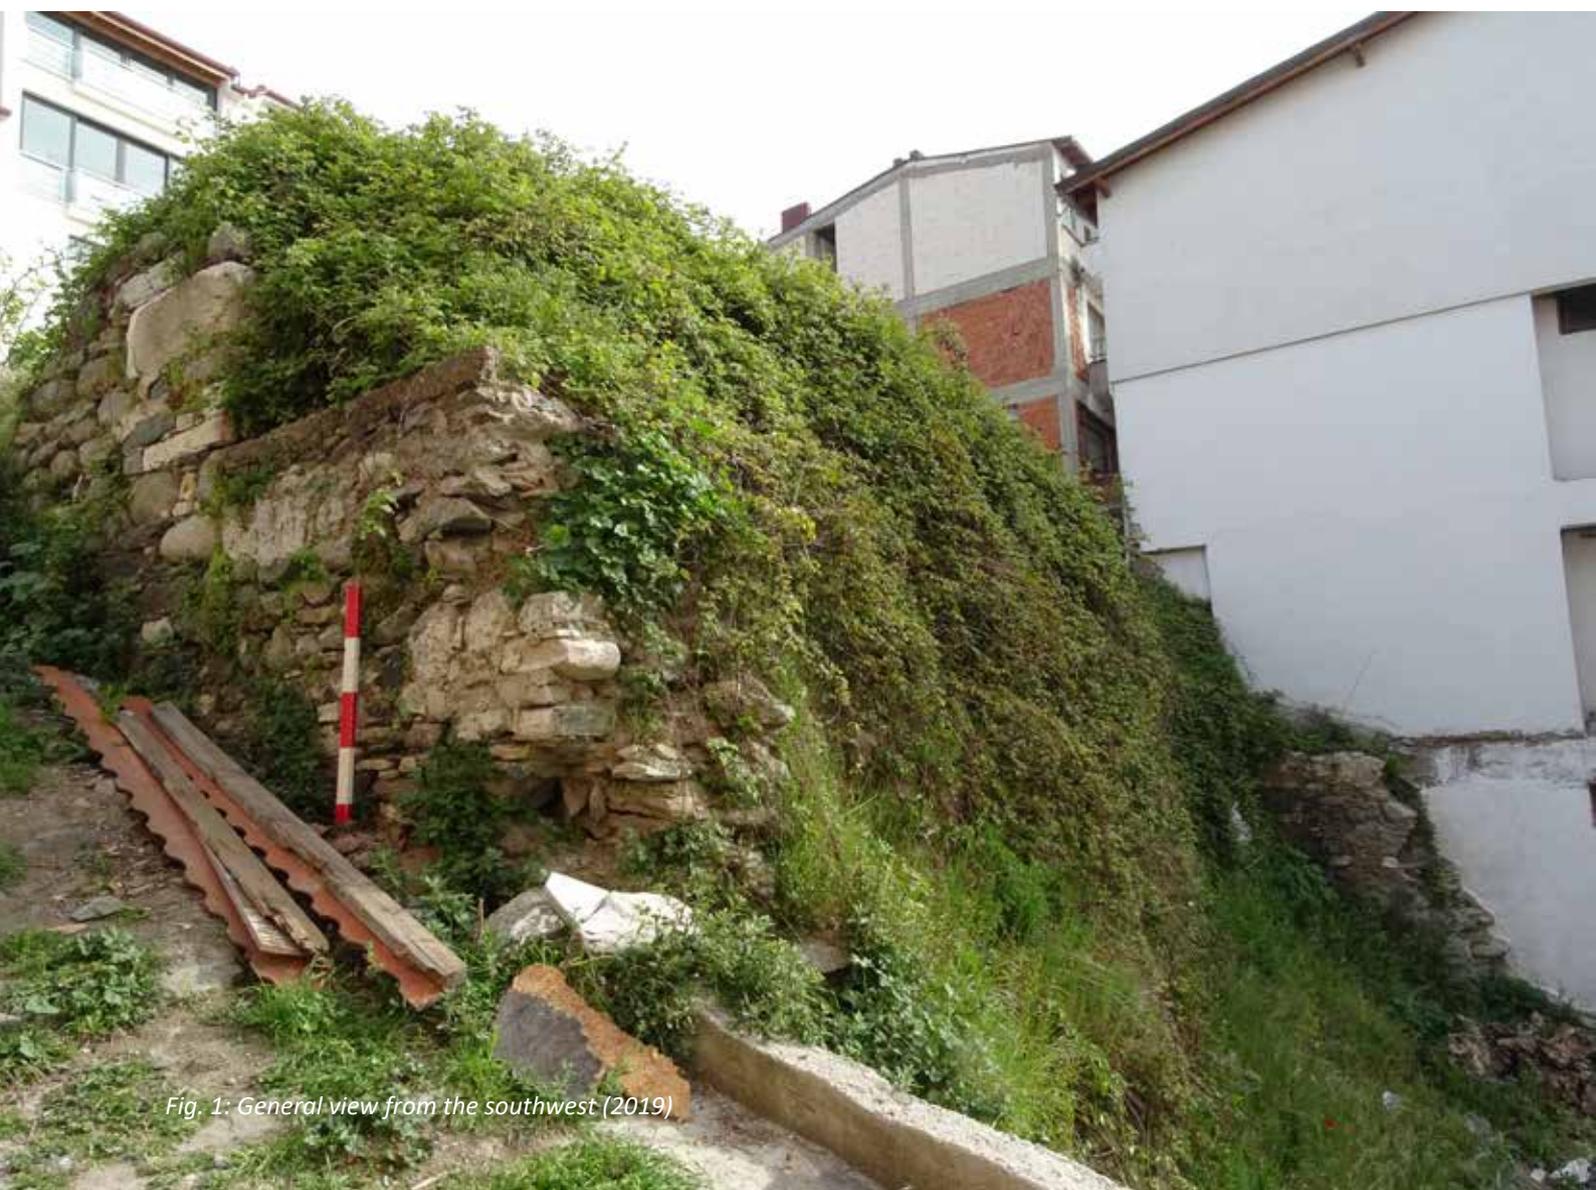
Fig. 1: General view from the southwest (2019)

The synagogue is located on the corner of Recep Gümüş Street and Kalyoz Street in the Merkez District on Marmara Island. The lot is 100 m away from the seashore. It is located on terrain descending from north to south and has an area of approximately 170 m². The building, which is thought to have a rectangular plan, is currently in ruinous condition. Only a small section of its main walls has survived (Fig. 1).

Plant growth in the lot prevented detailed observations regarding the eastern and southern boundaries of the structure. There is a reinforced concrete apartment in the neighbouring lot to the east, which adjoins the main wall of the building (Fig. 1).

The building is of importance for it provides information about the existence of a Jewish community on Marmara Island; however, it has mostly decayed and collapsed due to neglect. Except for the main walls of unknown original height, architectural-structural elements related to the building's plan or interior spatial arrangement could not be identified on site. New information about the building can be obtained through an excavation within the structure, conducted under the supervision of the Ministry of Culture and Tourism. Access to the lot should be controlled and plant growth should be stopped to prevent further damage to the remaining elements of the building.

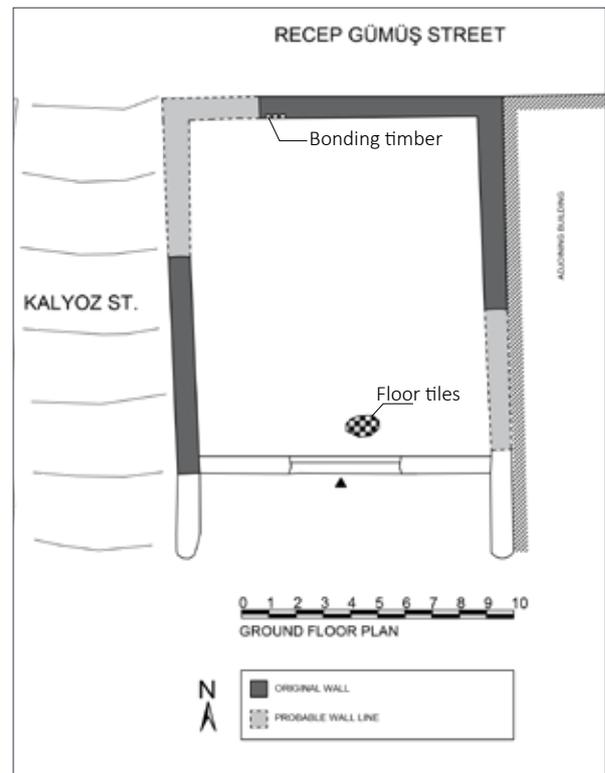
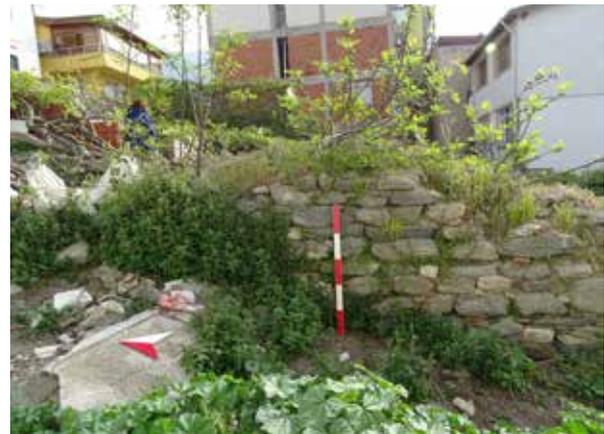
Fig. 2: Western façade detail and sill stone fragment (2019)

The western façade of the building that faces Kalyoz Street is approximately 13.7 m long. The northern end of the rubble masonry wall has fallen, while the remaining section in the south stands about 1-1.5 m above ground. Large stone blocks are used in the southern corner to reinforce the masonry (Figs. 1-2). On the western façade, the wall course continues from the corner to the neighbouring building –or possibly the courtyard– to the south with a level difference. Approximately 2-2.5 m of this wall remains.

There is a stone fragment on the pavement of Kalyoz Street, which probably belonged to the doorsill of the courtyard gate. The location of this fragment indicates that the original gate was probably located on the southern or western façade (Fig. 2).

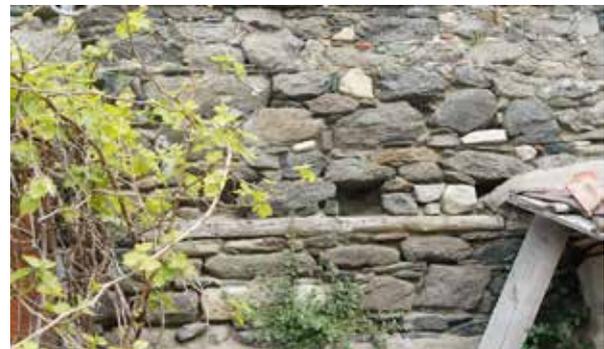
Fig. 3: Timber wall plate in the northern wall and beam holes (2019)

façade. The 3.5-m-long section of the wall near the western edge is collapsed. On the inner surface of the wall, there is a timber wall plate with a course of rubble on top that has recurring beam holes (Fig. 3). These must either be related to the lost floor beams of the women's gallery (*mechitza*) or the timber trusses.

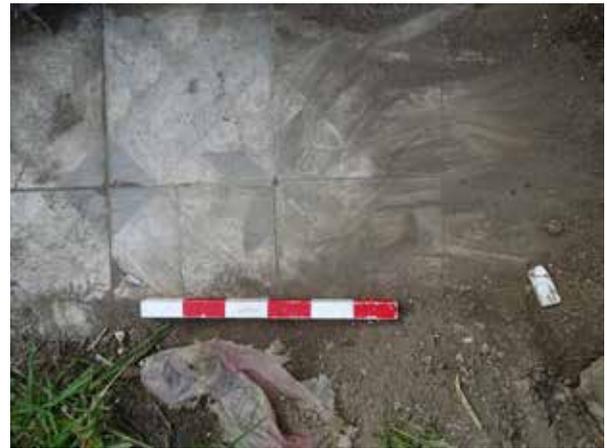
Fig. 4: Details of the terrazzo tiles flooring (2019)

entire area. Flooring of 20x20 cm cement tiles is seen in a small area (Fig. 4). This flooring, which can be considered as modest, provides information about the original floor level and material.

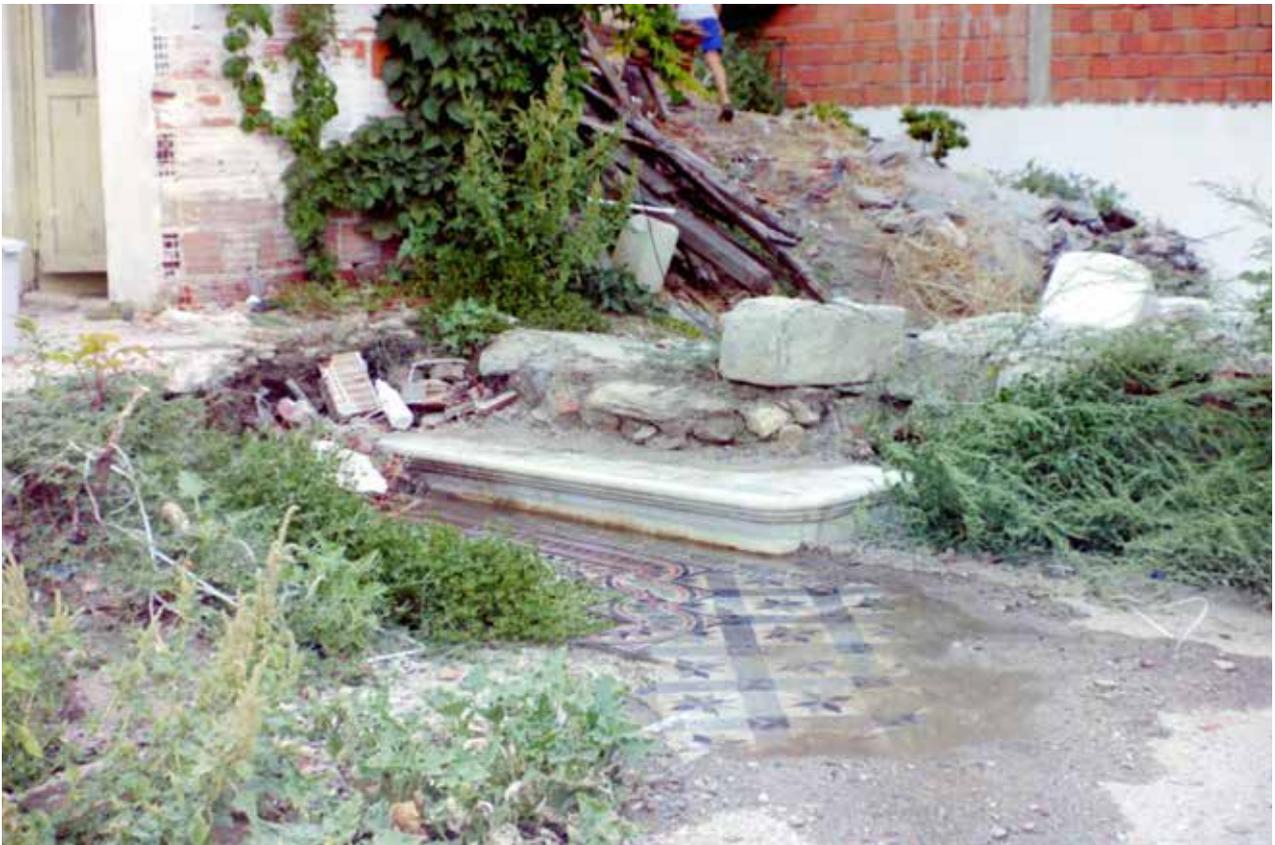
The space of worship can only be evaluated based on the photographs taken by Tanyeli and her team in 1999. According to these, the entrance –with an inscribed doorsill– is in the middle of the southern wall (Fig. 7). There are the traces of the holy ark (*hechal*), where the Torah scrolls were kept, with a marble step in its front on the interior of the eastern wall (Fig. 5). The *tevah*, which was once in the middle of the space, is surrounded by terrazzo tiles that have geometric and stylized floral patterns (Figs. 5-6). The void between western and

Fig. 5: Tanyeli no.46 Prayer hall, looking east, the marble step in front of the hechal, terrazzo tiles flooring, and the vegetation on the left in the place of tevah (1999)

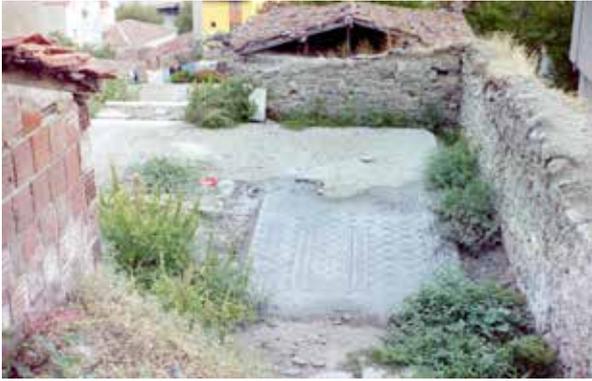
Fig. 6: Tanyeli no.40 Western half of the prayer hall, looking south, terrazzo tiles flooring (1999)

southern walls as well as the tile flooring in the western half indicate that there was a row of timber seating mounted on at least these walls, which is a common feature for such a small-scale building (Fig. 6). Since there are not any entrances despite the beam holes in the northern wall, the women's gallery (if there was one) would have extended along the northern and possibly the western wall, and access would be provided via an outdoor staircase to the south. According to the liturgical requirements of Judaism, every synagogue must have a courtyard. The courtyard of this building might have been to the south and its entrance could have been from the western or southern façades.

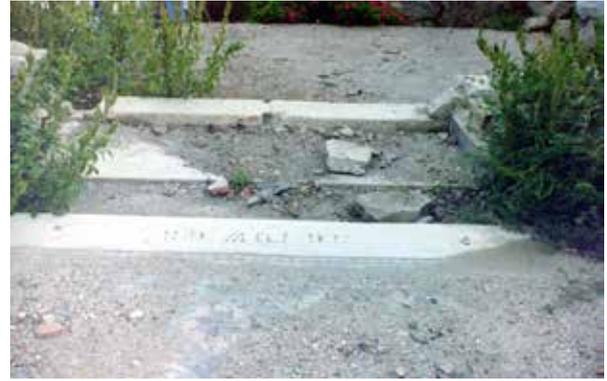
Fig. 7: Tanyeli no. 45 Doorsill with Hebrew inscription (1999)
