Agios Andreas Monastery

District of Erdek, Karşıyaka Neighbourhood, Fener Adası Locality	Construction period/date: Beginning of the 20th century
GPS: 40°27'30.0"N 28°04'23.6"E	Current status: Abandoned
	Ownership status: Private ownership
Registration date and number: Bursa KTVKKBK 08.10.2009 - 5080

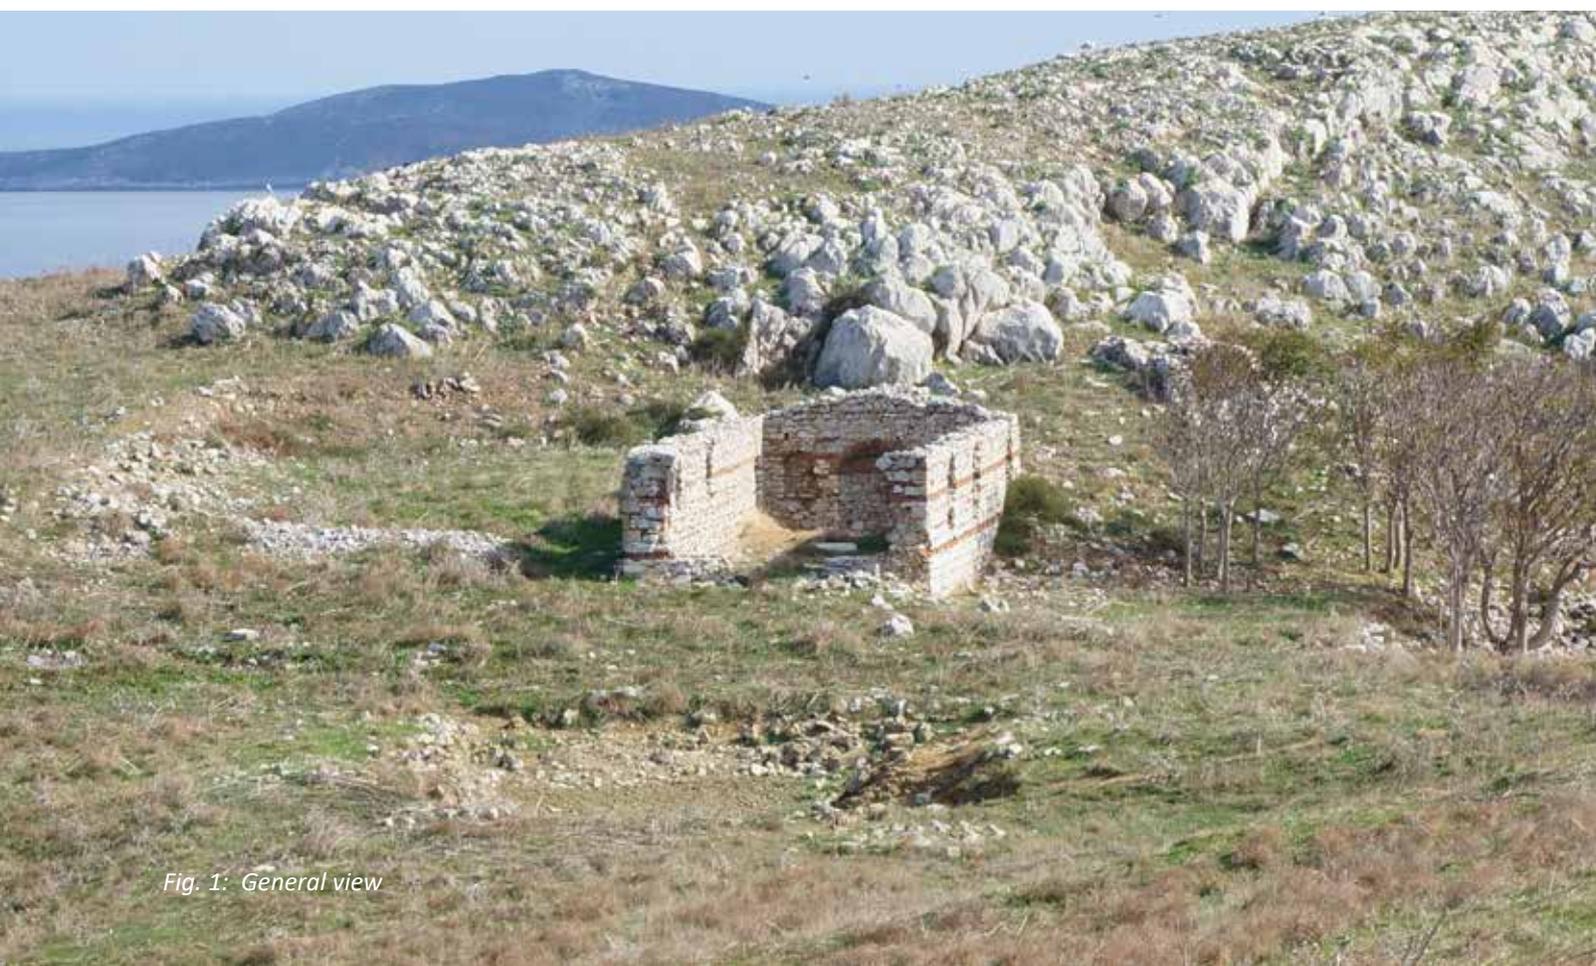
Fig. 1: General view

The plan organization of the church on the second terrace can be traced because its main walls have survived (Fig. 1). The western wall of the church, where the entrance was located, has completely collapsed. There are three round, arched windows on the southern and northern walls. The curving niche covered by an arch of solid bricks on the eastern wall is the apse (Fig. 2). There is a square niche with a lintel to the south of the apse and another niche with a round arch to its north. The apse is not attested on the exterior. The roof has not survived, but the triangular pediment on the eastern wall indicates that it was a gable roof (Fig. 3).

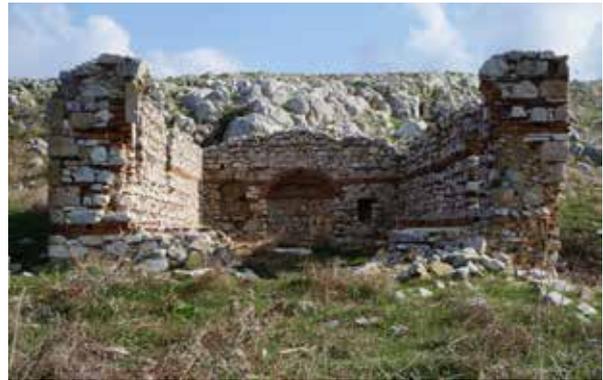
Fig. 2: Main wall to the east and the apse

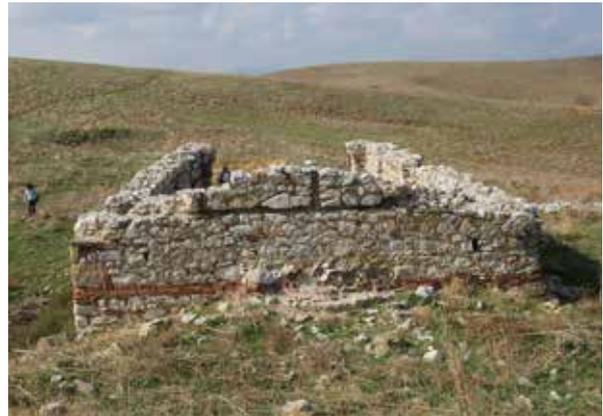
Fig. 3: Triangular gable

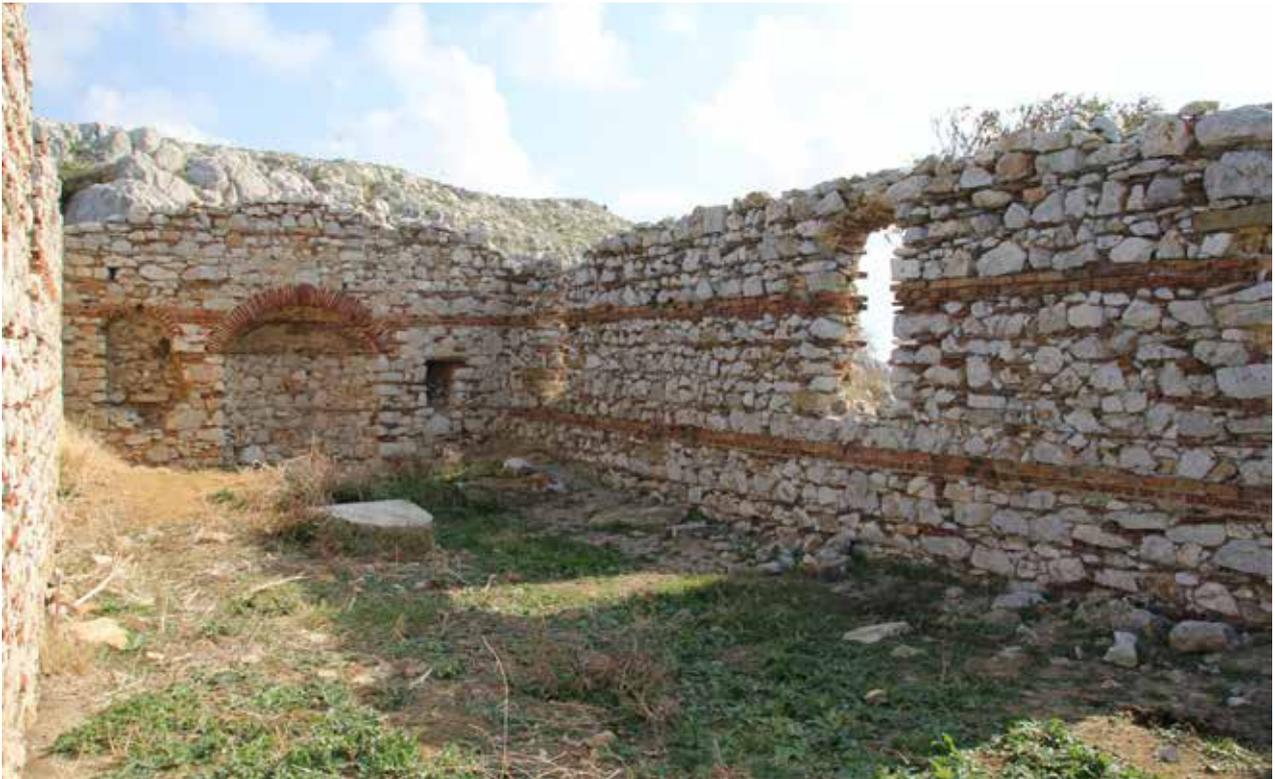
the solid bricks, forming the arch of the niche in the north of the eastern façade, are 21x10x5 cm. The curving apse is formed by square bricks with dimensions of 27.5x27.5x3 cm. The thickness of the brick belt courses is 13~14 cm (Fig. 4).

Fig. 4: Brick belt courses

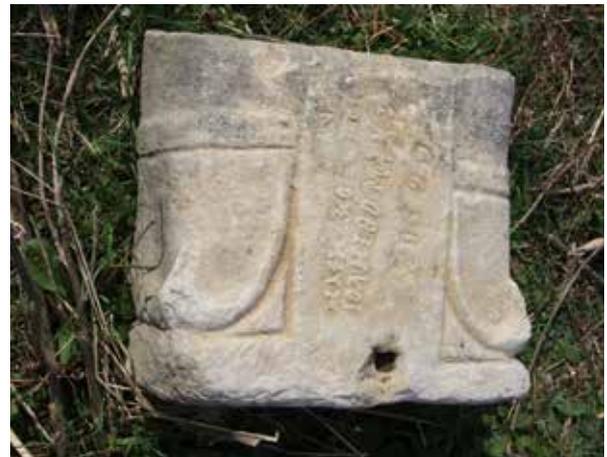
Fig. 5: Inscription dated 1699
