Kartal House ('Yılanlı' House)

District of Marmara, Asmalı Neighbourhood, Köyiçi Locality	Construction period/date: Late 19 th century
GPS: 40°37'02.2"N 27°42'22.0"E	Current status: Abandoned
	Ownership status: Private ownership
Registration date and number: Bursa KVKBK 18.08.1990 - 1295

Kartal House ('Yılanlı' House): Conservation Report of Wall Paintings

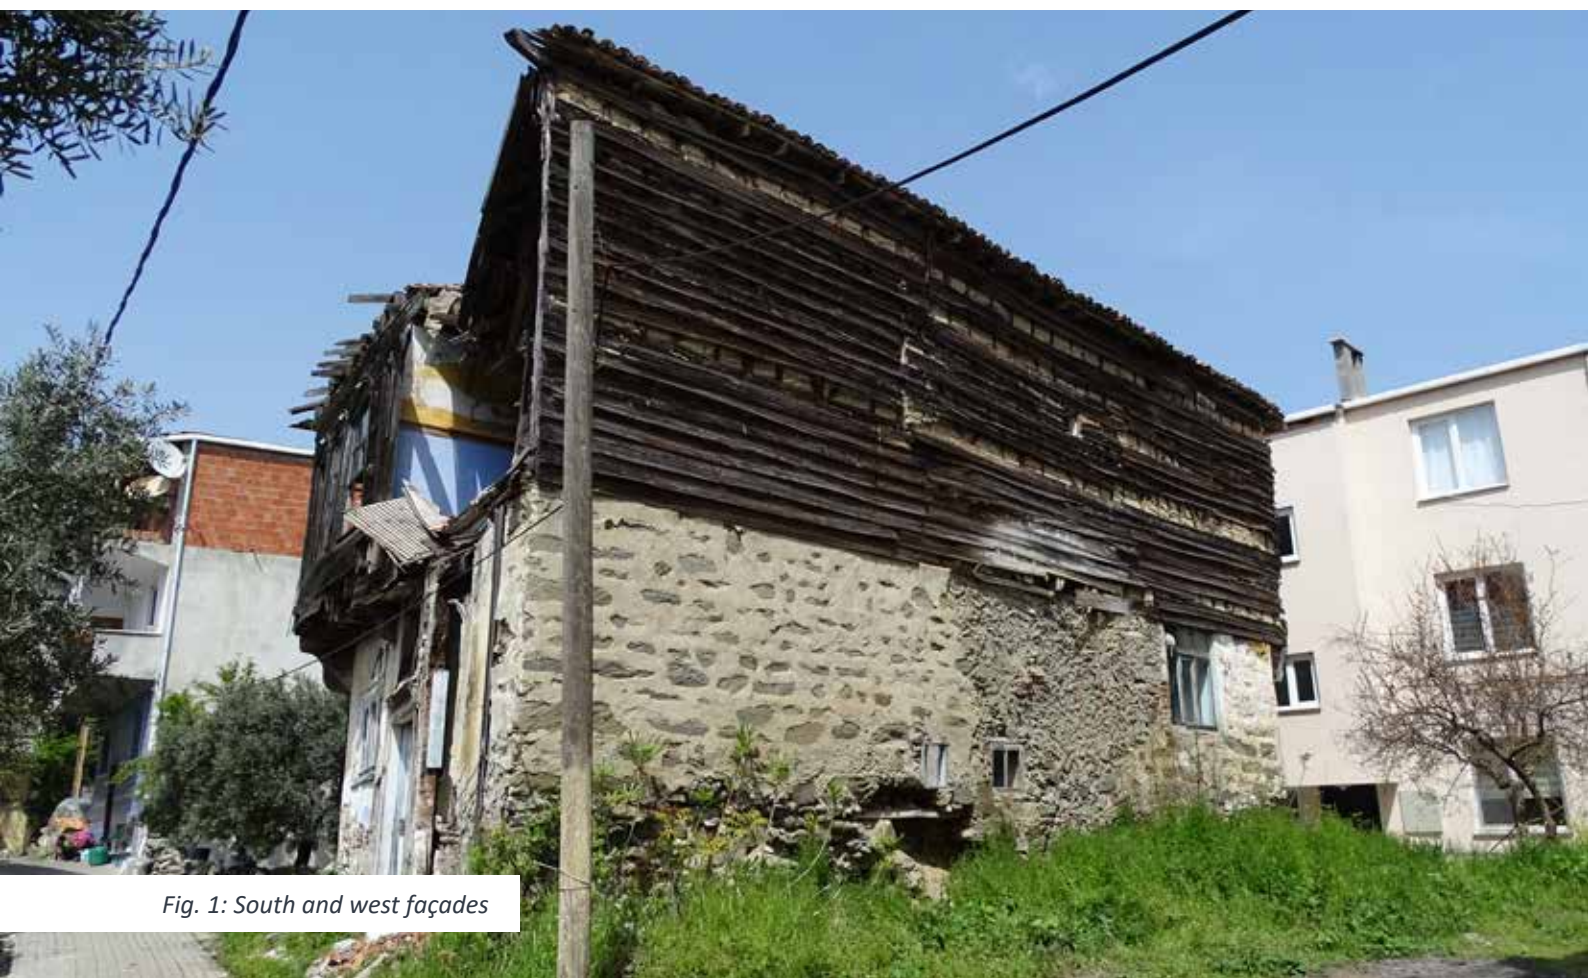
Fig. 1: South and west façades

to the window in the east, indicating repairs (Fig. 1). The western and northern walls have a timber frame with rubble infill. Bricks are seen in both walls as well as the eastern one. The stone walls are plastered with earth-based plaster and limewashed. The southern wall of the upper floor is built of timber frame with mudbrick infill and clad with overlapping timber boards (*yali baskısı*). The eastern, northern, and western walls of the upper floor are clad with wood laths (*bağdadi*). The building has a four-sided hipped roof.

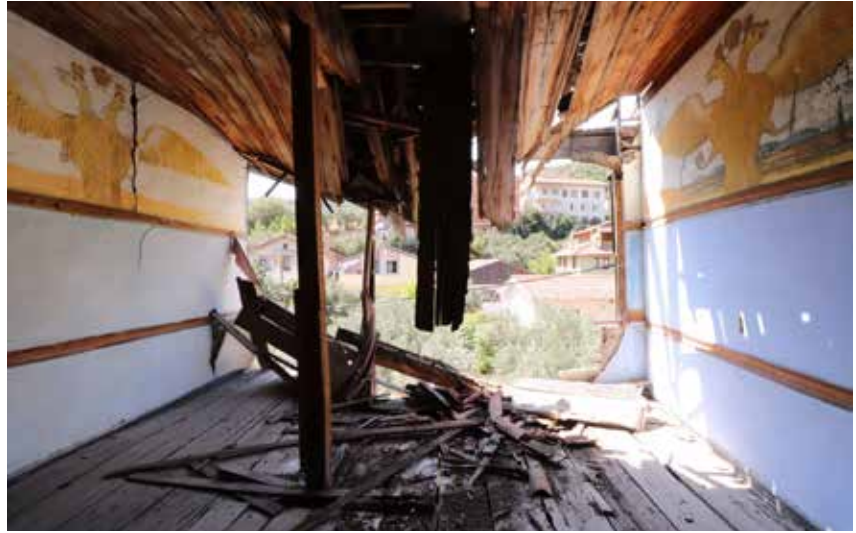
The stairs starting from the kitchen door extend southward and turn west to provide access to the upper floor (Fig. 3). Here, there are two rooms to the east of the L-shaped *sofa* and one room to the northwest. The western wall and the superstructure of the western wing of the *sofa* have fallen (Fig. 4). The north-south hall that connects these rooms is considered part of the *sofa* and called *vliakos* in Greek (βλιακός; ηλιακός, derived from the word 'sun'). These rooms are illuminated with plenty of windows, providing a very commodious space. Their wooden doors are double-winged

Fig.4: Current condition of the west wall

The plan organization and spatial features of the abandoned building are discernible. However, it has been neglected to such an extent that it can only withstand the effects of earthquakes or rainwater for one or two more years at most. Especially the large-scale collapses in the roof and openings pose a significant threat to the wall paintings surrounding the *sofa*. The cracks in the walls and the fissures in timber posts are significant. Partial collapses in the walls of the ground floor provide uncontrolled access to the building, making it susceptible to vandalism. Although there are traces of repair on the southern wall, the western wall is about to collapse entirely. This western wall also poses great danger for the surroundings and passers-by.

are sophisticated to a degree rarely found, perhaps not found, in Anatolia. In order to prevent further structural deterioration such as the collapse of its walls and roof, the house should be structurally supported with additional posts.

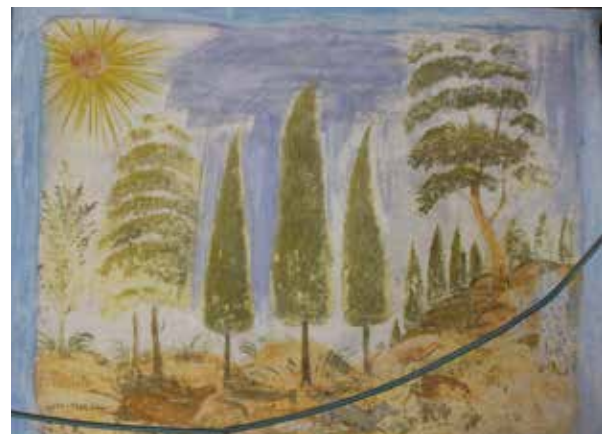
Fig.10: Landscape depiction in the south part of sofa's east wall

condensation cause various deteriorations not only in the building materials but also in the paint layers. Damages in the paint layers of the *sofa* include chalking, disintegration, cracks, flaking, and spalling due to the uncontrolled temperature, humidity, and water penetration. Another factor accelerating the deterioration of paint layers on all wall surfaces is water leakage due to the collapse of the roof. This factor plays an active role in the deterioration of both building materials and paint layers, making the latter vulnerable to degradation. The wall paintings on the eastern wall to the south of the doorways are only partially covered with blue paint, while those to their north are completely obscured by it. The original wall painting is visible in the part where this blue wash is lost (Figs. 10, 16).

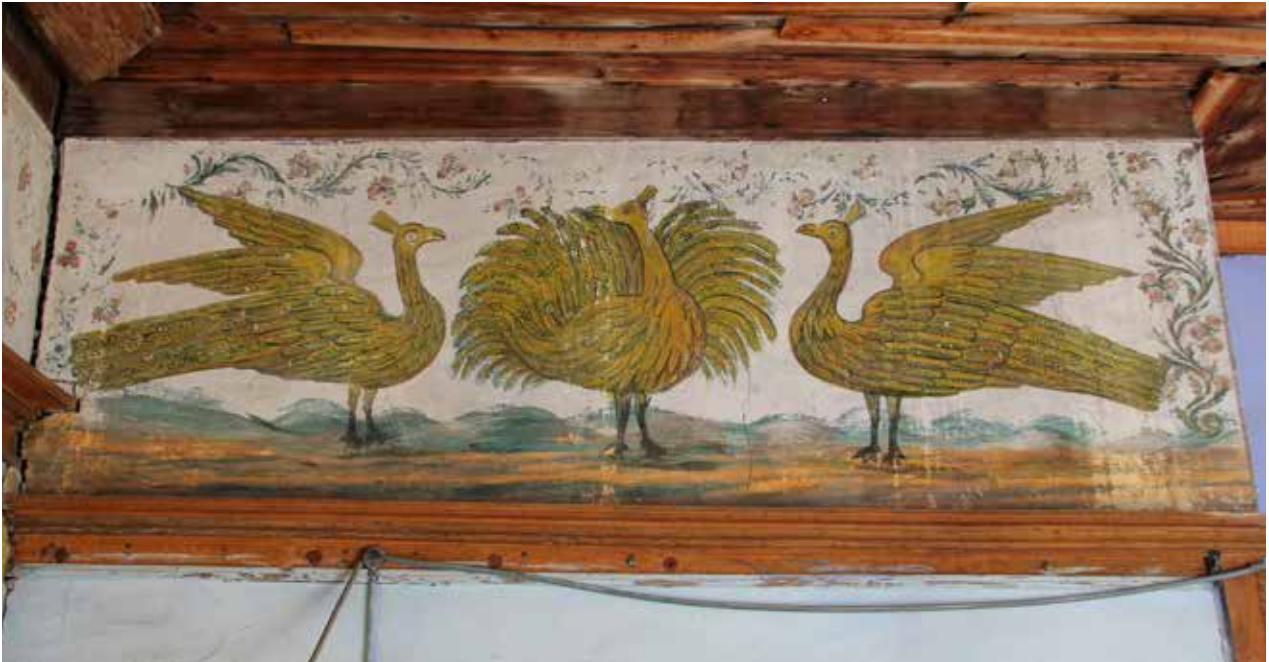
Fig.11: Current condition of the south wall

Cracks and capillary cracks are observed on the paintings on the southern wall. The wide detachments at the intersection of the eastern and western walls do not only threaten the wall paintings but also the building's structural system (Fig. 11). Water penetration is a prominent problem because the roof and the western wall have partly collapsed. If water is not prevented from entering the building, it is likely that microorganisms, algae, and lichens will proliferate, and that the movement of salts in the soil and building materials will cause further physical, chemical, and biological issues. These problems may be compounded by other environmental factors, thereby accelerating the deterioration of the structural system as well as the ornamentation. Large cracks are observed over the doorways in the *sofa*'s eastern wall (Fig. 7). There are capillary cracks and old repair plaster above the window on the northern wall of the *sofa*'s north wing (Fig. 8). On the northern wall of the *sofa*'s western wing and the western wall of the northern wing, in the areas with the double-headed eagles, the supporting plaster has largely been preserved, but capillary cracks are found on the surfaces of the wall paintings (Figs. 5-6).

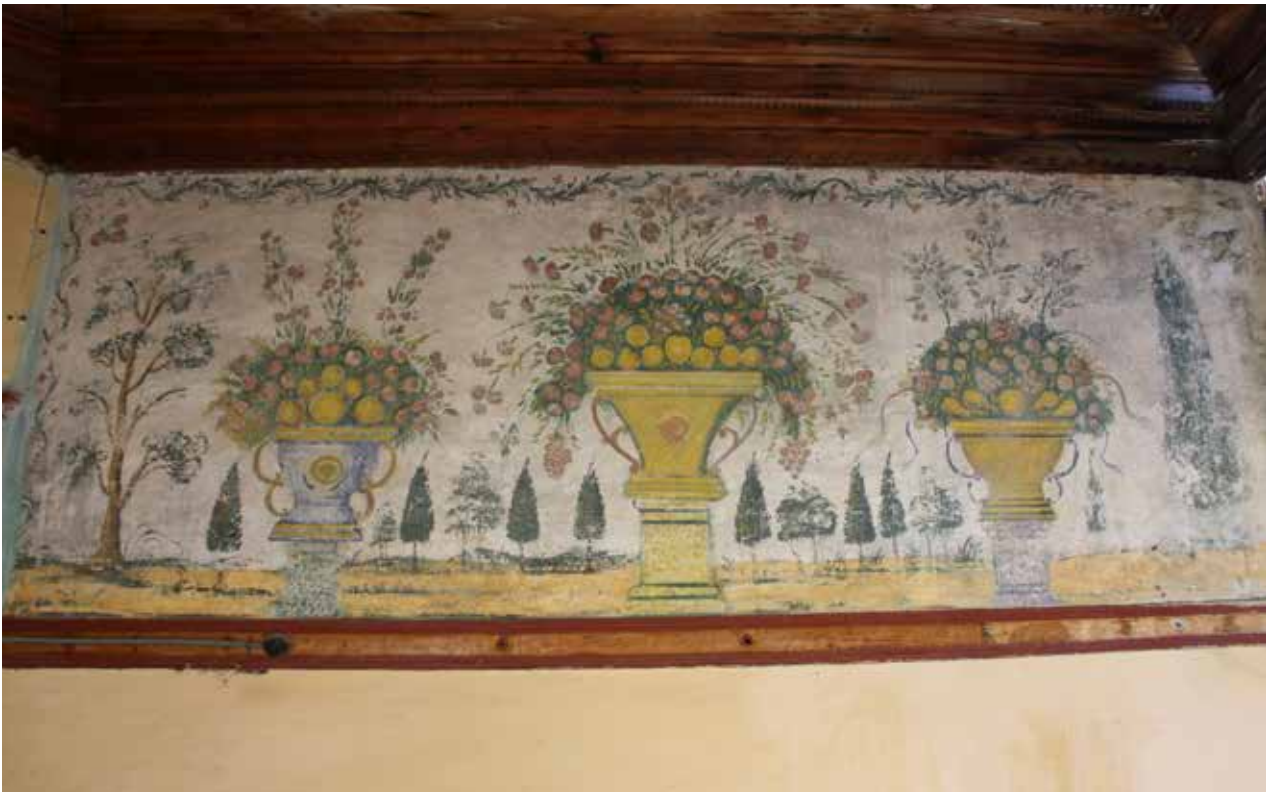
Fig.12: South wall of the northwest room

The northwestern room has problems caused by the collapsed western wall and windows. Loss of plaster is noted in the western section of the painting on the southern wall (Figs. 12, 17). There are also capillary cracks and traces of nails on the paint's surface. The main carrier and support layers of the painting on the eastern wall, however, is generally well preserved (Fig. 12).

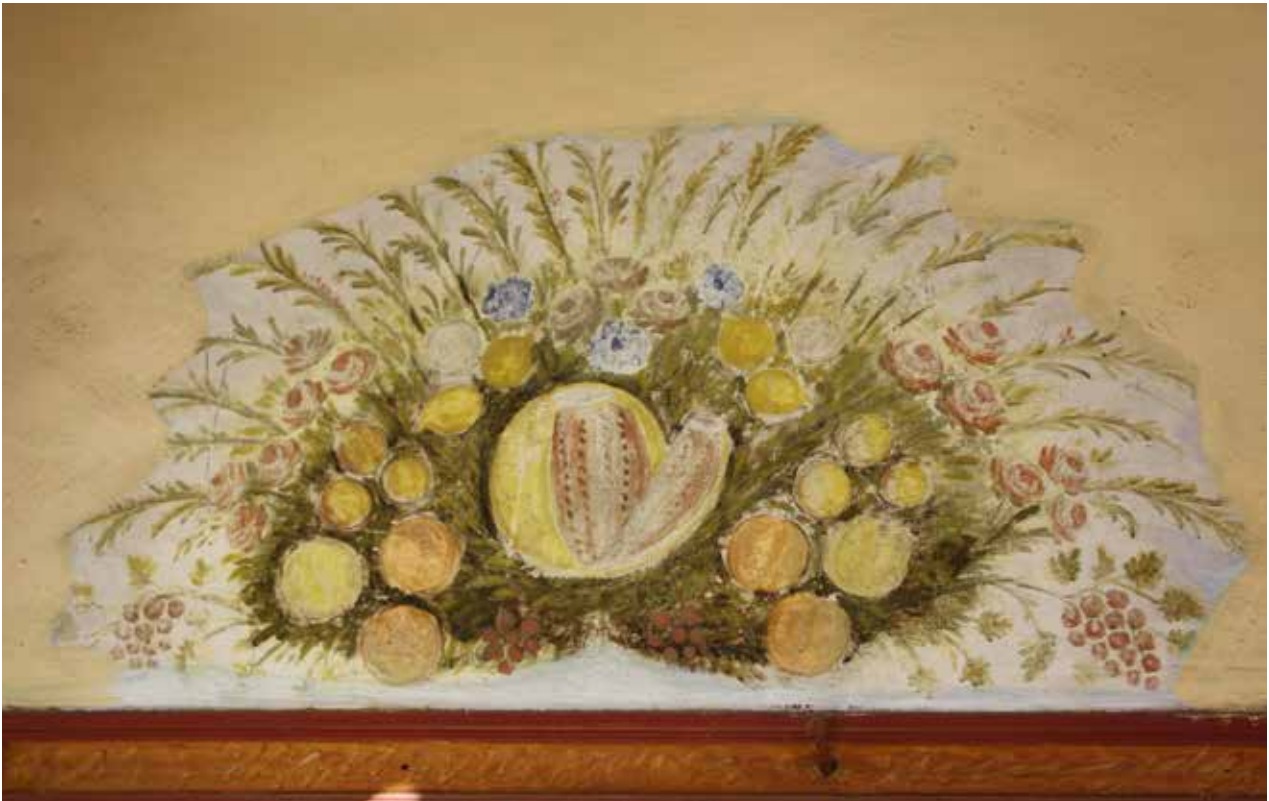
Fig.13: East wall of the northwest room

is better preserved than all the others in this house (Fig. 13). This wall was painted over in peach colour in later periods, but the area where the composition is found was not covered. There is occasionally paint running on the surface. The wall painting on the southern wall has become susceptible to external factors such as temperature, changes in humidity, wind, condensation, rain, sun, and water leakage due to the collapsed western wall (Figs. 12, 17). Therefore, damages such as loss of material, water leakage, and soot were identified on the paint surface. Loss of material was also observed in the painted ornamentation on the exterior brackets due to their exposure to the elements.

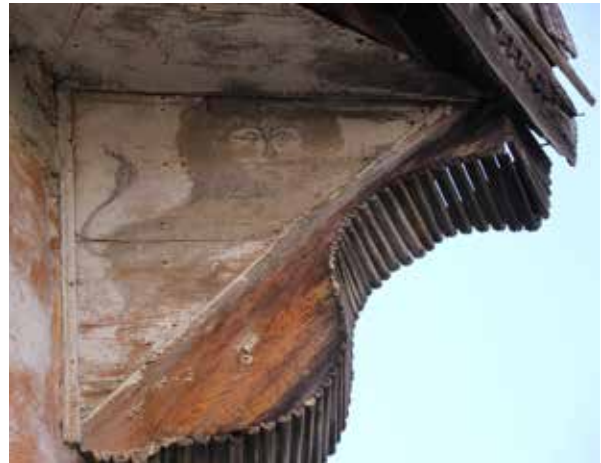
Other decorative elements in the building are found on the brackets on the external façade (Fig. 14). These decorations on timber surfaces are completely exposed to the elements.

Fig.14: Depictions on the brackets (*eliböğründe*)

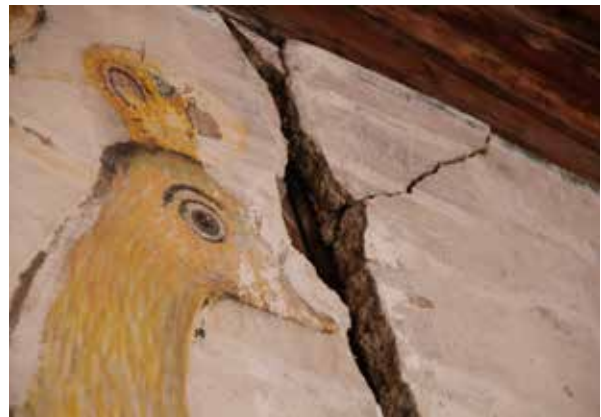
Fig.15: Large crack on the south wall

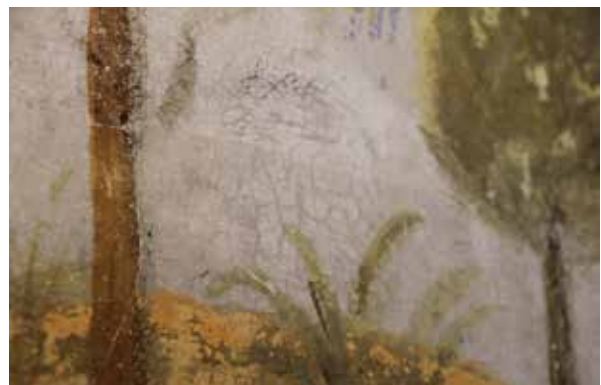
Fig.16: Deterioration of the paint layer on the east wall

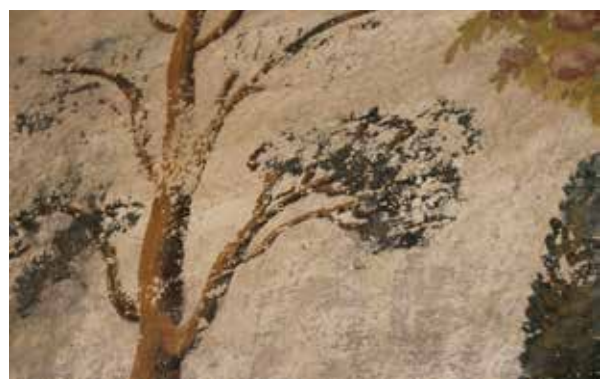
Fig.17: Loss of paint on the south wall of the northwest room
