Mehmet Yelken House

Gamze Özmertyurt

District of Marmara, Ekinlik Neighborhood	Construction period/date: 19th century
	Current status: Abandoned
GPS: 40°32'50.8"N 27°29'14.5"E	Ownership status: Private ownership
Registration date and number: Not registered

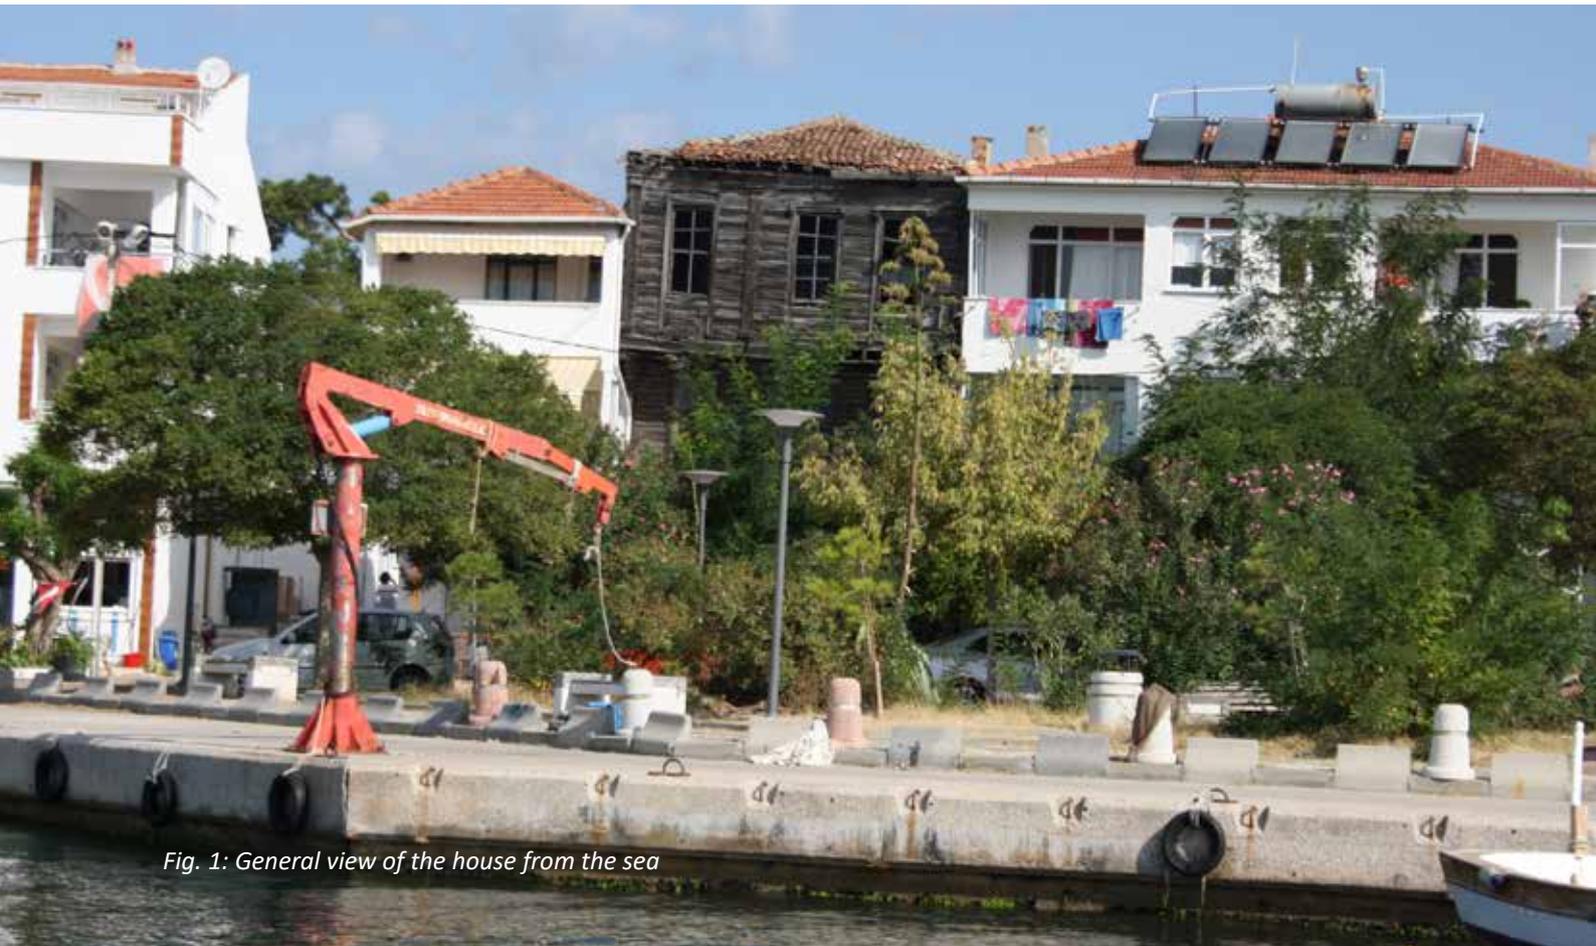
timber-and-tile hipped roof that slopes in four directions (Fig. 1).

Fig. 1: General view of the house from the sea

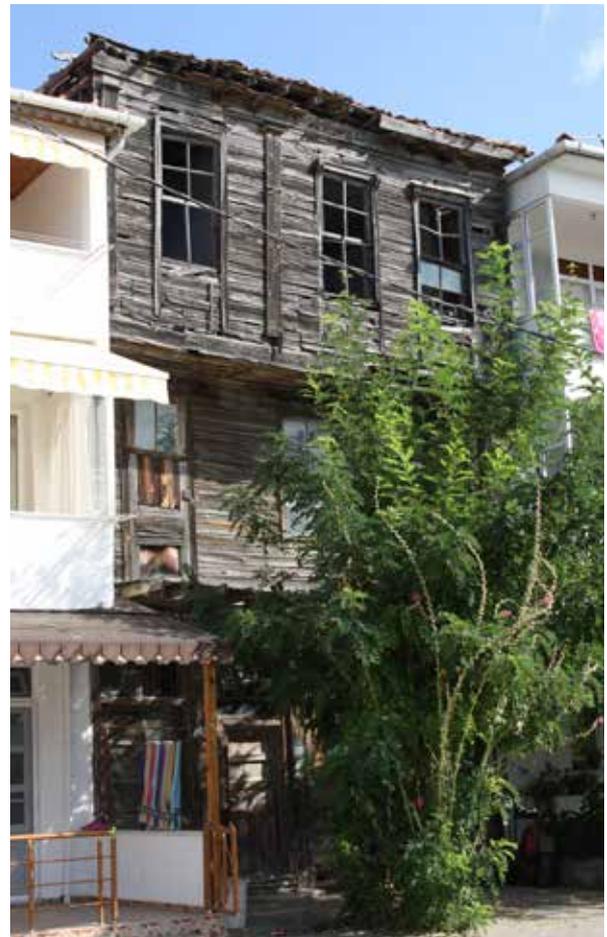
ground floor is a series of timber beams carrying planks, indicating a balcony; the south-western room on the first floor has a doorway opening onto this balcony (Fig. 3). A balcony along the entire façade is a feature rarely attested in traditional Turkish house architecture. The second floor projects out entirely.

Fig. 3: Timber projection at the top level of the ground floor on the south façade

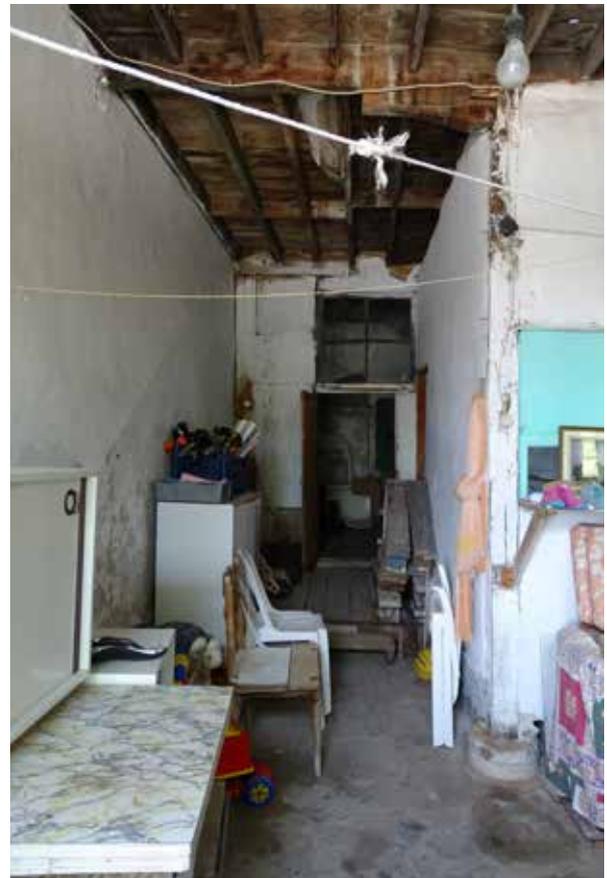
Fig. 6: Southeastern room on the first floor

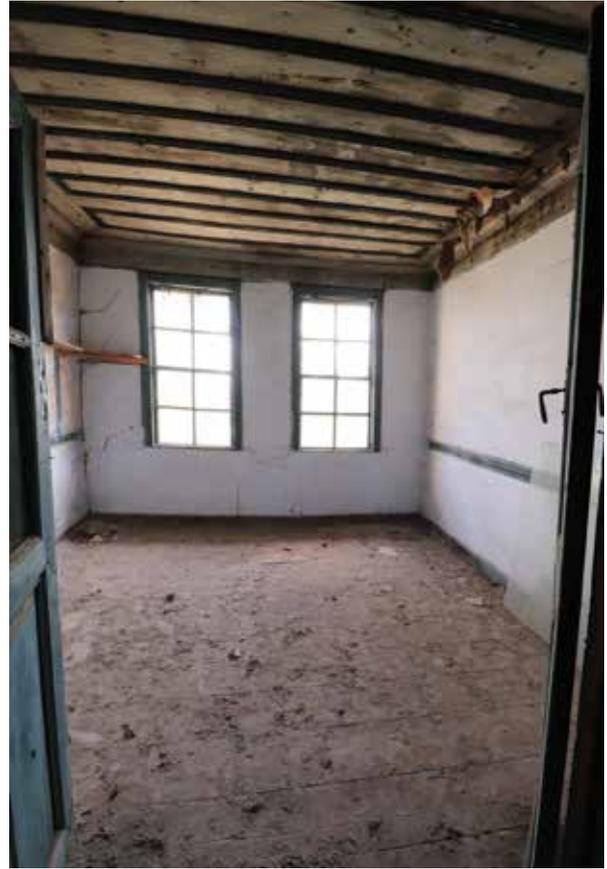
Fig. 7: Second floor sofa and the staircase leading to the roof

The ceiling over the staircase leading to the third floor, which is thought to have existed in the original building but has not survived, has completely collapsed. Apart from the sections of collapsed roof on the second floor, there are losses of infill materials in some of the walls.

The holes created during the later addition of a door to the first floor and the exterior plaster that has been falling off to reveal the brick infill indicate that the building has been under unfavourable circumstances. The conserved parts of the building are the ceilings of the rooms on the first and second floors and the ceiling of the second-floor *sofa*. Additionally, the decay observed in the stairs may be remedied and the staircase can be consolidated.

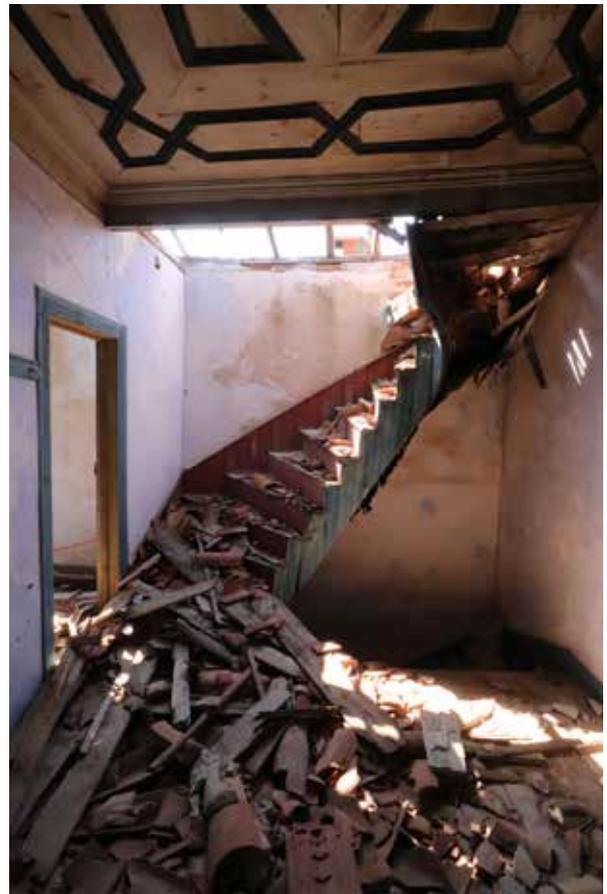
Fig. 8: Southeastern room with decorative ceiling on the second floor

This unregistered building is threatened by neglect. The house should be registered as soon as possible. Although it has a roof, the building is completely exposed to external weathering conditions due to the collapses in its roof structure. The timber ceilings, flooring, and the windows should be cleaned, repaired, and renewed in accordance with their original design. The timber-frame structure should be consolidated as a whole and renewed where necessary. There are undefined spaces that resulted from alterations of
