# Tahsin Tutucu House

District of Marmara, Ekinlik Neighbourhood	Construction period/date: <b>19<sup>th</sup> century</b>
	Current function: <b>Abandoned</b>
GPS: 40°32'50.2"N 27°29'22.3"E	Ownership status: <b>Private ownership</b>
Registration date and number: <b>Bursa KTVKKBK 18.8.1990 - 1297</b>

# Tahsin Tutucu House: Conservation Report of Wall Paintings

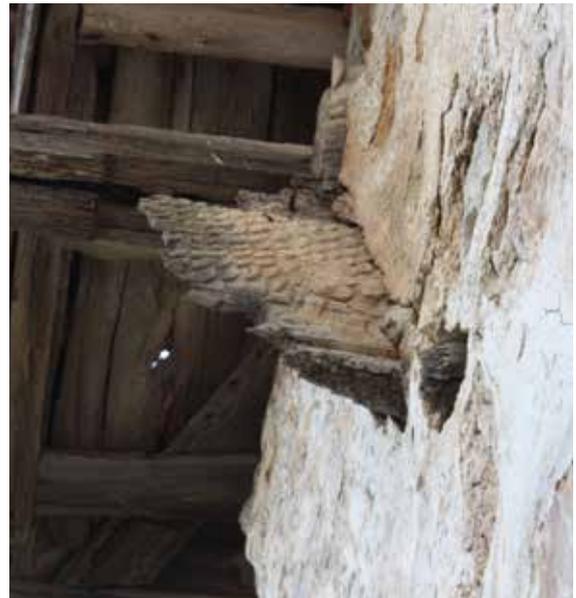
*Fig. 4: Remains of a timber eagle figure at the northern end of the west façade*

stones and rubble seen on this façade are plastered in between. There are the remains of a carved wooden eagle on the northwest corner, underneath the eaves (Fig. 4). This timber piece that resembles a console supporting the eaves has fine workmanship and is in poor condition.

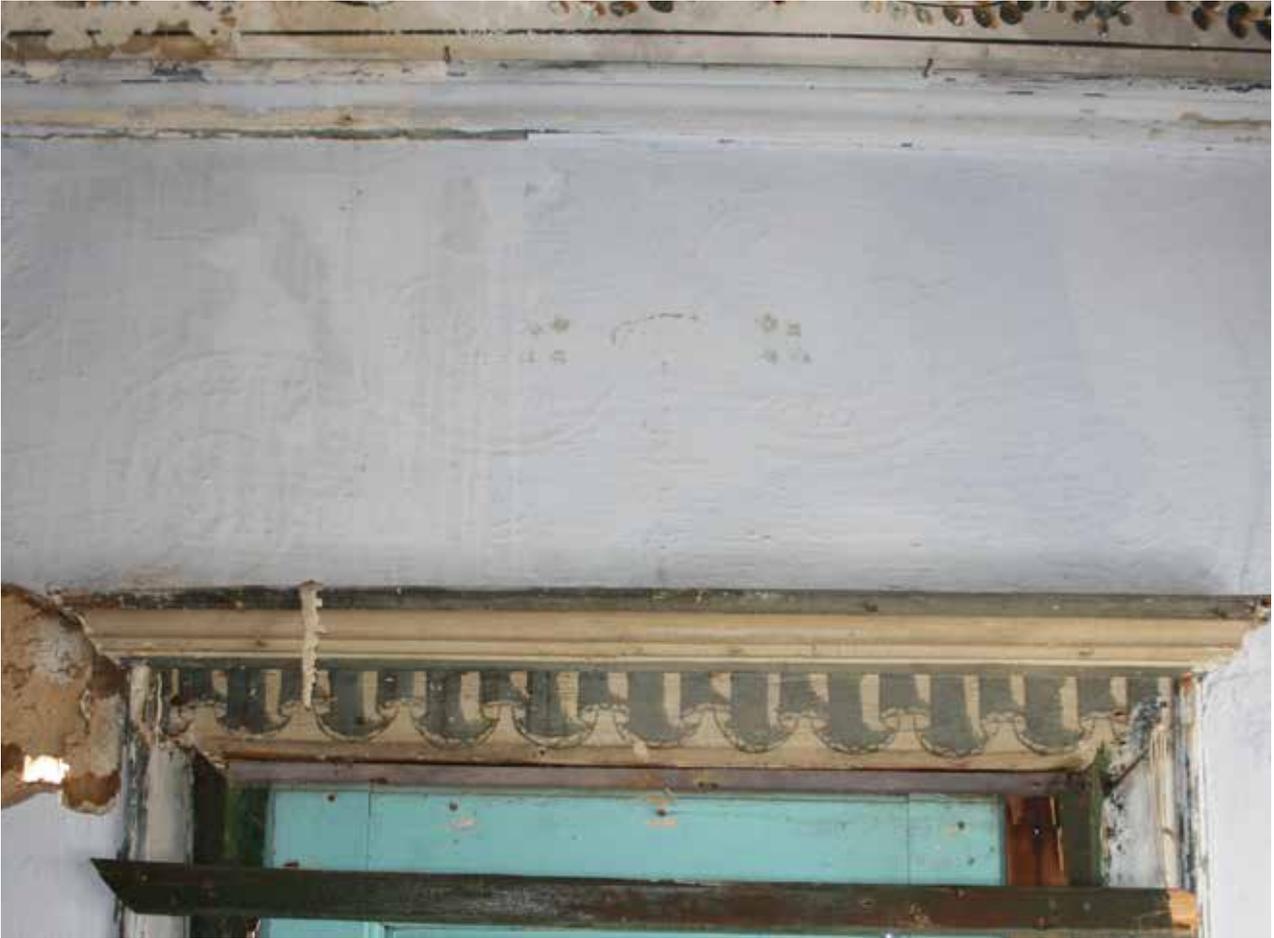
*Fig. 12: The traces of the wall painting plastered with wash on the south wall above the western window*

running along the walls, the baroque decoration on the window lintels in the southern wall, and other ornamentations on the windows, which were later painted over (Fig. 12). In addition to these decorations, there is ceiling lath-work (*çıtakari*) as other important decorative elements of the room (Figs. 9, 13). However, it is noted that water leakage caused by the superstructure has had a significant effect on the ceiling decorations. Therefore, loss of paint, loss of fragments, loss of original decoration, humidity problems, intense dry deposits and loss of timber durability are observed in some parts of the ceiling decoration. The surface of the ceiling decoration was covered with paper in the past. This wallpaper was attached to the timber ceiling, which is thought to be original, with the help of iron staples. During this process, iron staples reacted with water and oxidized, causing the exposure of the ornamented surface to deterioration due to the corrosion of iron.

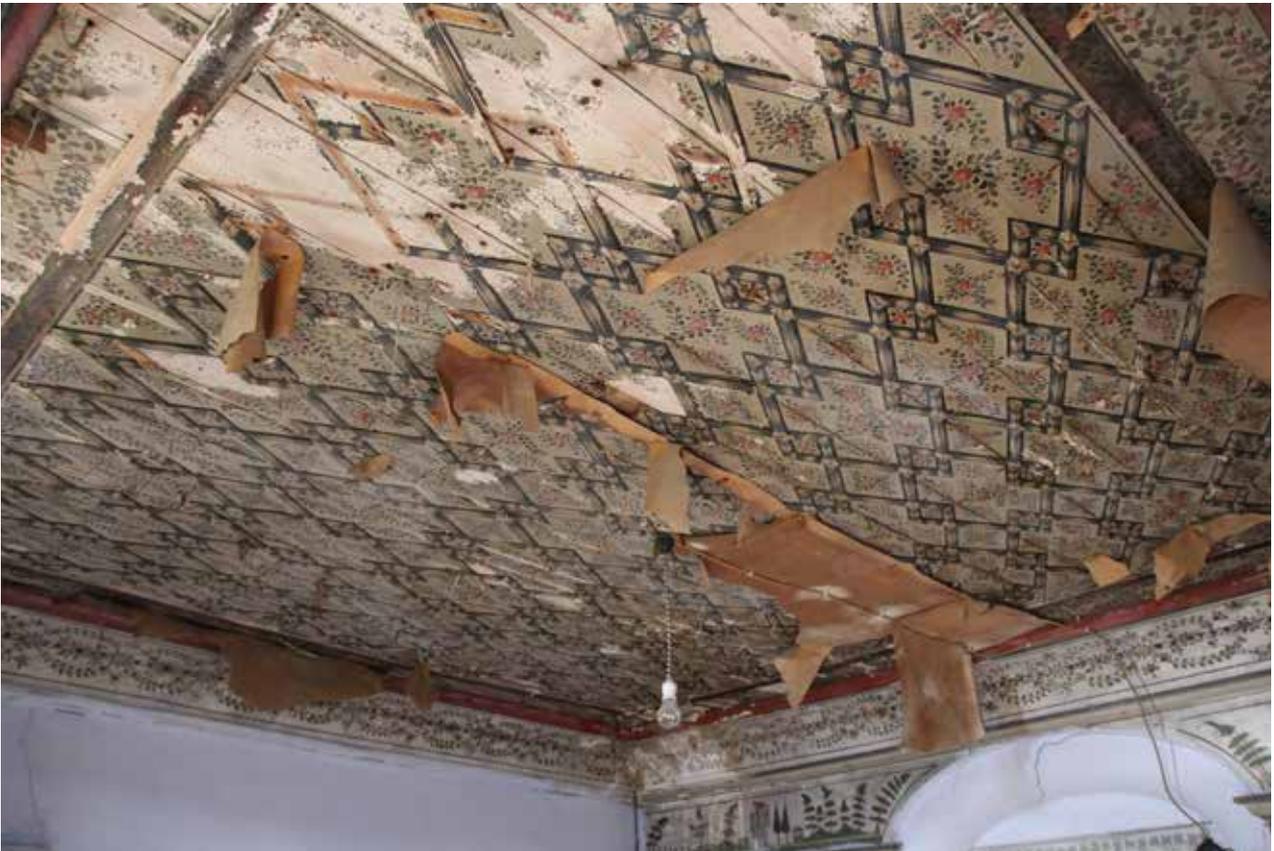
*Fig. 13: General view of ceiling with wooden lath decoration (çitakâri)*

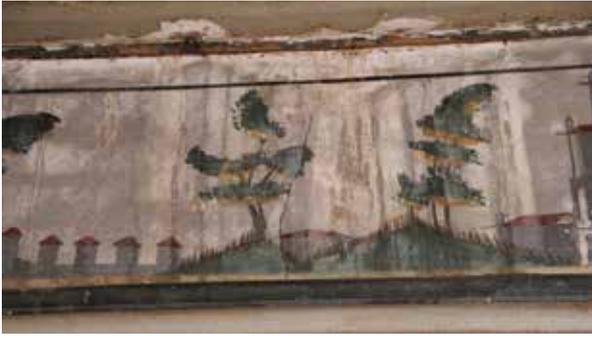
The paint layers are greatly affected by the deterioration of building materials, especially the wall structure and the plaster. Damages to the paint layer –such as flaking, spalling, chalking, disintegration, and cracks– generally occur in environments where temperature and humidity are not controlled. Water leakage is observed all around the room due to the condition of the superstructure. For this reason, water leaks are noted on the surface of the wall paintings and these leaks affect the conservation of the original paint layer and cause various problems due to the lack of temperature and humidity control on the original wall painting surface. In plasters where lime is used as a binding material, water that contains dissolved carbon dioxide reacts with calcium carbonate, causing deterioration. Therefore, changes in the humidity of the walls or the environment, water leaks, rising damp, and condensation cause various types of deterioration in paint layers as well as in other building materials (Figs. 14-15). Since a continuous wet-dry cycle will cause

Fig. 14: Water leaks on the north wall

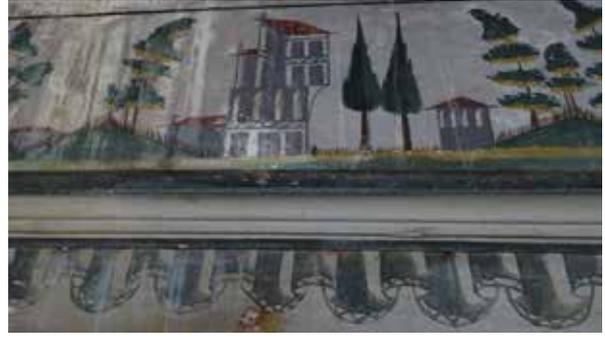
Fig. 15: Water leaks on the north wall and baroque ornamentation details of the closet on the north wall

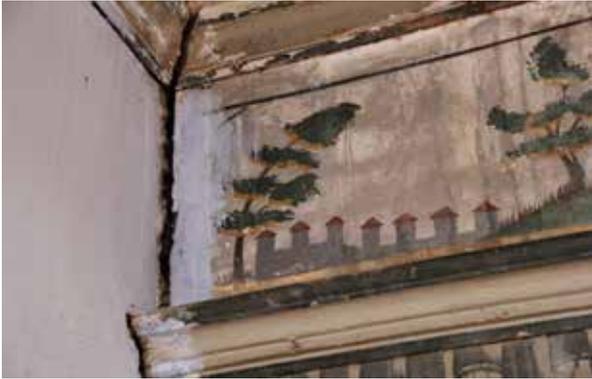
Fig. 16: Wall detachment and poor-quality paint layer

The plaster layer behind the wall paintings on the northern wall is generally preserved, but there are occasional detachments and capillary cracks (Figs. 16-17). There are wide openings, especially at the points where the northern wall intersects with the eastern and western walls, which have probably affected the main carrier (Fig. 16). If these detachments and capillary cracks are not taken under control, serious interventions will be required in the near future. A black soot layer is observed throughout the fresco surface (Fig. 17). Soot may result from moisture problems, uncontrolled water leakage, negligence, the use of stove for heating, lost doors and windows. These causes will bring many other problems, such as the capillary cracks observed in some parts of the fresco surface. There are structural cracks in the paint layers due to the building's extended exposure to improper heat and moisture conditions (Figs. 10, 17).

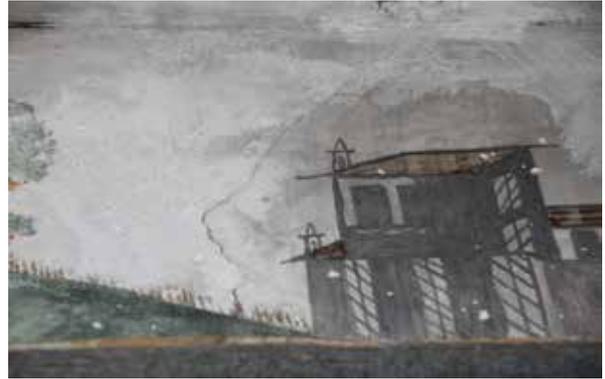
Fig. 17: Poor quality paint, cracks and soot layer
