Metin Doğantimur House

District of Marmara, Merkez Neighbourhood	Construction period/date: 19 th century
	Current status: Abandoned
GPS: 40°35'06.4"N 27°33'11.7"E	Ownership status: Private ownership
Registration date and number: Bursa KTVKKBK 15.1.1996 - 4904

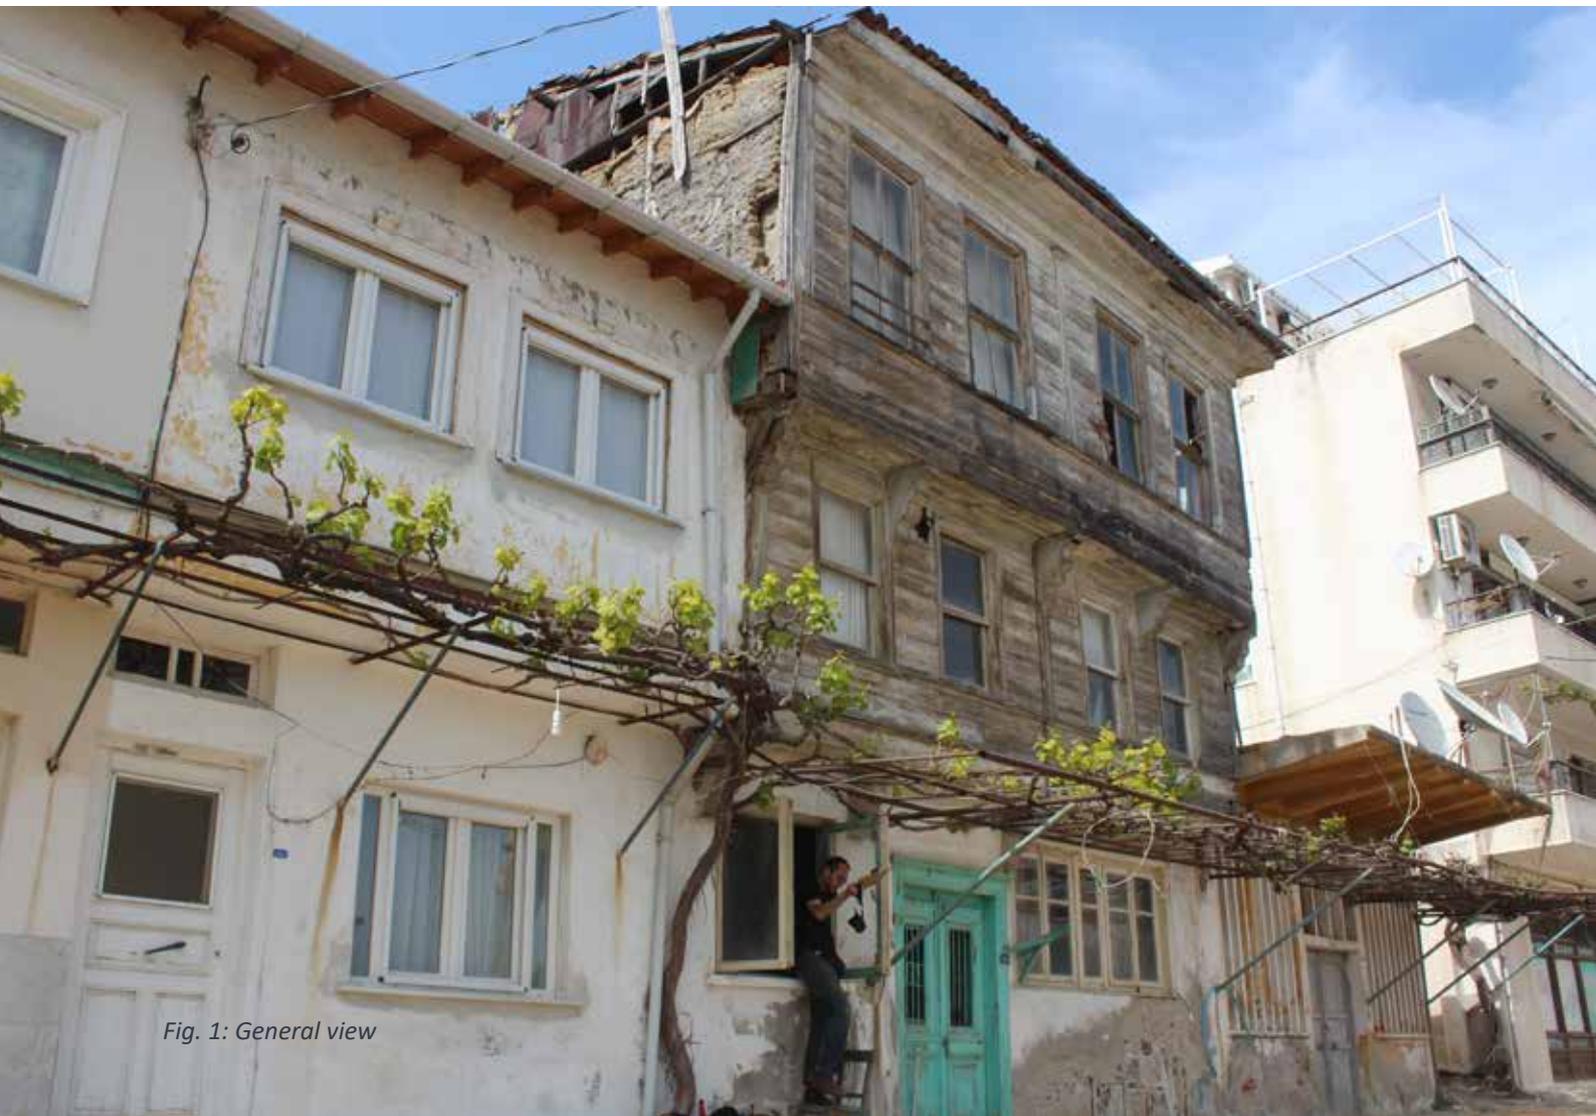
Fig. 1: General view

The building is composed of the ground, first, and second floor (Fig. 1). Since it is adjoined by other buildings only the southern façade and certain parts of the eastern and western façades are visible. The ground floor features a double-winged door and two double-case-ment windows of different sizes on both sides of the door. The first and second floors project outwards by 40 cm at two stages. The first floor has four sash windows with proportions of 1:2. This is also true for the second floor, but the windows of the first and second floors differ in size and their middle vertical jamb arrangement.

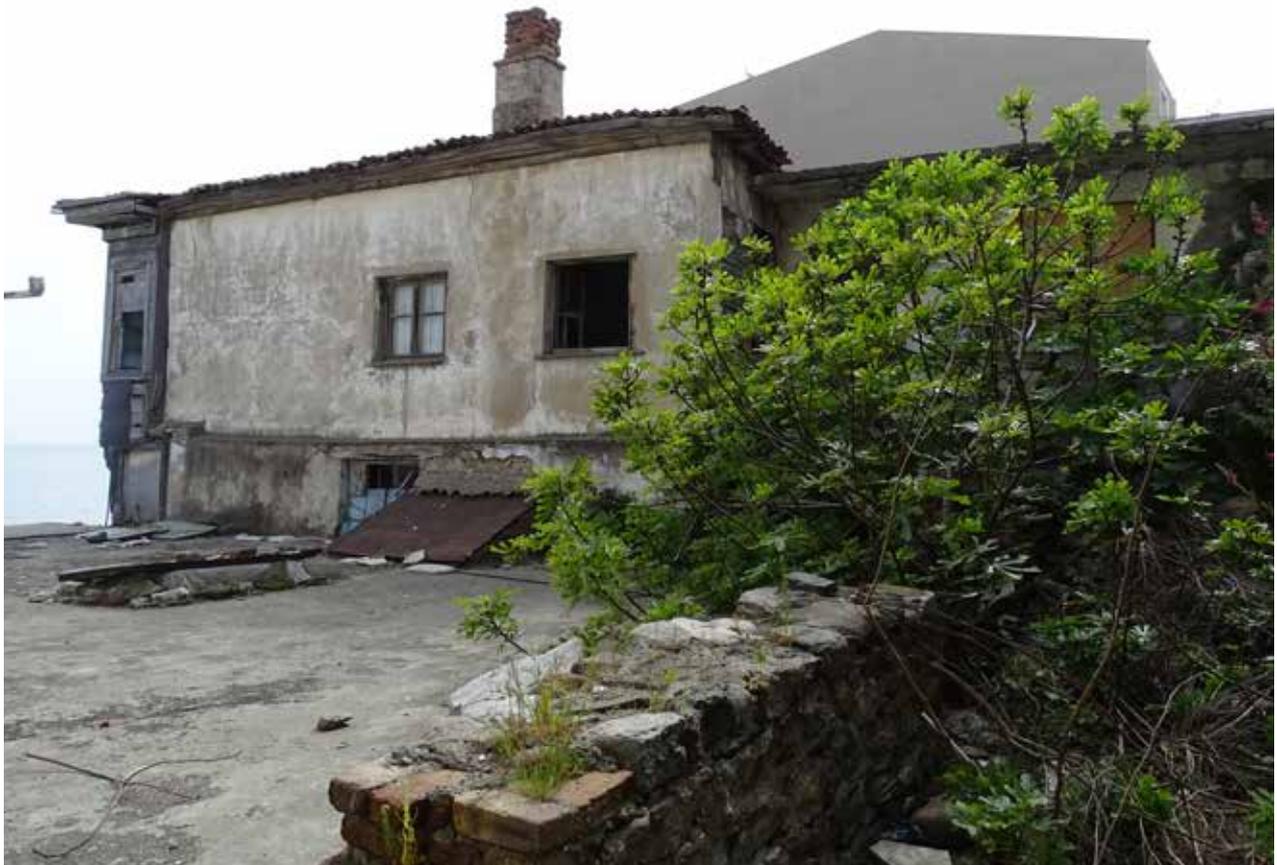
Due to the one-storey structure attached to the residential building, only the first and second floors of the eastern façade can be seen (Fig. 2). On the plastered façade, there is one

double-case-ment timber window on the first floor and two on the second floor. The east-ern side of the timber projection, which is not plastered, has a sash window with a 1:2 pro-portion as well. Reinforced concrete annex in the northern part of the building can be traced on this façade. There are no windows on the western façade, which is only visible at the second-floor level.

Fig. 2: Eastern façade

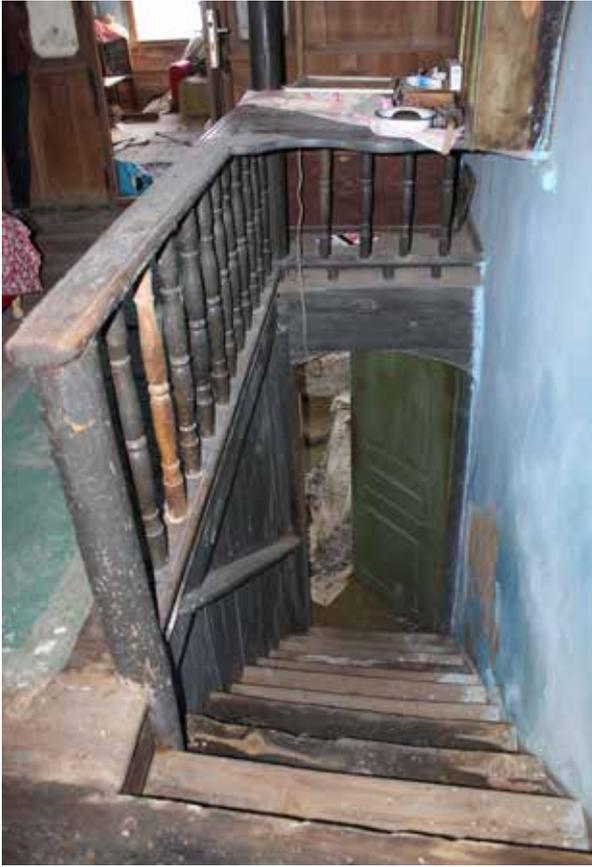
Fig. 3: Stairs between the ground and first floors

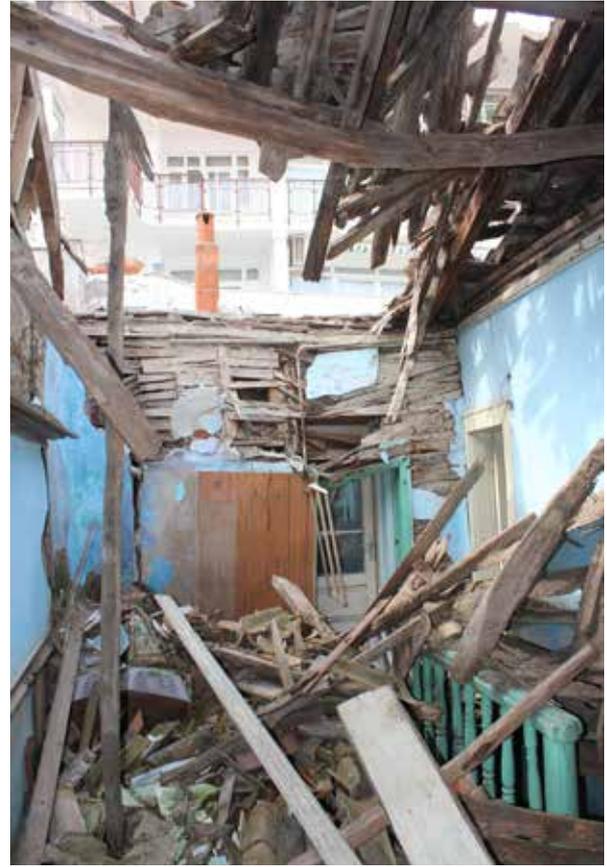
The stairs leading to the second floor are separated from the space by a timber door, similar to the arrangement on the ground floor. The first and second floors have the same layout. Since the roof was heavily damaged and has partially collapsed, the plan layout of the second floor could not be measured but was only examined by visual observation (Fig. 4).

There are structural problems and deteriorations due to the abandonment of the building. The partial collapse of the roof exposed the second floor to effects of rain, snow, and wind, thus it necessitates urgent intervention. The lack of protection against the elements poses a threat to the ground and first floors, which are overall well preserved. The loss of material of plaster and cracks in this layer are observed on all of the walls. Some of the flooring has caved in due to the roof's collapse. There is loss of material in the timber, overlapping panels on the façade, the ceiling of the main entrance hall, and the timber brackets supporting the projections.

Fig. 4: Collapsed roof and damaged second floor

The cave-in creates intense pressure on the building, especially at the second-floor level, and causes damage to the walls. Frame reinforcement must be applied as an emergency measure at this level.
