# Temel Şorta House

*İnci Türkoğlu*

District of Marmara, Asmalı Neighbourhood, Köyiçi Locality	Construction period/date: <b>Second half of the 19<sup>th</sup> century</b>
GPS: 40°37'02.3"N 27°42'25.8"E	Current status: <b>Abandoned</b>
	Ownership status: <b>Private ownership</b>
Registration date and number: <b>Bursa KTVKKBK 15.01.1996 - 4904</b>

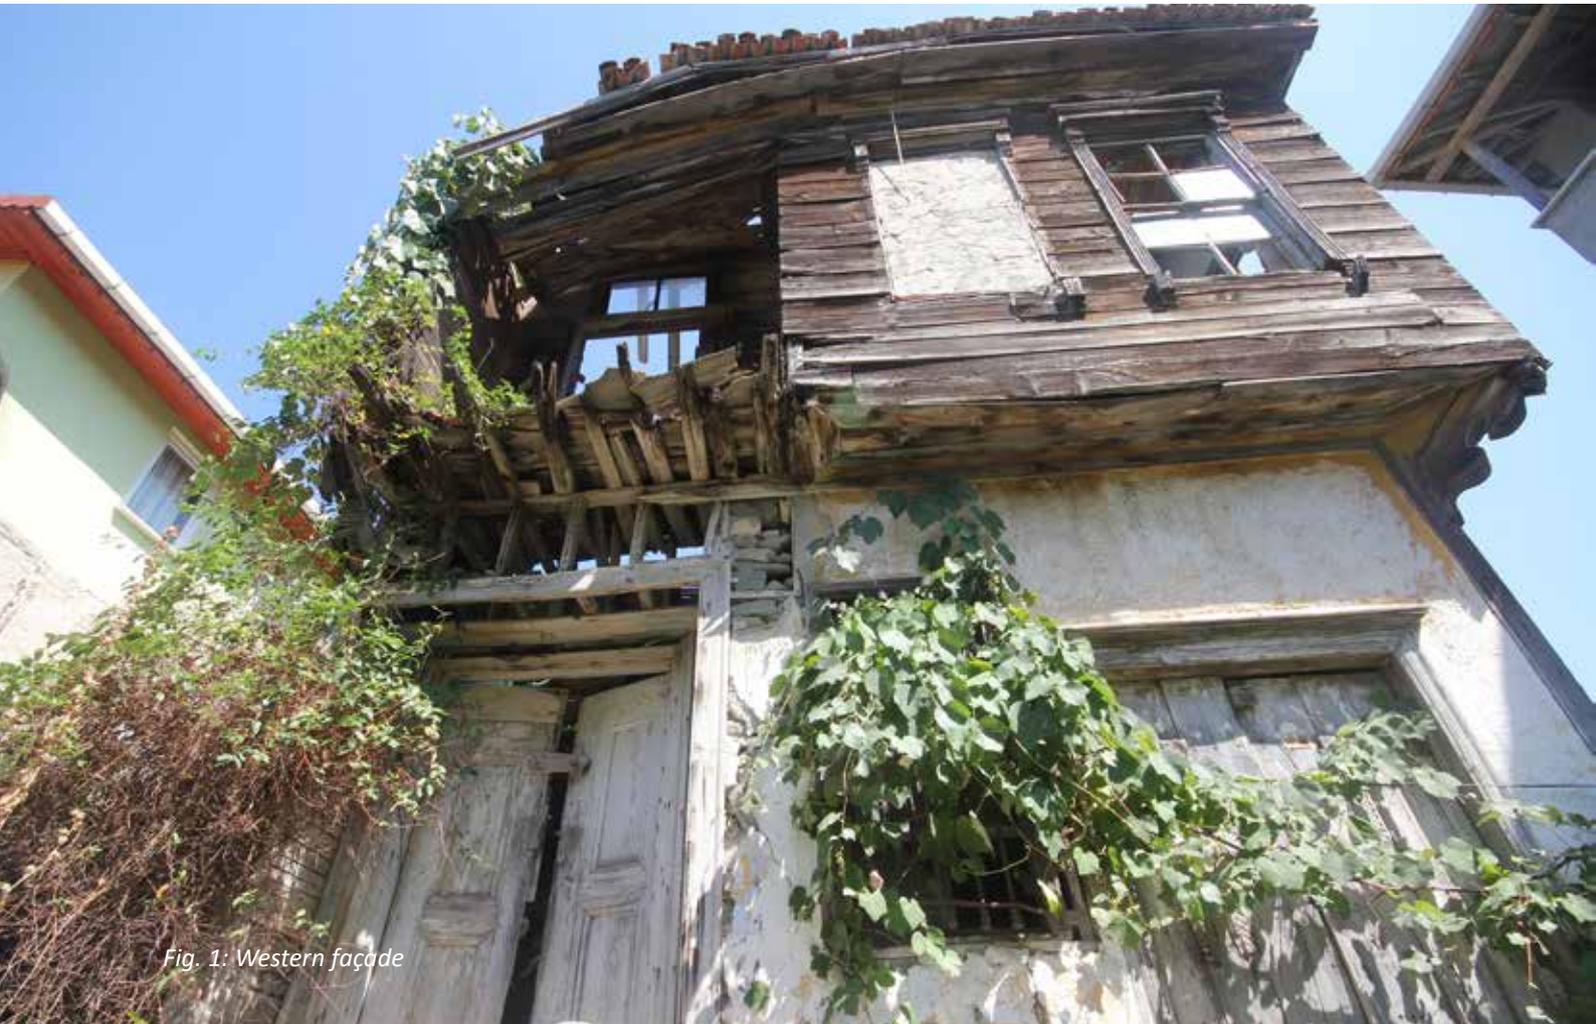
Temel Şorta House is a two-storey building with a rectangular plan extending in the north-south direction. The northern half of the building is ruined at present (Fig. 1). The

Fig. 1: Western façade

It can be understood from the differences in material that additions and repairs had been made before the building was abandoned. These differences are especially prevalent in the section used as commercial space. Structural cracks, vegetation, surface weathering, and material loss are observed in the extant walls. Half of the roof has collapsed; damages such as collapsed flooring, loosened timber planks, and fallen roof tiles are also noted. The building is structurally in poor condition, thus it poses a danger to its surroundings. The partially-preserved balcony and eaves are in similar condition.

The building faces a high risk of deterioration and loss of further materials. It should be structurally supported or consolidated in order to prevent the ongoing deformations and collapses, especially to stop the collapse of load-bearing walls. Structural timber elements should also be consolidated. It is necessary to renew the timber flooring and ceilings urgently.

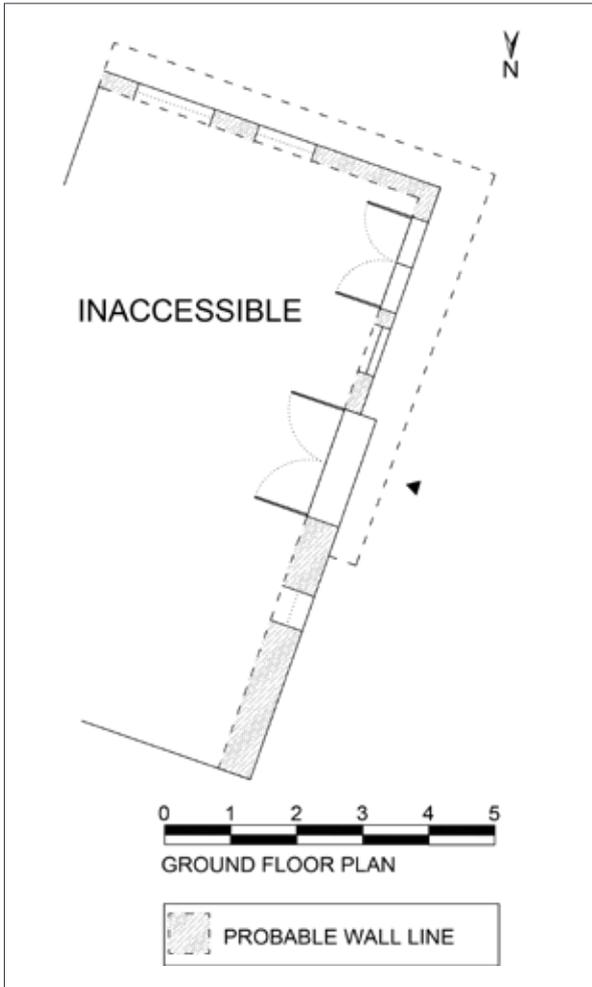
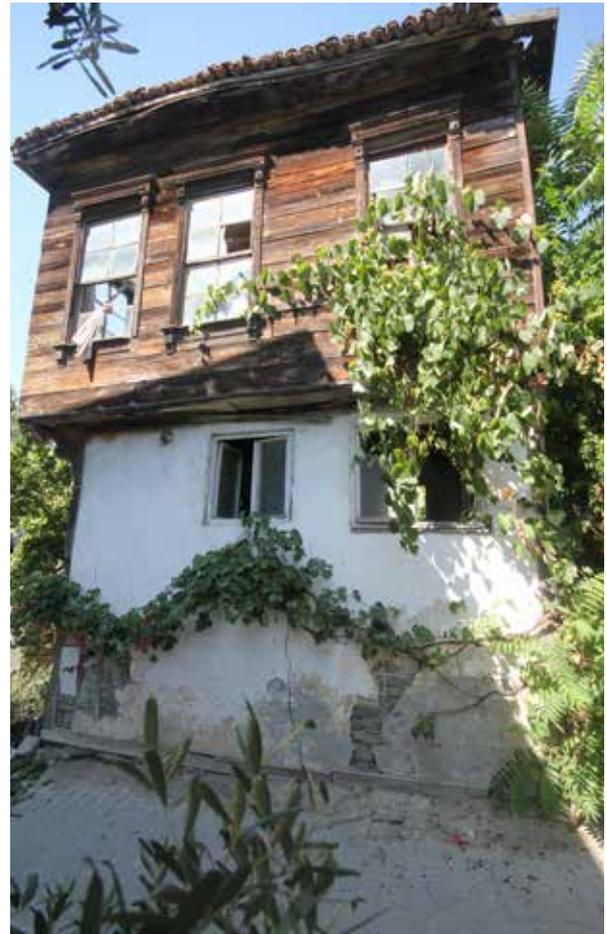
Fig. 2: Southern façade

The western and southern façades of the house facing the street have an elaborate organization (Figs. 1-2). Access into the house was provided by two doorways on the western façade - one on the central axis and the other to the south of the façade. The large, double-winged door in the south provided access to the commercial space downstairs. The main entrance to the house is from the door in the middle. Although it is narrower than the other door, it is still double-winged. The door is elevated from the street level and accessed by steps. There are two rectangular windows with double casements on the ground floor of the southern façade. The upper floor projects along the entire western and southern façades. The projection sits on a timber bracket (*eliböğründe*) covered by wood laths. Above the main entrance of the house on the western façade is a narrow balcony (open *sofa*, *gezemek*). There are two window

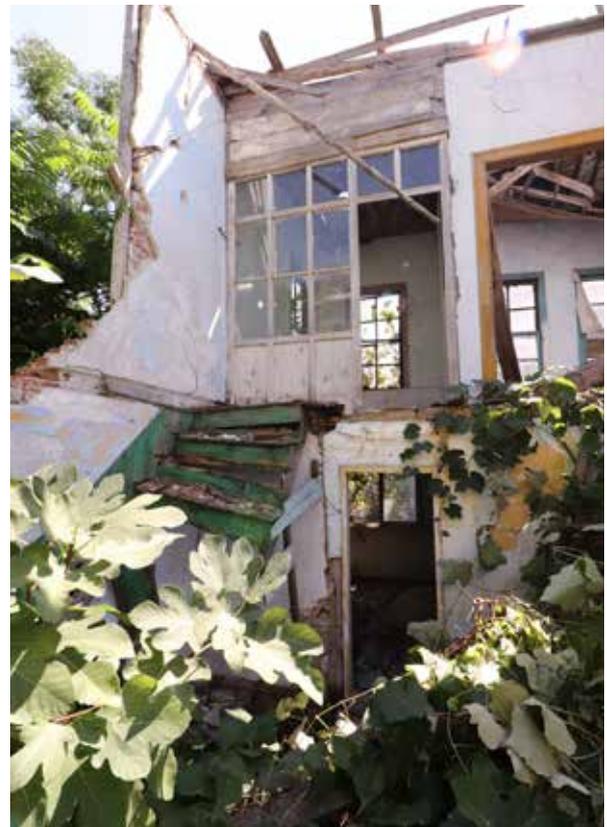
Fig. 3: Interior view of the south wing

At present, the interior can be observed from the ruinous part to the north (Fig. 3). Although the northern section of the house has collapsed, the remaining spaces reveal that the building had a plan organization with rooms flanking an inner *sofa*. There are two rooms on the southern side of the *sofa* –in the extant section– on both the ground and first floors. The green-painted, timber staircase leading upstairs is attached to the eastern wall. As it is understood from the ruinous section, there is a fireplace on the northern wall, indicating that a kitchen was probably in this area.

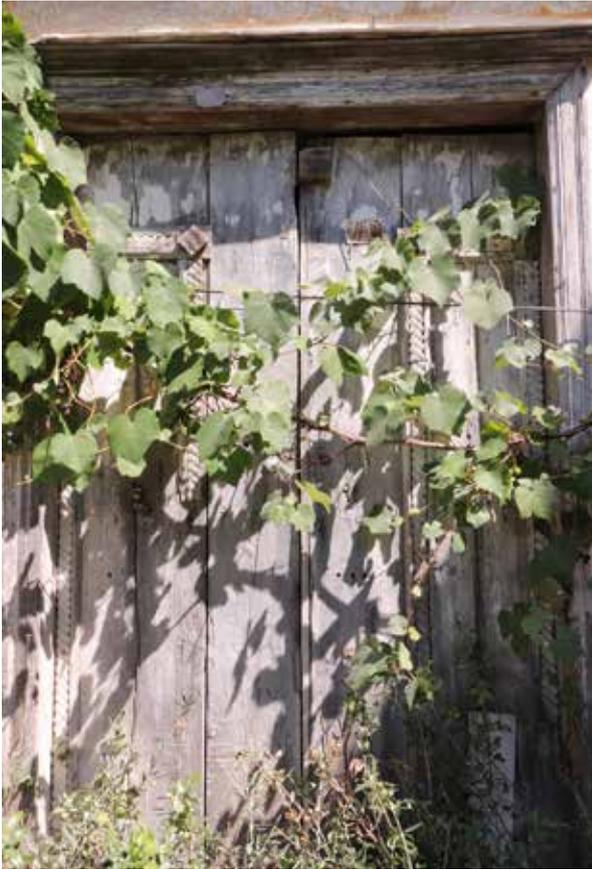
Fig. 4: Store door

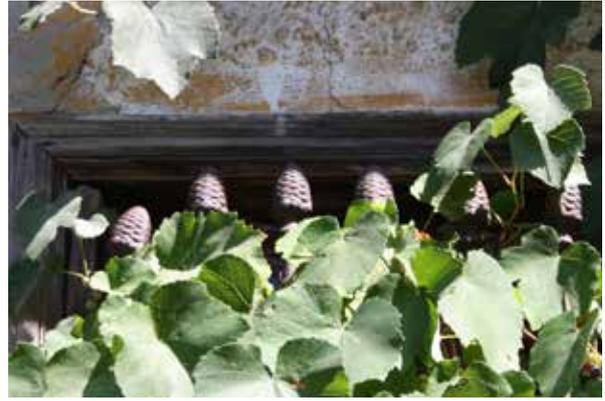
Fig. 5: The detail of the window bar at the ground floor level of the western façade

The decorations cluster around the doors and windows. There are two timber-frame mouldings on the door to the south of the western wall, arranged as two vertical rectangles constructed by gluing the timber elements together and nailing them on the door wing. Two layers of rhombuses are placed at an angle at the corners of the spiralling frame mouldings (Fig. 4). Although the windows are quite plain, the one between the two doors has iron bars that terminate in bud motifs at the bottom and as pinecones at the top, which is a rare type of ornamentation (Fig. 5).
