Müjdat Arı House

Mustafa Akçaöz

District of Marmara, Asmalı Neighbourhood, Köyiçi Locality	Construction period/date: 1912
	Current status: Abandoned
GPS: 40°36'58.8"N 27°42'25.7"E	Ownership status: Private ownership
Registration date and number: Bursa KTVKBBK 15.1.1996 - 4904

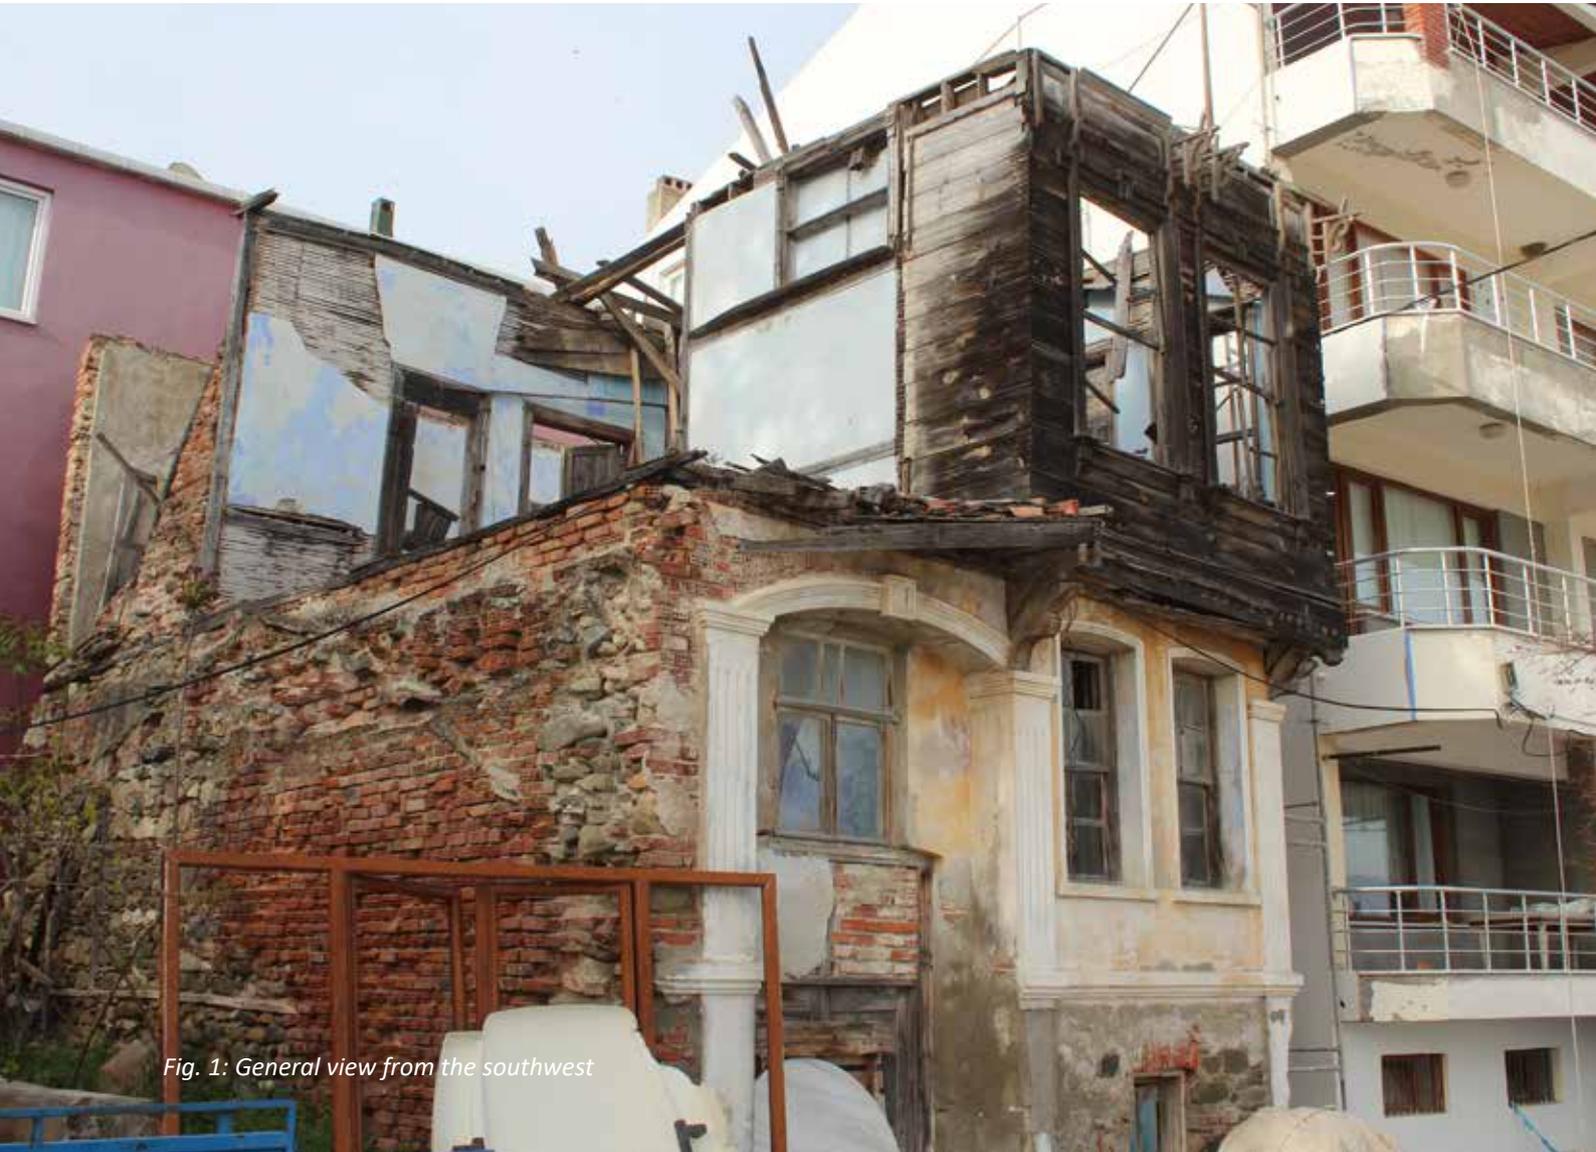
Fig. 1: General view from the southwest

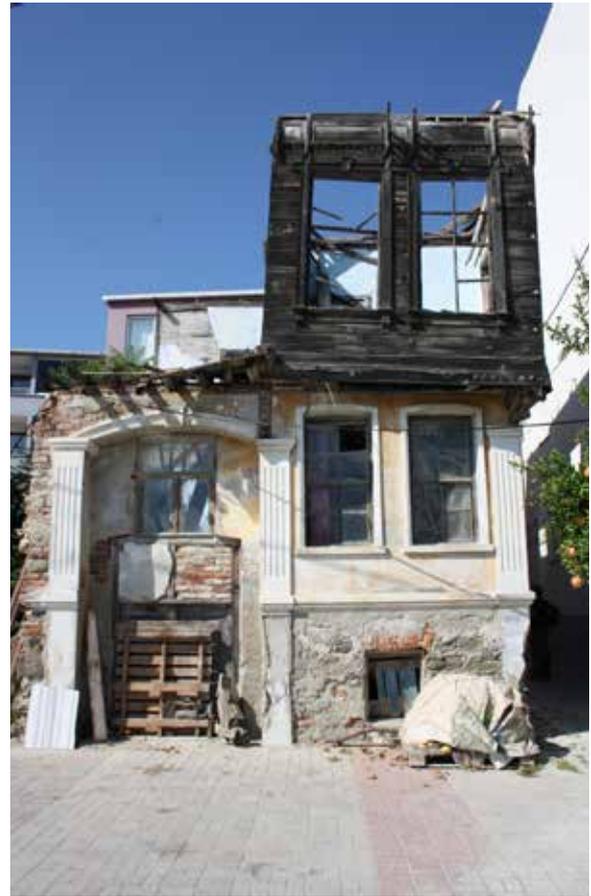
Fig. 2: Southern façade, general view

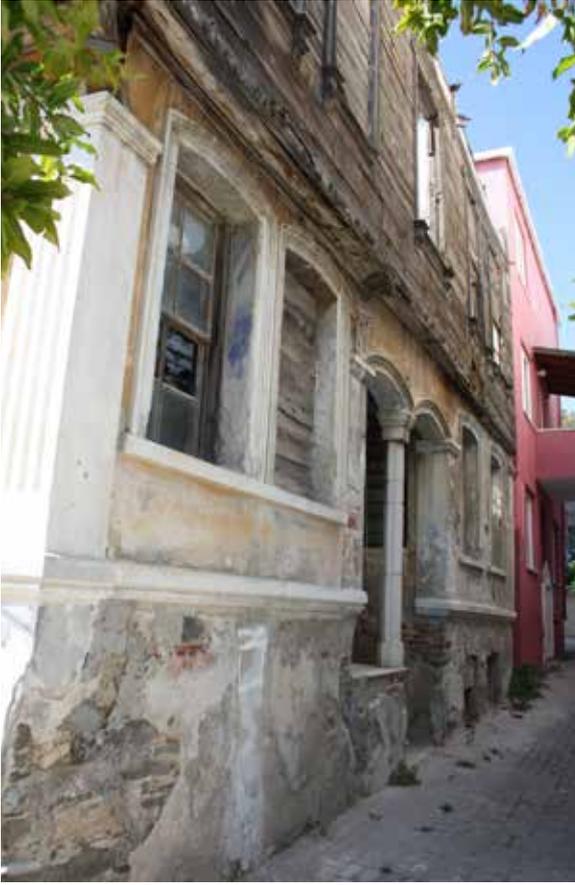
Fig. 3: Eastern façade, general view

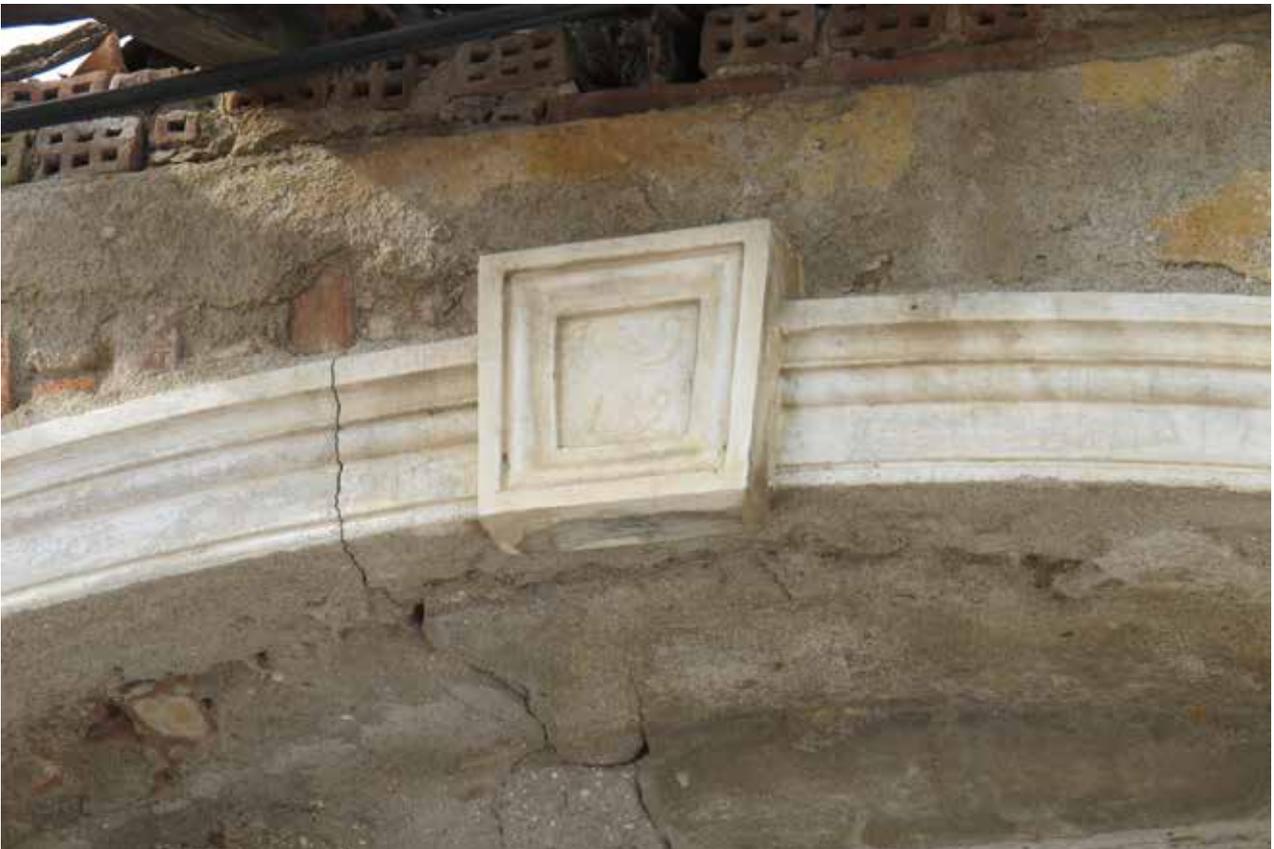
The numbers 1912 on the four corners of the protruding keystone of the entrance arch on the southern façade indicate that the building was constructed or repaired in 1912 (Fig. 4). The building must have been rebuilt or repaired after the big earthquake in Thrace on July 27, 1912. The house was abandoned in 1992.

Fig. 4: Keystone with date
