# İrfan Yıldırım House

*Umut Almaç*

District of Marmara, Merkez Neighbourhood	Construction period/date: late 19 <sup>th</sup> century – early 20 <sup>th</sup> century
GPS: 40°35'09.1"N 27°33'16.6"E	Current status: <b>Abandoned</b>
	Ownership status: <b>Private ownership</b>
Registration date and number: <b>Bursa KTVKKBK 15.01.1996 - 4904</b>

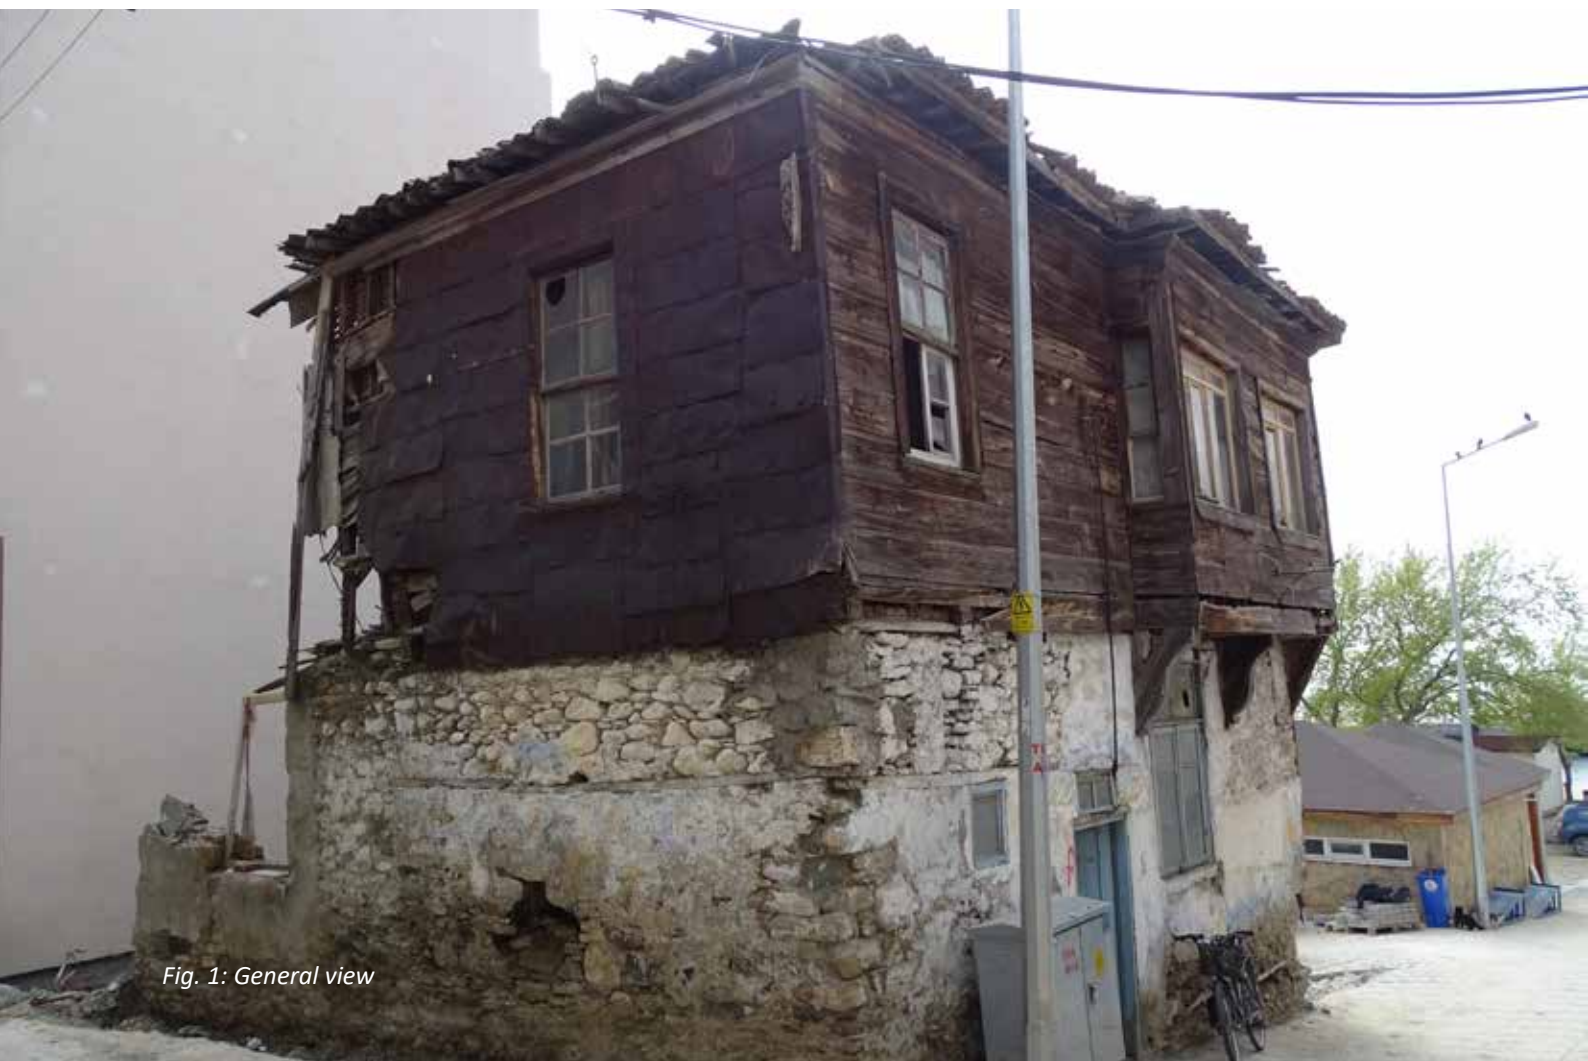
Fig. 1: General view

door on the western façade, from Kadi Street (Fig. 1). On both sides of the entrance are windows; the one to the north is small and square, while the one to the south is rectangular. The latter window is under a partial projection on the first-floor that is clad with overlapping timber boards. This projection is only the southern half of the façade and carried by three timber brackets covered with wood laths. It has two windows facing the street and a side window facing north. There is a sash window with timber casing on the northern half of this façade. The façade ends with eaves protruding from the wall surface.

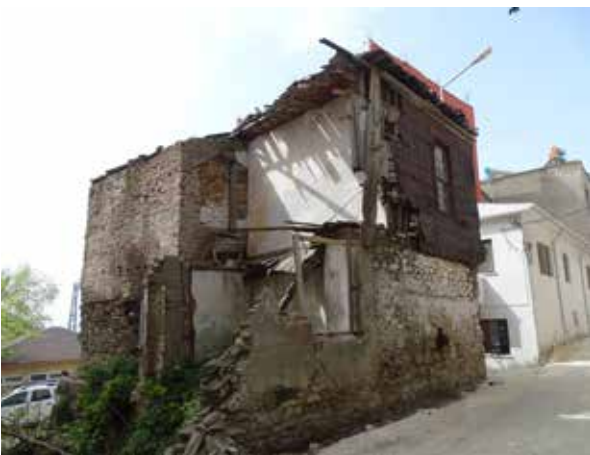
The northern façade facing Şehit Ömer Street has partially collapsed in the north-east (Fig. 2); therefore, the boundaries of the structure and the façade arrangement could not be precisely determined. There is a window opening on the ground floor near the northeastern corner. This window may belong to either the surveyed building or the adjacent structure, which is currently lost. The original timber cladding of the walls on the upper level is covered with sheet metal up to the profiled roof moulding. The original cladding can be seen in the sections where the sheet metal is lost. There is a sash window in the centre of the façade.

Fig. 2: Northern façade

The building is damaged and the roof is in ruinous condition. Rainwater penetration accelerates the building's deterioration. Structural problems in the northeastern corner have caused partial collapse in this section. The house has formerly undergone interventions of varying scale in different periods. The original architectural elements and their proportions have changed over time both on the façades and in the interiors. A two-storey, masonry annex was built in the southeastern corner of the building as a result of changing needs.

The building is severely damaged and requires urgent measures to prevent total collapse. It will inevitably fall in a short time if protective measures are not taken. Therefore, architectural documentation should start immediately in order to obtain as much data as possible before the building collapses. Damage to the surroundings should be prevented by security strips and information panels. Since the building is in close vicinity to the mosque and the shopping centre, which are daily frequented, precautions should be taken immediately to solve the problem of structural safety.
