# Kamil Kanat House

*Gamze Özmertyurt*

District of Marmara, Asmalı Neighbourhood, Köyiçi Locality	Construction period/date: <b>Late 19<sup>th</sup> century</b>
	Current status: <b>Abandoned</b>
GPS: 40°37'02.9"N 27°42'25.1"E	Ownership status: <b>Private ownership</b>
Registration date and number: <b>Bursa KTVKBK 15.01.1996 - 4904</b>

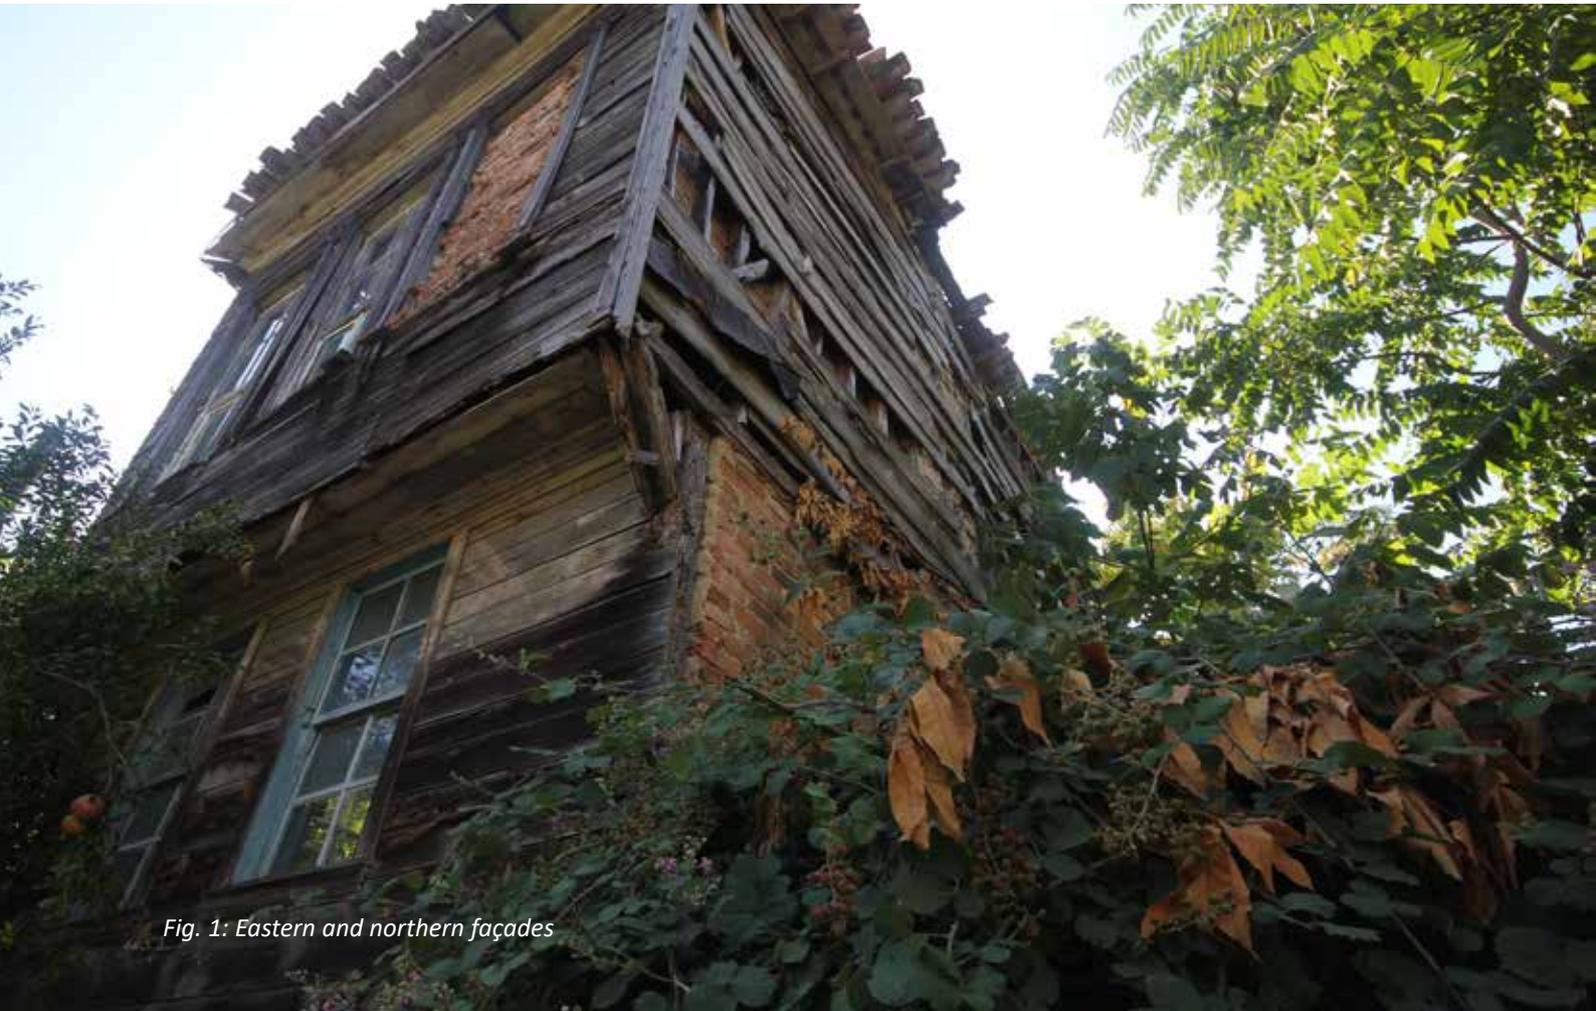
Fig. 1: Eastern and northern façades

The northern façade is completely blind (Fig. 1). The only detail on this façade is the protrusion of the chimney starting from the ground floor.

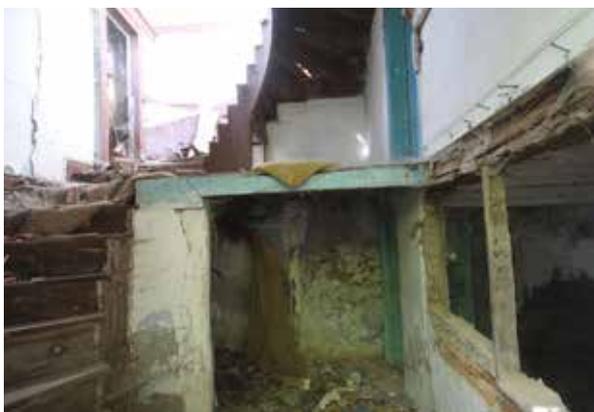
Fig. 2: Entrance hall on the ground floor, kitchen on the right and sofa of the first floor above

It corresponds to the L-shaped entrance hall (Fig. 2). According to the former residents, this space was used to process olives. The kitchen, accessed through a door from the entrance hall, is located on the eastern wing of the ground floor. It has a fireplace that is covered by a timber hood. Since the floor is entirely covered by earth, it is not clear whether there was a staircase going downstairs. There are also pits resulting from illicit digging that have damaged the floor. The timber ceiling of the kitchen has wooden beams. The walls are mainly plastered with lime, although certain sections are covered with modern ceramic tiles. The kitchen counter extends along the southern wall.

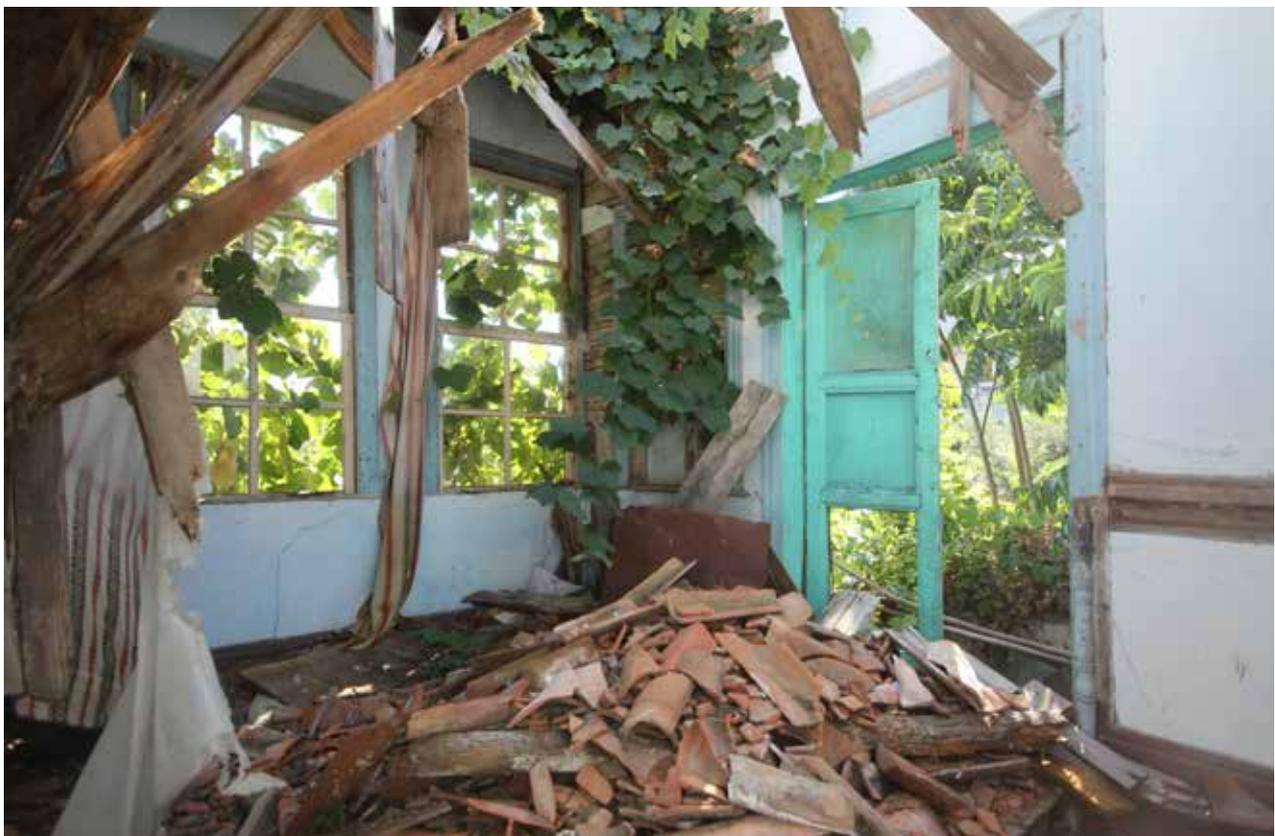
A curving staircase in the north of the first-floor hall leads to the second floor. On the second floor, the staircase reaches the *sofa*, which is arranged as a room with a rectangular plan (Fig. 3). The *sofa* is surrounded with a room on the east; a niche with shelves and a double-winged timber door painted green on the west. This doorway probably allowed access to the western room, which is currently destroyed. There are two timber sash windows on the south wall of the *sofa*. The *sofa*'s roof has partially collapsed, thus it is open to weather conditions. The walls, timber windows, and door of the eastern room are painted green. The northernmost one of the three sash windows on the room's eastern wall was later blocked with bricks. Timber-frame walls with wood laths can be seen where paint is

Fig. 3: Second floor's *sofa* and the timber door opening to non-existent room on the west

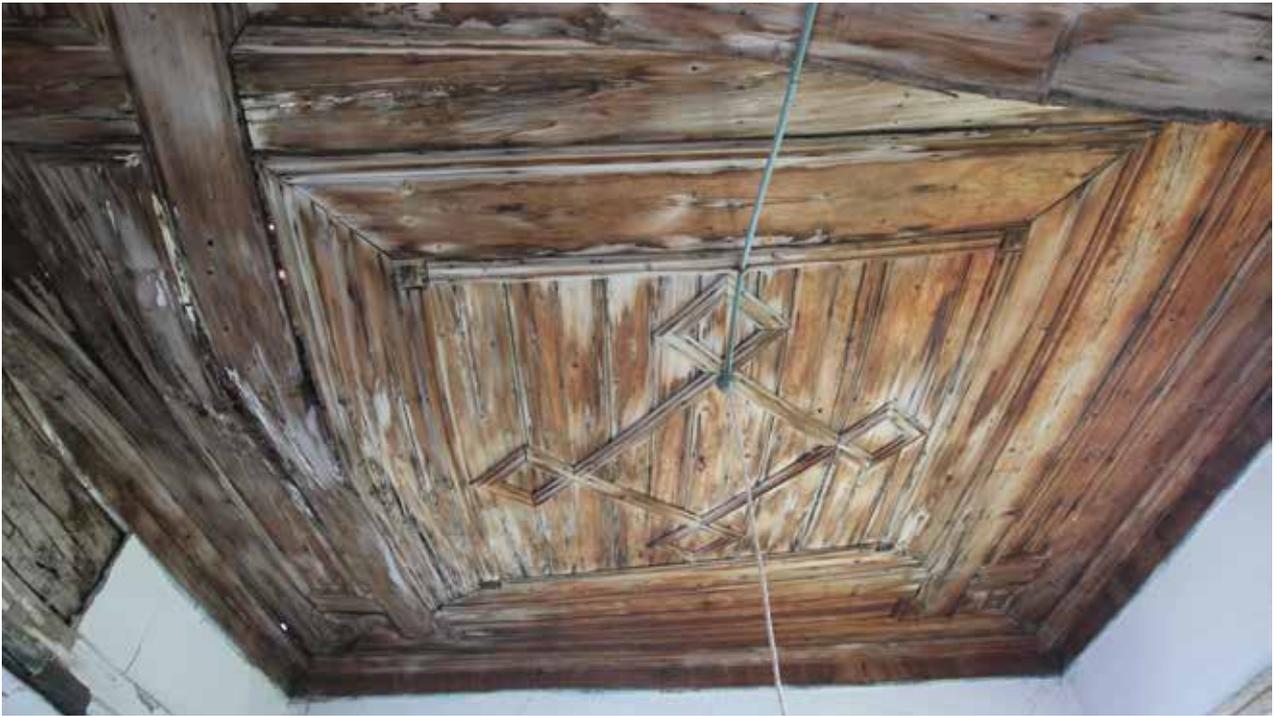
Fig. 4: Ornamented ceiling on the second floor

lost. The timber ceiling in this room has wood laths arranged in geometric motifs (Fig. 4). Intense vegetation covering the window, door casings, and flooring prevents the observation of details in certain parts in this space.

As seen in any house without dwellers, the building is neglected and faces the danger of gradual obsolescence. The plan organization is not legible since the western part of the building has collapsed. The closed window openings affect the original façade organization. The plaster layer on both the exterior and interior walls of the ground floor is largely lost. The building's roof has mostly collapsed. Deterioration has accelerated, especially on the upper floors. Plant overgrowth has increased in the house since it is exposed to external weather conditions such as rainwater and wind. Even though the kitchen is thought to have been accessed by stairs, its floor level cannot currently be observed. This is mainly because of the damage caused by illicit digging and the deterioration of the flooring. The original ceilings may collapse at any time. The ornamented ceiling on the second floor is

at great risk since the roof structure began to deteriorate. Although the roof's collapse causes problems, the biggest issue is negligence due to abandonment.

This registered structure is under threat due to negligence. Families that once resided here have moved into the new, reinforced concrete buildings to the east and south of the building. The roof is currently damaged. Vegetation and material decay within the building indicate that the roof is insufficient to protect it from external conditions. A protective roof should be built over the structure as soon as possible to act as a temporary precaution. Timber flooring, ceilings, windows, and stairs need to be renewed. The timber-frame system should be consolidated, strengthened, and renewed where necessary. A restoration project should be prepared to renovate and rehabilitate the building in line with its original form. Otherwise, building's collapse is inevitable. After the building's restoration, an information panel should be placed to raise awareness and increase the potential for visitors.
