# Ulu House

District of Marmara, Ekinlik Neighborhood	Construction period/date: <b>June 26, 1827</b>
	Current status: <b>House, in seasonal use</b>
GPS: 40°32'50.5"N 27°29'20.5"E	Ownership status: <b>Private ownership</b>
Registration date and number: <b>Bursa KTVKKBK 18.08.1990 - 1297</b>

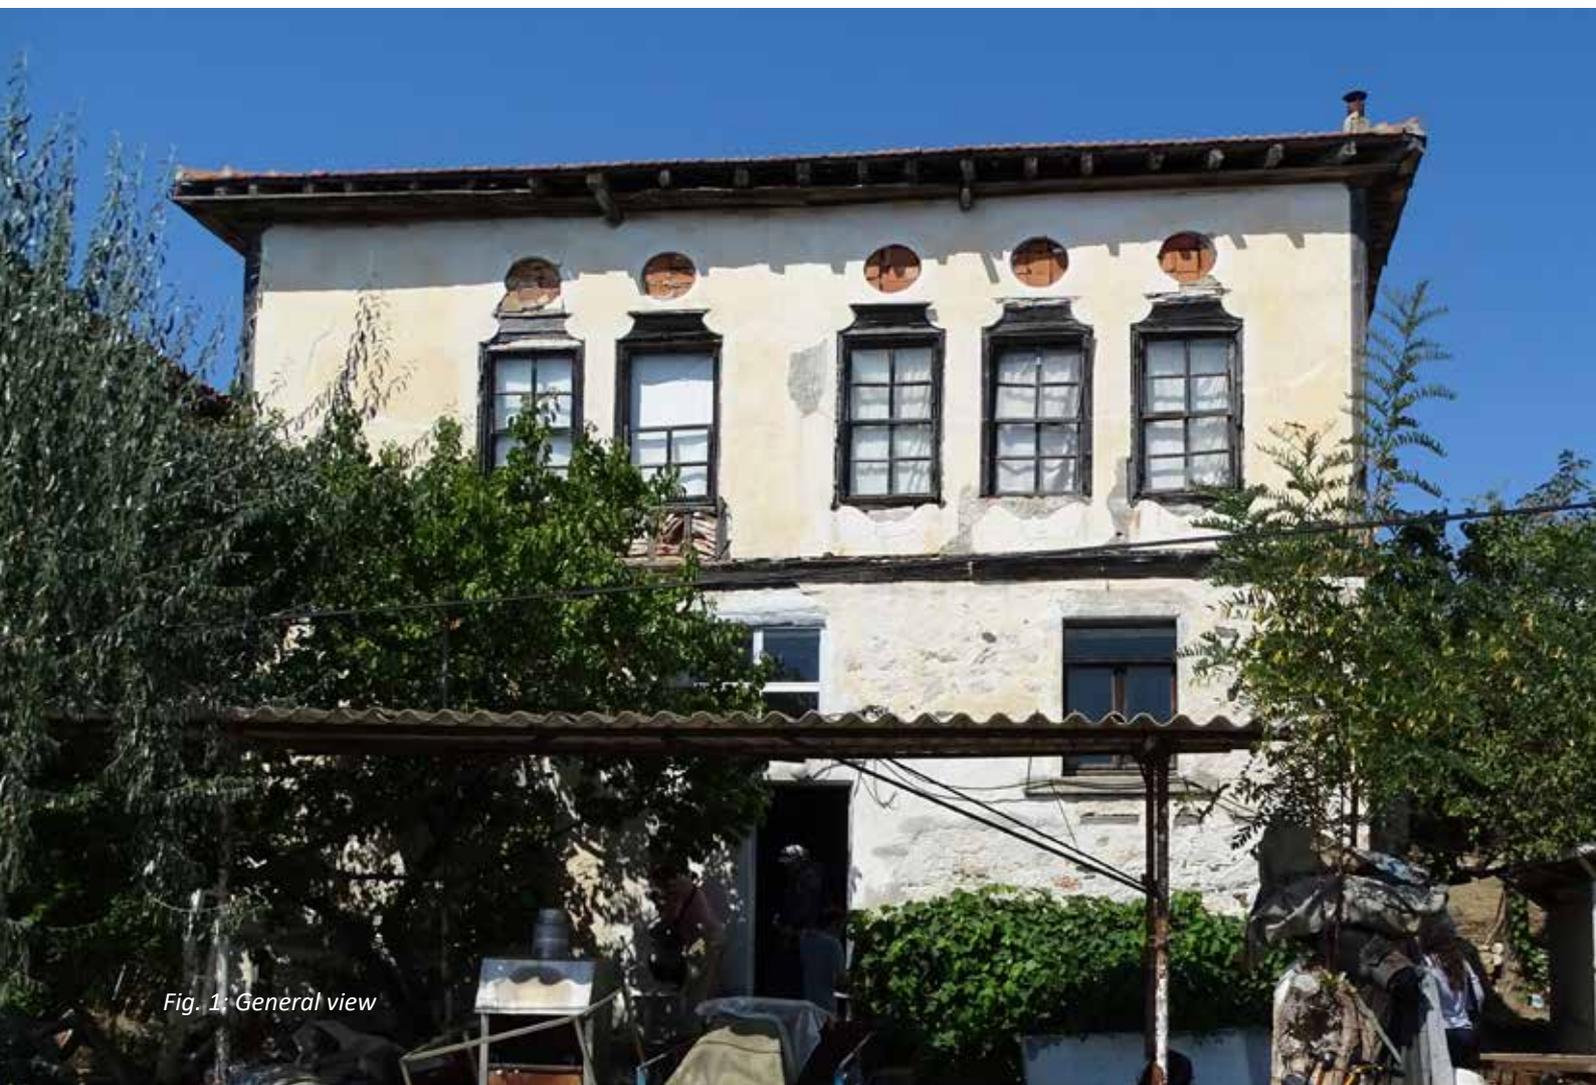
Fig. 1: General view

The entrance to the building is through the southern façade facing the Marmara Sea (Fig. 1). There are reinforced concrete buildings to its east and west, one of which is repaired. The building has a square-like, rectangular plan with a floor area of 10.89x9.84 m. The lot is 30 m away from the seashore and sits on sloping land that descends from north to south. The building is located on the western edge of the lot.

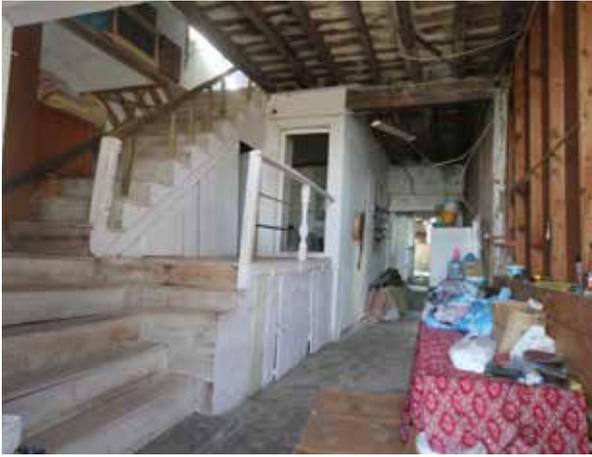
Fig. 2: Central hall on the ground floor

The ground floor opens into a central hall extending in the north-south direction (Fig. 2). The original floor covering cannot be identified since the floors are currently covered with screed. There are doors, which provide access to the building, on both ends of this central hall. The stone masonry walls are about 90-100 cm thick. The ceiling has two rows of beams on top of each other. An L-shaped staircase provides access to the upper floor. After the first four steps, at a height of 70 cm, is a passage to the cellar underneath the stairs. There is a kitchen with a fireplace to the northeast of the central hall, near the northern entrance. Another room with a rectangular plan is accessed through this kitchen, elevated by four-five steps. The window on the eastern wall of this room was closed and converted into a fireplace outlet.

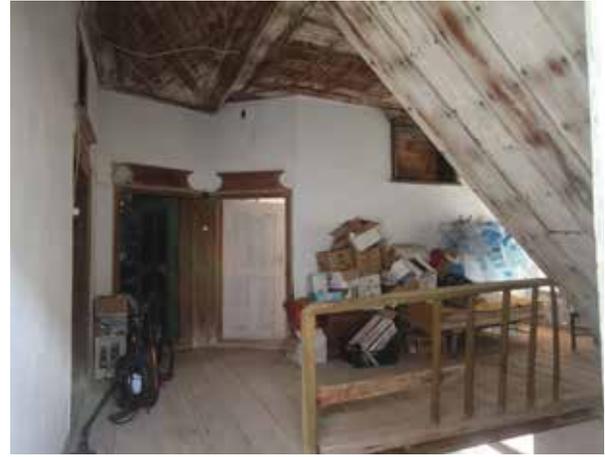
Fig. 3: Northern end of the sofa upstairs

The staircase leading upstairs is timber. Its balustrades are also timber and painted white. The upper floor's layout features an outer *sofa* (Fig. 3). The timber ceiling of this *sofa* is ornamented with wood laths (*çitakâri*). On the eastern wall of the *sofa* is an *iconostasion* for
