Ekinlik Greek School for Girls

Emre Kishalı, Ioannis Papachristou

District of Marmara, Ekinlik Neighbourhood	Construction period/date: 1911
	Current status: Ruinous
GPS: 40°32'46.1"N 27°29'08.9"E	Ownership status: State Treasury
Registration date and number: Bursa KTVKKBK 18.08.1990 - 1297

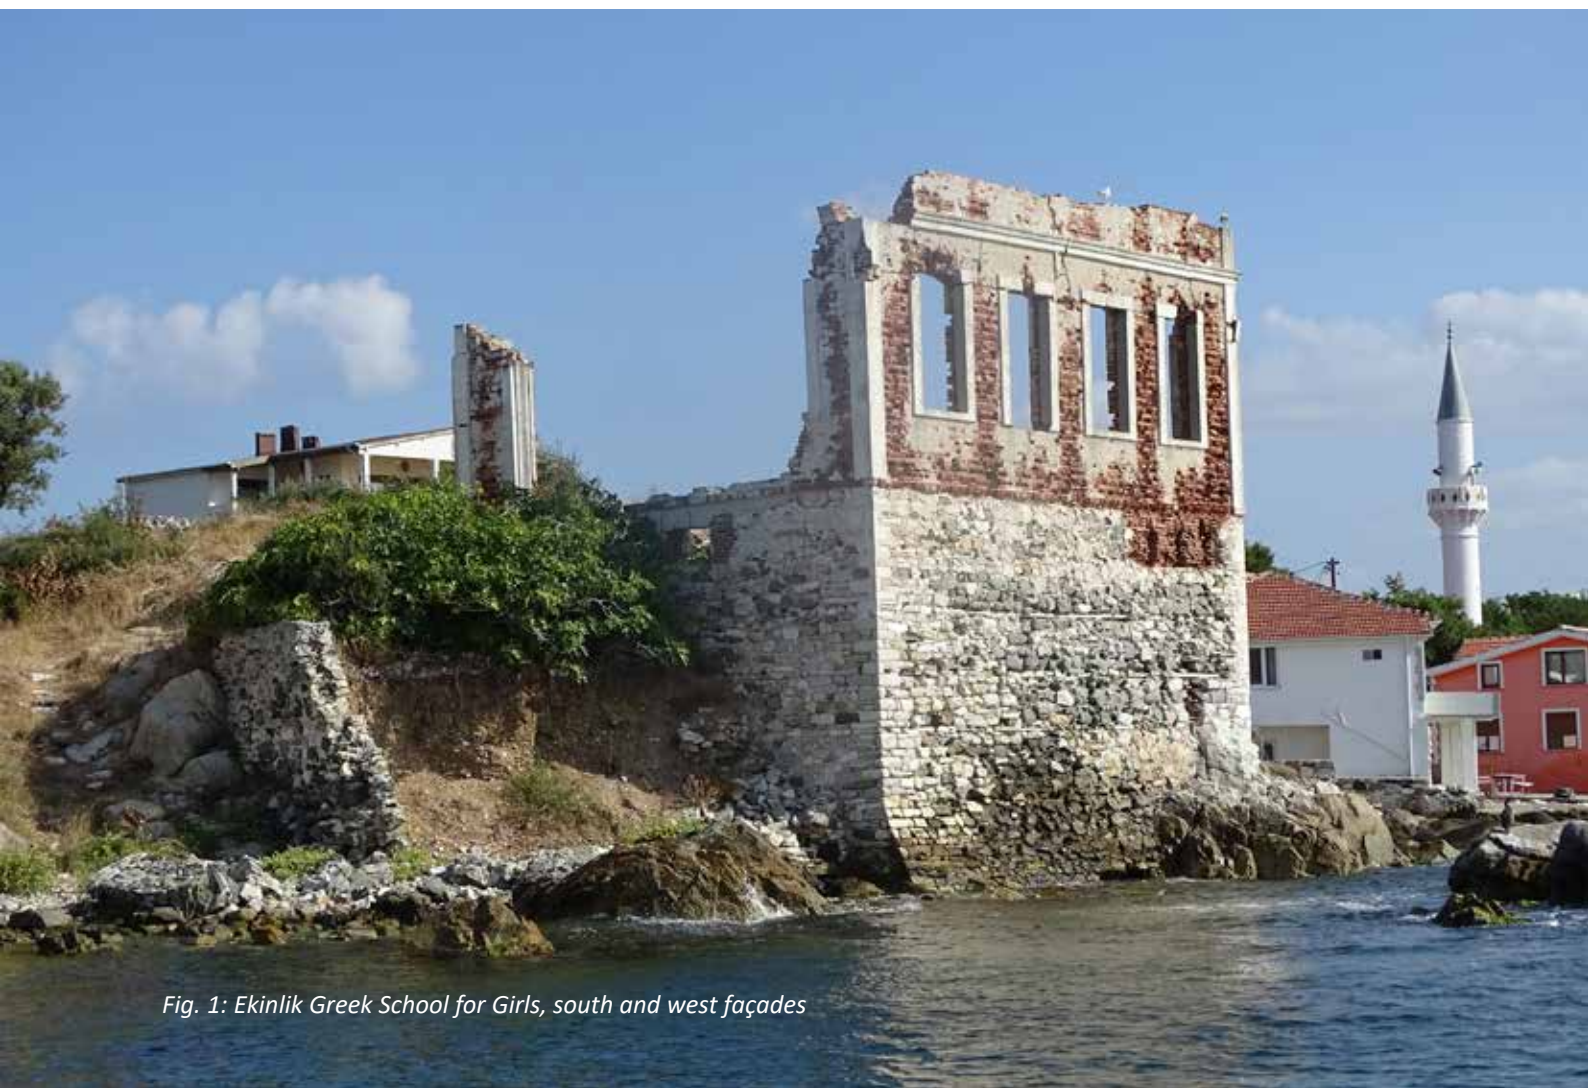
Fig. 1: Ekinlik Greek School for Girls, south and west façades

The southern façade, which is the best-preserved section, faces the sea (Fig. 1). It has three small, arched windows on the basement level, close to the eastern edge. On the ground floor, there are four 120 cm-wide windows that are framed by jambs. There is a row of bricks in lieu of moulding between the basement and ground floor. The moulding between the ground and first floors is composed of three horizontal, profiled elements.

The main walls of the first floor, flooring, and roof structure of the historic building have not survived. Although the southern façade of the ground floor still stands, the walls of the other façades have largely fallen. The main and partition walls of the basement are extant. Loss of materials and structural cracks are attested on the southern façade. Access to the building is not controlled, and there is no information panel. Plant growth is seen in the building, especially in the basement, and around it.

other and the structure will behave like a box. However, since only the southern façade of the ground floor has survived with no connection to the others, it carries increased risk of damage. The deep cracks and loss of material attested on this façade are indicators that the brick walls deteriorate day by day. The southern façade of the basement is adjacent to the Marmara Sea, reducing the durability of the materials here. That the rubble walls are exposed to exterior conditions poses a risk for the structure.

Consolidation work is recommended for the surviving parts of the building. ICOMOS Turkey Charter for the Conservation of

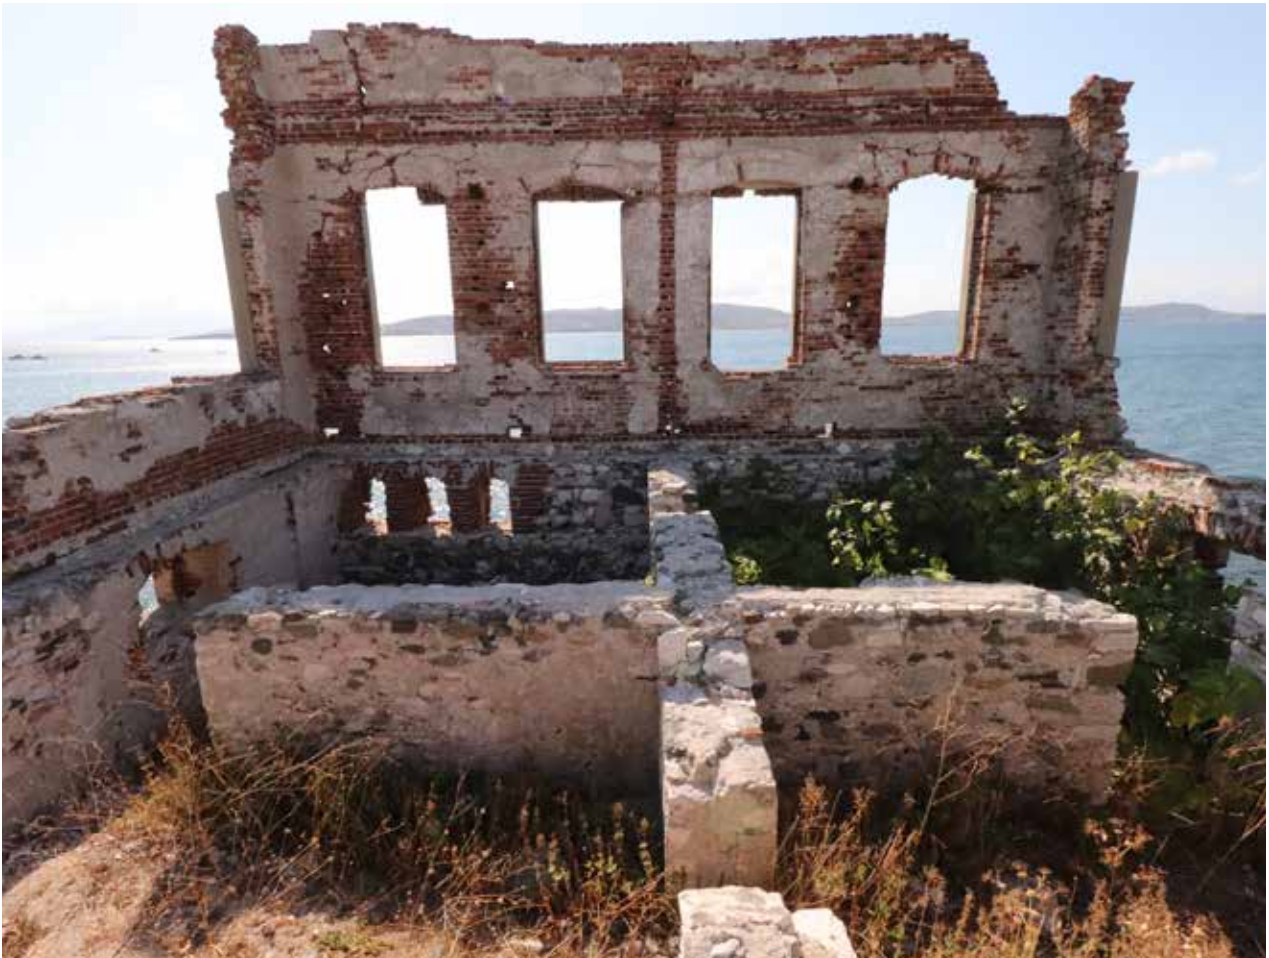
Fig. 2: Ekinlik Greek School for Girls, partition walls in the basement and the southern wall of the ground floor

The basement level was explored during the field survey (Fig. 2). The northern wall has a thickness of 81-82 cm, whereas the thickness of partition walls varies between 52 and 55 cm. The construction technique of the masonry wall changes towards the ground floor. The thickness of the stone masonry walls decreases by 30 cm on the ground floor level, and supports walls made of face bricks with six holes. The brick masonry is composed of two courses of full bricks with dimensions of 20x9.5x6.5 cm, followed by a course of one full and two half brick alignments. The transition between the basement and the ground floor is accentuated by a moulding made by the 4 cm protrusion of the bricks measuring 22x10x6 cm.

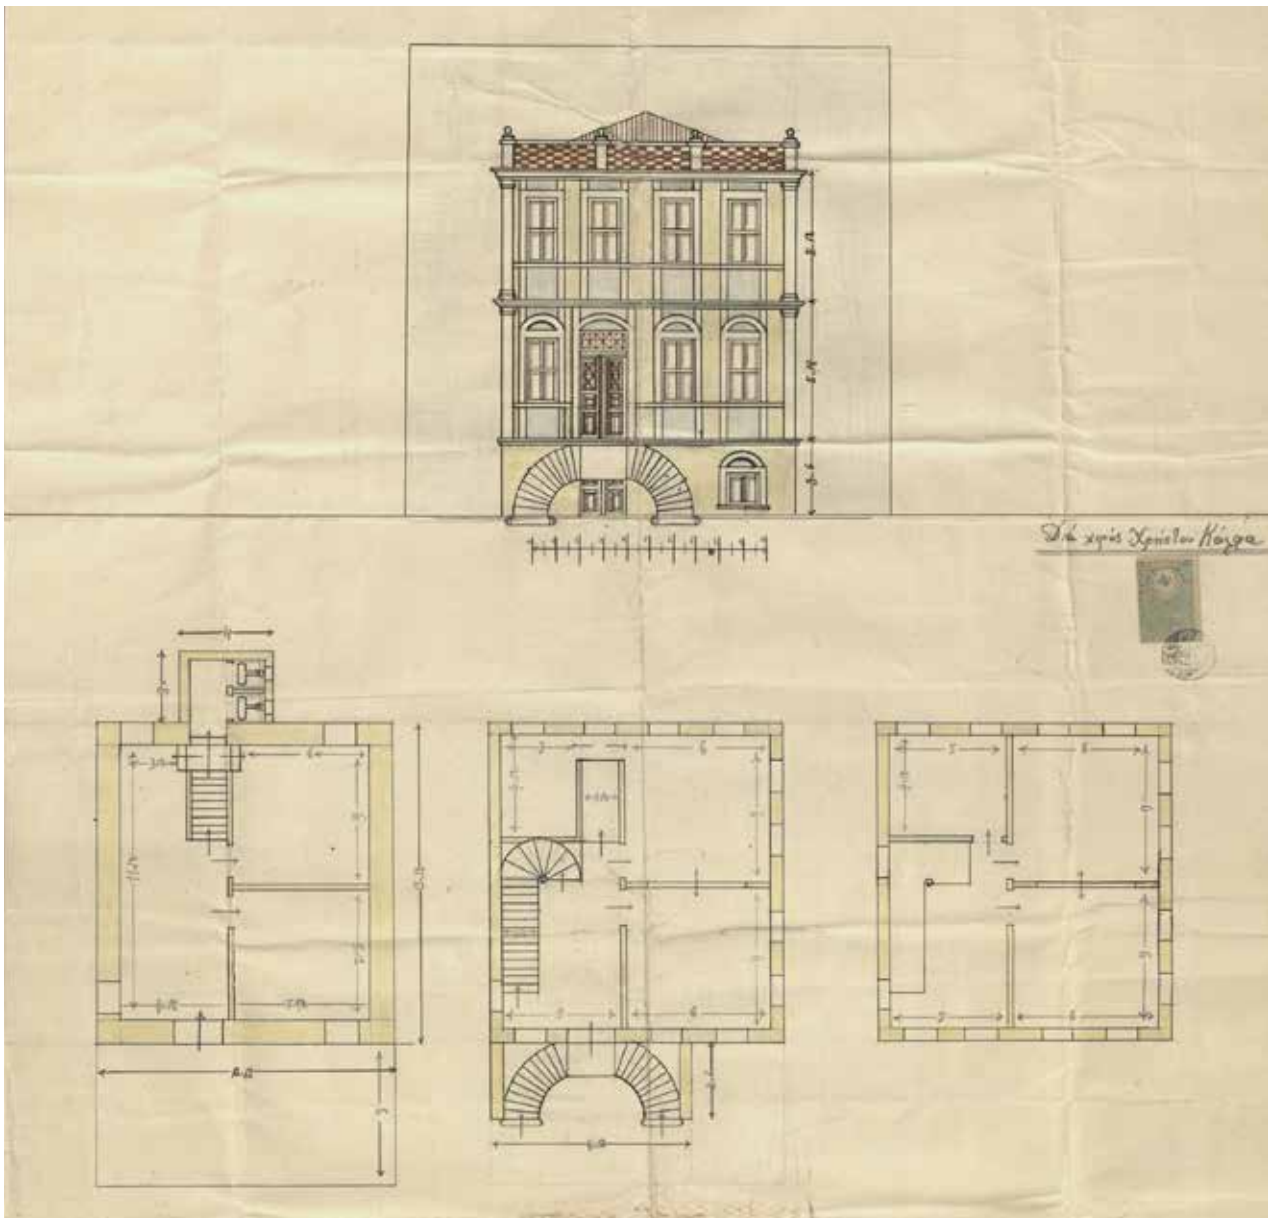
Plan and façade drawings of the school are found in the Ottoman Archives of the Presidency of the Republic of Turkey (Fig. 3). When these drawings are compared to the existing remains, the entrance and spaces of the basement floor are seen on the western façade. According to the drawing, there are only three spaces at this level, whereas four spaces are discernible at present. The space to the north is divided in two by a wall, unlike the archived plan. The entrance to the basement in the west opens to the western space in the northern section that is divided in two and measures 4.10x4.90 m. The dimensions of the eastern space in the north section are 4.10x5.70 m. The partition walls and the door opening between these two spaces are not seen in the archived plan. Such differences suggest that the building was either not constructed based on this plan or renewed later. According to the archived plan, the wet spaces, which protrude to the east, and the eastern rooms on the ground floor (upper floor) are reached by a staircase in the northeastern section. The traces of these wet spaces and the staircase cannot be observed today. The spaces to the south of the basement are accessed via the northern section. There is an opening with a depressed arch that is approximately 130x60 cm to the east of the southeastern space, which measures 6.00x5.12 m. There are three arched, 30x60 cm windows to its east. Through this section one reaches the southwestern space, which measures 5.12x5.12 m. An arched window opening is seen on the western façade of this space.

According to the archived drawings, there was another staircase in the ground floor entrance hall that provided access to the first floor (Fig. 3). This element has not survived. A staircase and landing across the ground floor entrance, leading to the basement, are also attested in the plan for this floor. Two separate rooms to the north and south can be accessed via this landing. The southern room could also be accessed via another door from the entrance hall. There is another space to the southwest of the entrance hall, with dimensions of 6.00x6.00 m.

Fig. 3: Drawings of the building from the Ottoman Archives of the Presidency of the Republic of Turkey
