Marmara Greek School for Girls (Pantelidia)

Umut Almaç, Mustafa Akçaöz, Ioannis Papachristou

District of Marmara, Merkez Neighbourhood	Construction period/date: 1912-1914
	Current status: Recently abandoned, planned reuse as a museum.
GPS: 40°35'09.9"N 27°33'34.9"E	Ownership status: State Treasury
Registration date and number: GEEAYK 20.12.1975 - 8791 / TKTVYK 27.02.1987 - 3045 / Bursa KVTKBK 15.01.1996 - 4904

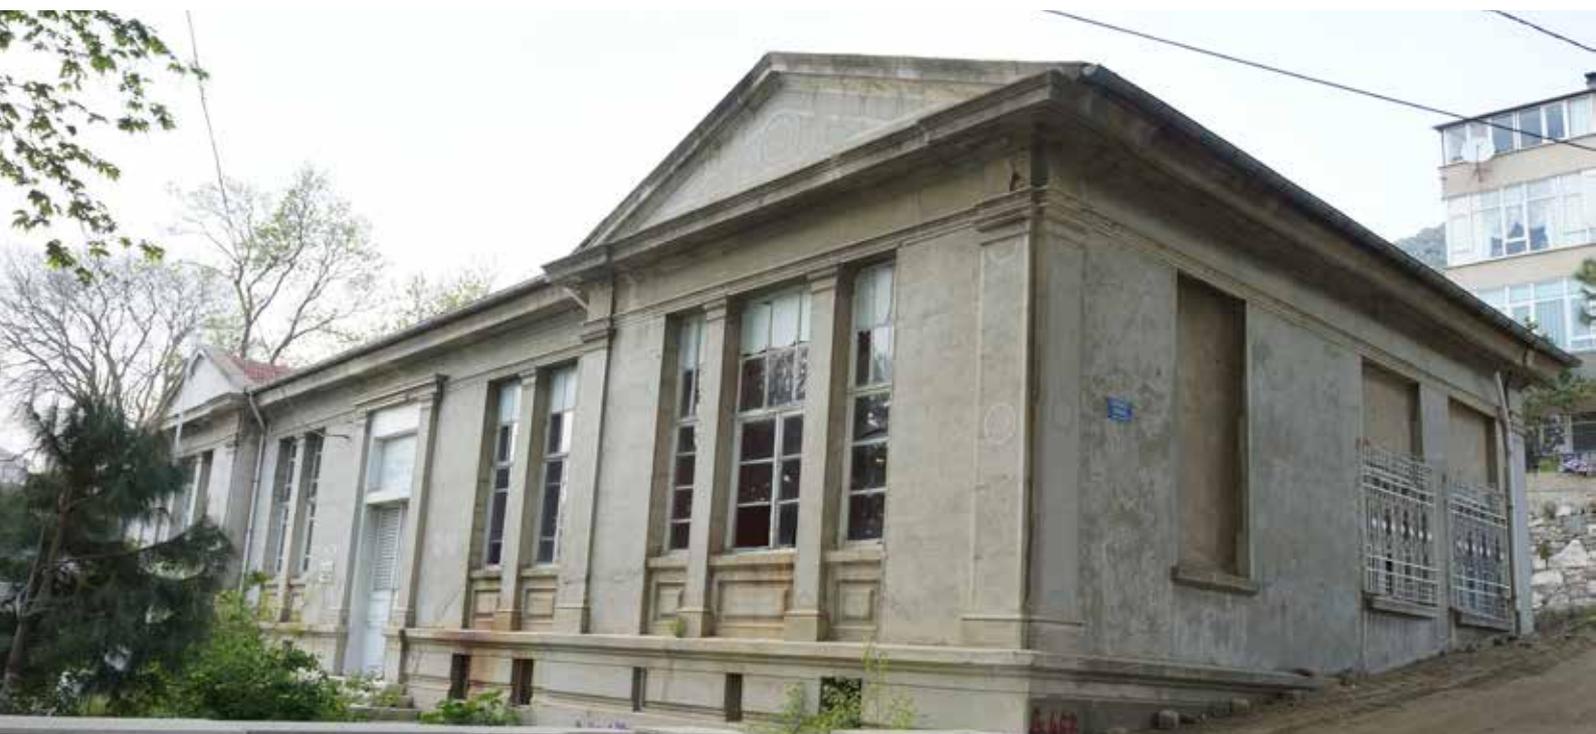
Fig. 1: Southern façade

The southern façade of the building, facing Hükümet Street, is more elaborate than the others (Fig. 1). It is in symmetrical order with a length of about 28 m and it is articulated by the entrance in the centre and the triangular pediments on the east and west wings. Artificial stone cladding (plaster shaped to imitate stone), which was frequently used –especially on exterior façades– in Istanbul at the turn of the century, was also utilized in this building. Pilasters extending from the ground to the roof, profiled floor and roof mouldings, and decorative elements around the openings accentuate the southern façade.

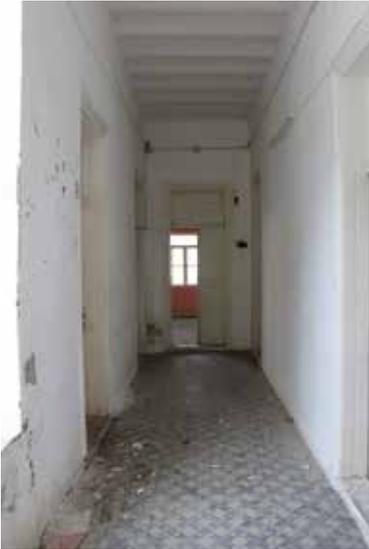
Fig. 3: Ground floor corridor with concrete tile flooring and jack-arch ceiling

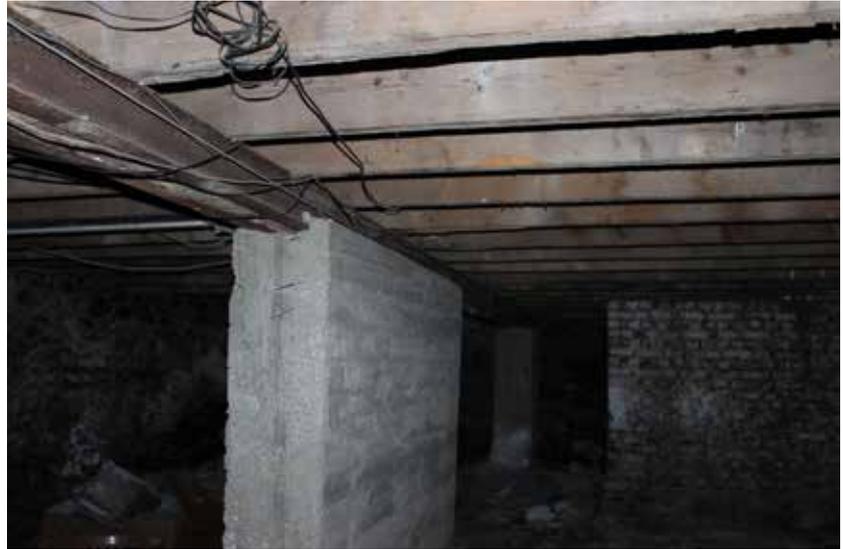
Fig. 4: Basement, reinforced concrete intervention

There is not any serious structural damage that can cause total collapse in the building. However, there are vertical cracks and disintegration in the courses of the brick posts due to the concentrated load transferred from the floor. Probably in relation to these damages, reinforced concrete elements have been added in the basement (Fig. 4). Moreover, the I-beams of the jack-arched flooring show signs of serious corrosion, especially in the basement, and have lost their mechanical properties at certain points.

The brick posts in the basement should be temporarily supported by a reversible intervention, until more extensive conservation measures can take place. Moreover, the I-beams in the basement that are severely corroded should be examined one by one in order to identify their cross-section losses and load carrying capacity, and determine the necessary structural interventions. The conservation approach should adopt minimum interventions by using traditional materials/techniques. New materials and details can be used if necessary for the building to regain its original bearing capacity and strengthen structural elements, but they must be used without damaging its original features since the building is a cultural property.
