# Marmara Greek School for Boys (Kyriakidia)

*Emre Kishalı, Mustafa Akçaöz, Ioannis Papachristou*

District of Marmara, Merkez Neighbourhood	Construction period/date: 1910
	Current status: <b>Public Education Centre</b>
GPS: 40°35'11.9"N 27°33'30.4"E	Ownership status: <b>State Treasury</b>
Registration date and number: GEEAYK 20.12.1975 – 8791, TKTVYK 27.02.1987 – 3045, Bursa KTVKBK 15.01.1996 – 4904

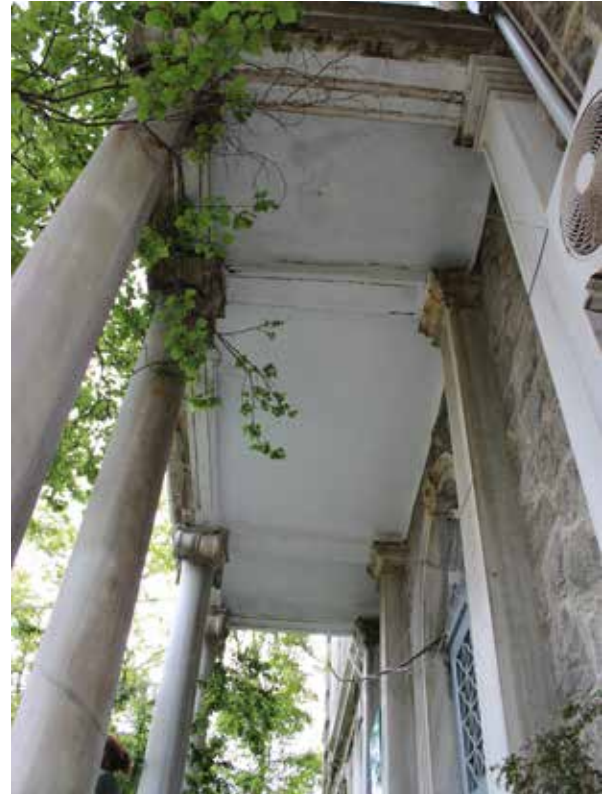
*Fig. 3: Connection detail for column capitals*

The columns with Ionic capitals and the pilasters with Doric-like capitals are connected to each other with steel beams, which also support the flooring of the projection on the first floor (Fig. 3). The double-row elements with closed cross-sections that connect the column capitals have a width of 8-9 cm. The joinery around the window openings was changed to PVC during recent repairs.

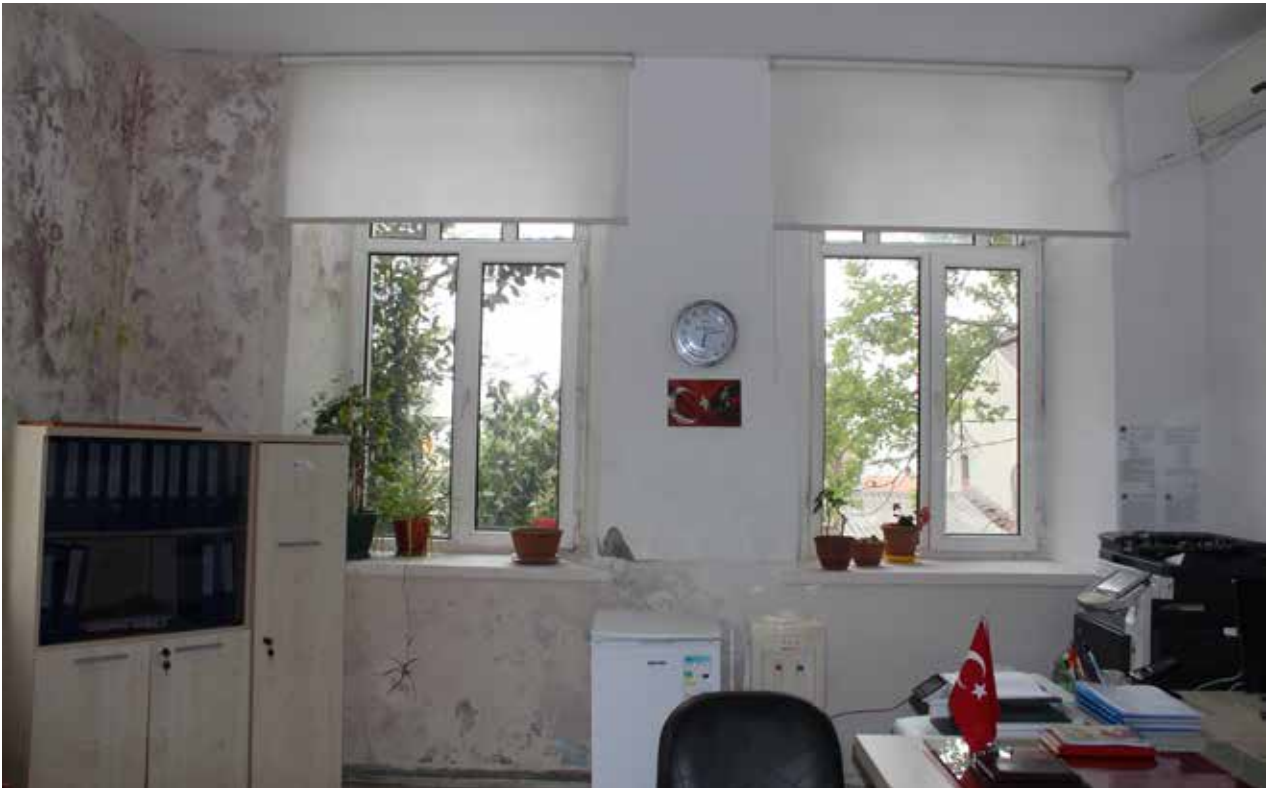
Fig. 4: Deterioration

On the other hand, some damage caused by recent interventions that affect the historical structure are discernible from the exterior. The replacement of the window joinery with PVC, the use of reinforced-concrete structural elements in the stone masonry structure, the use of cement-based mortar and plaster on the interior walls, and the improper implementations of certain details have caused various deteriorations arising from dampness. Dampness has caused the plaster layers to deteriorate. Mould and staining are attested on the northern wall of stairwell, the western wall of the deputy principal's room, and the janitor's room, as well as on the walls of the north-facing classrooms on the first floor. Due to high humidity, flaking is

seen on the interior surfaces (Fig. 4). These issues in the building, which affect its material strength and the health of its users, pose an important risk since it is currently a functioning structure.

The masonry walls that meet concrete flooring should be examined in detail. The structural and chemical effects of the cement-based material clearly cause deterioration in the original building elements (e.g. salt deposits, decrease in material strength). Therefore, necessary maintenance and repairs should be undertaken. The reinforced-concrete additions also pose a structural risk. Reinforced-concrete floors, built after the removal of the original timber flooring, add further load to the structure. The structural behaviour of the masonry structure in conjunction with the reinforced concrete slab should be further examined, since Marmara Island is in an earthquake zone.
