Winery

Umut Almaç, Ioannis Papachristou

District of Erdek, Paşalimanı Neighbourhood, Köyiçi Locality	Construction period/date: 1873
	Current status: Abandoned
GPS: 40°29'14.3"N 27°36'34.0"E	Ownership status: Private ownership
Registration date and number: Bursa KTVK BK 11.12.2014 - 3912

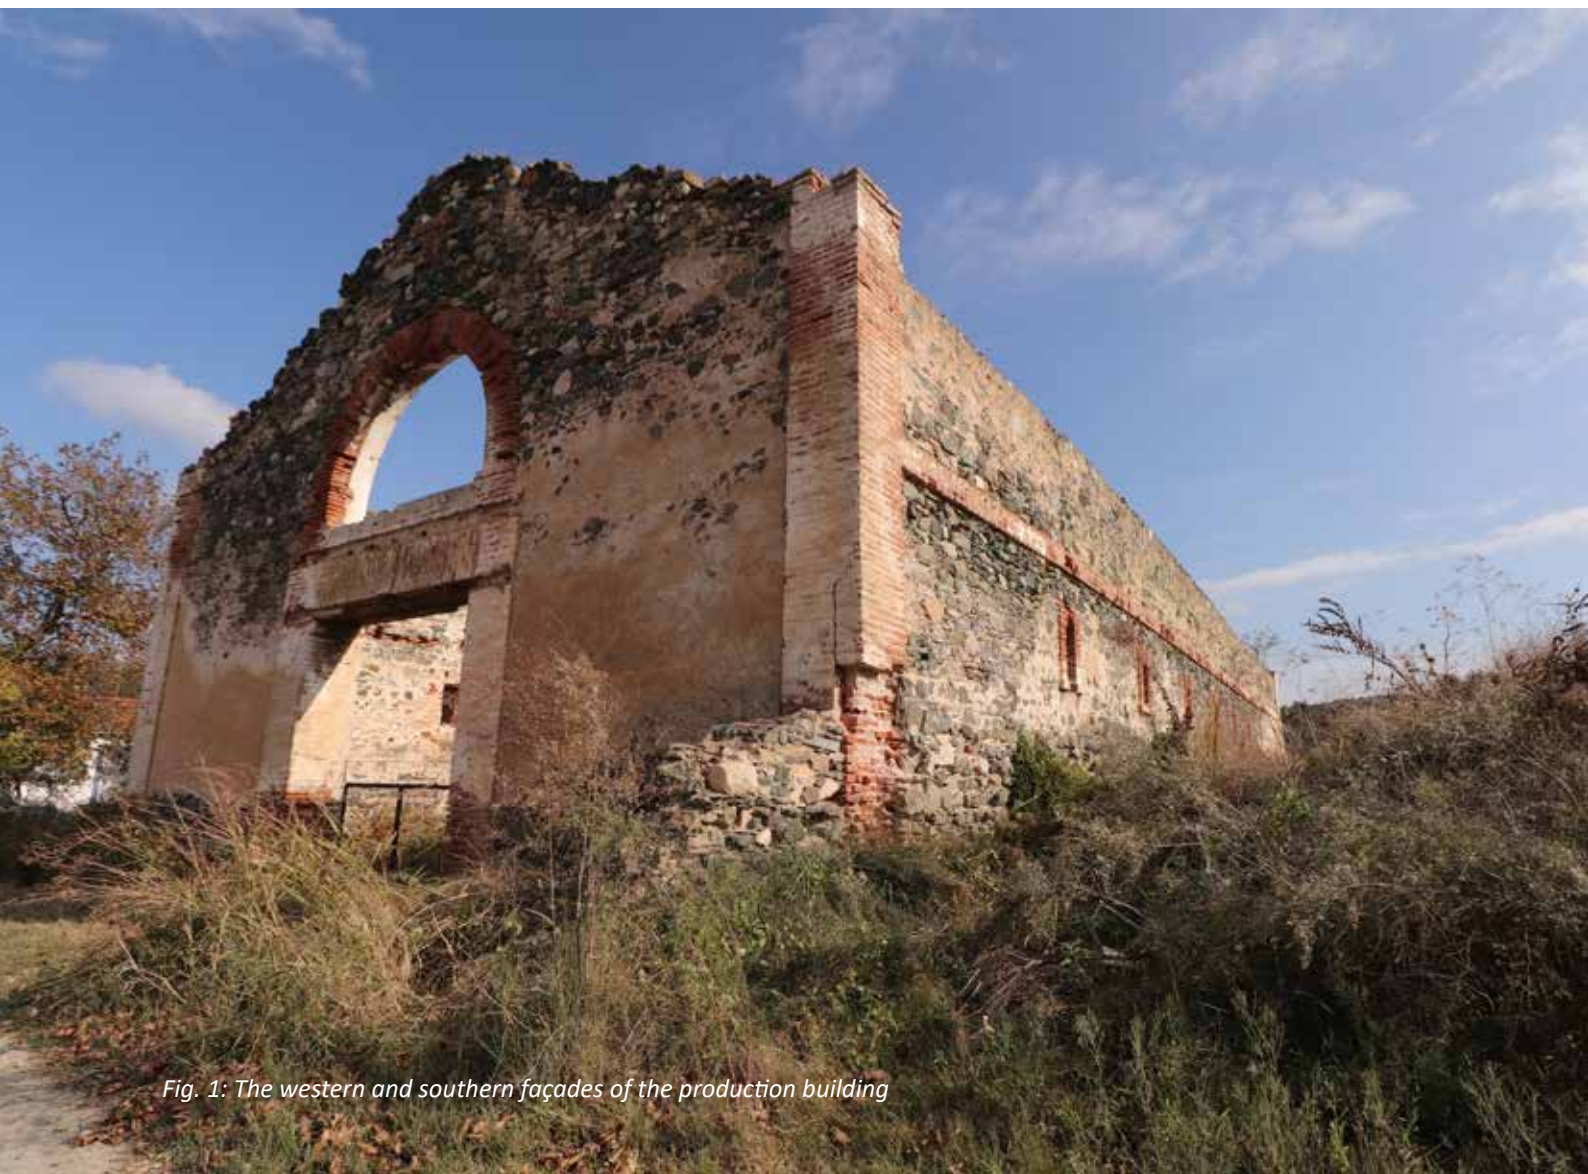
Fig. 1: The western and southern façades of the production building

The main walls, approximately 70 cm thick, are built with rubble and originally plastered over (Figs. 2-3). The corners of the building as well as the jambs and lintels of the openings are of brick and protrude 5 cm from the wall surface. The western façade with the gable contains the building's entrance (Fig. 1). In the centre of the façade there is the main doorway, approximately 3.50 m wide and 3.70 m high, with a lintel and a semi-circular window above (Fig. 5). Brick pilasters at the building's corners and in the entrance jambs have a width of three full bricks (about 75-80 cm), while the window arches have a width of two full bricks (50 cm). The brick lintel above the entrance is supported by three I-beams. Only one of these has survived, but they were once horizontally connected with iron bands. There are not any traces of window joinery in the window opening above the entrance door. However, there is a brick indentation on the interior of the arch, closer to the façade surface, where it must have been placed. The short iron bars that are placed at an angle from the masonry to the opening must have connected the joinery to the wall.

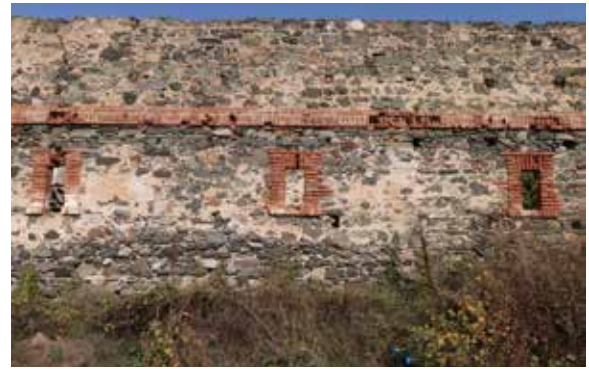
Fig. 2: The southern façade of the production building

The southern façade has a symmetrical organisation. There is a row of windows approximately 2.5 m above the ground level, and a brick moulding protruding 40 cm above this, probably at the level corresponding to the collapsed mezzanine floor (Figs. 2-3). The row consists of eight windows. These rectangular openings are 35x75 cm with brick jambs, lintels, and sills. They also have depressed arches on the interior (Fig. 3). The windowsills are flat on the exterior and slanted in the interior. The northern façade has a similar arrangement to the southern one. The only difference is that there are only six windows on

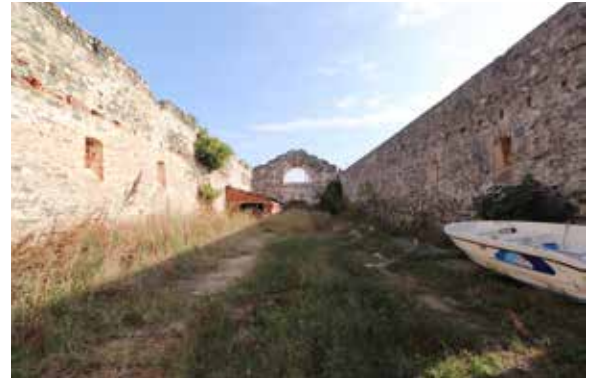
Fig. 3: View towards the east from the interior of the production building

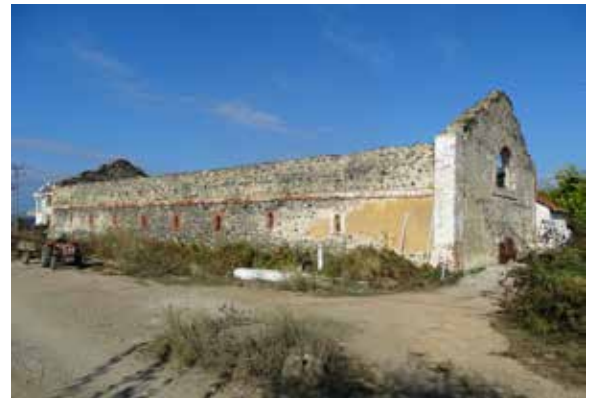
Fig. 4: The eastern and southern façades of the production building

The eastern façade is similar to the western one, except for the entrance (Fig. 4). There is a very shallow opening that is 2.10 m wide with a brick lintel in the centre of the eastern façade at the ground floor; this opening is suitable for material supply during the production process. Similar to the western façade, there is a semi-circular opening in the gable of the eastern façade. Iron elements that connect the window joinery to the masonry wall can also be seen in this opening.

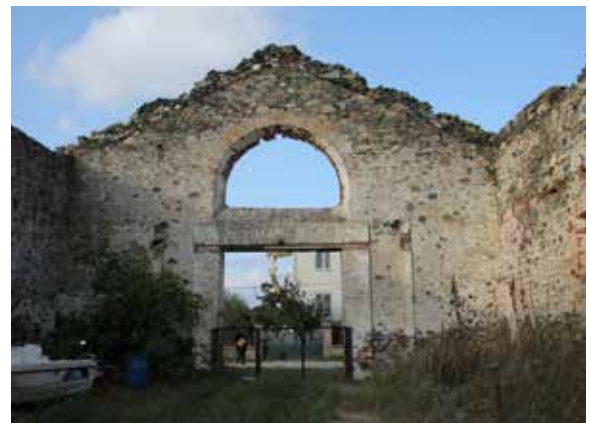
Fig. 5: Western wall of the production building

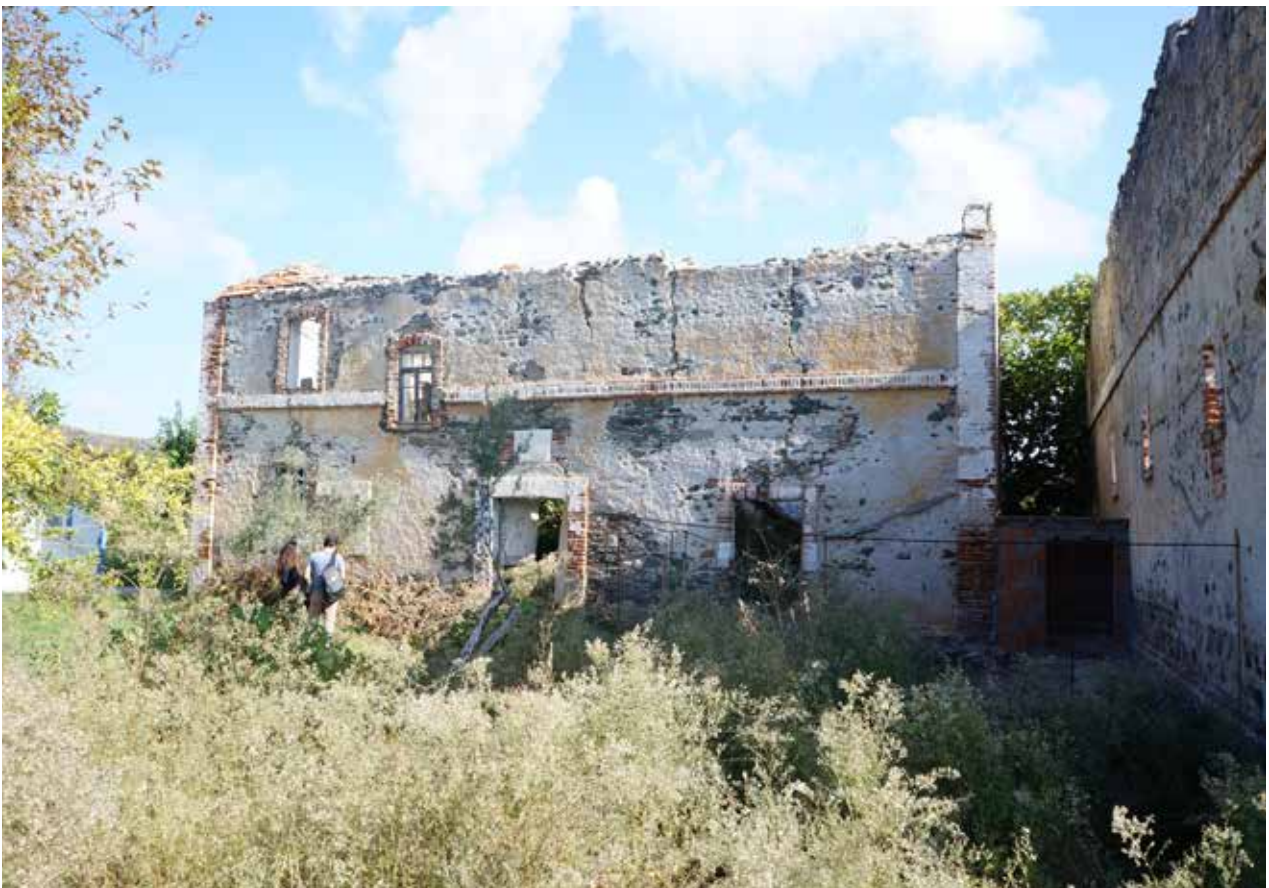
Fig. 6: Western façade of the administrative building

The western façade facing the earthen road has the main entrance (Fig. 6). It originally had a symmetrical organization that consisted

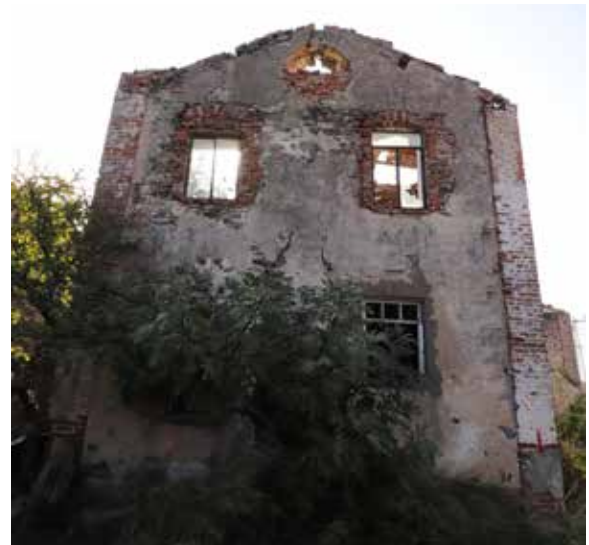
Fig. 7: Northern façade of the administrative building

On the northern façade, there are two symmetrical windows each in the ground and first floors, and a small circular window in the gable (Fig. 7). Except for the latter, all windows were added later using hollow bricks to

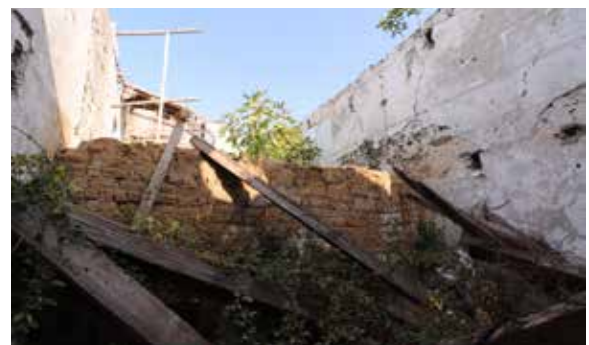
Fig. 8: View towards the north from the interior of the administrative building

The mudbrick partition walls bounding the entrance hall on the north and south, as well as the timber-frame walls covered with wood-laths, are interventions related to the transformation of the northern part of the hall into a house (Fig. 8).

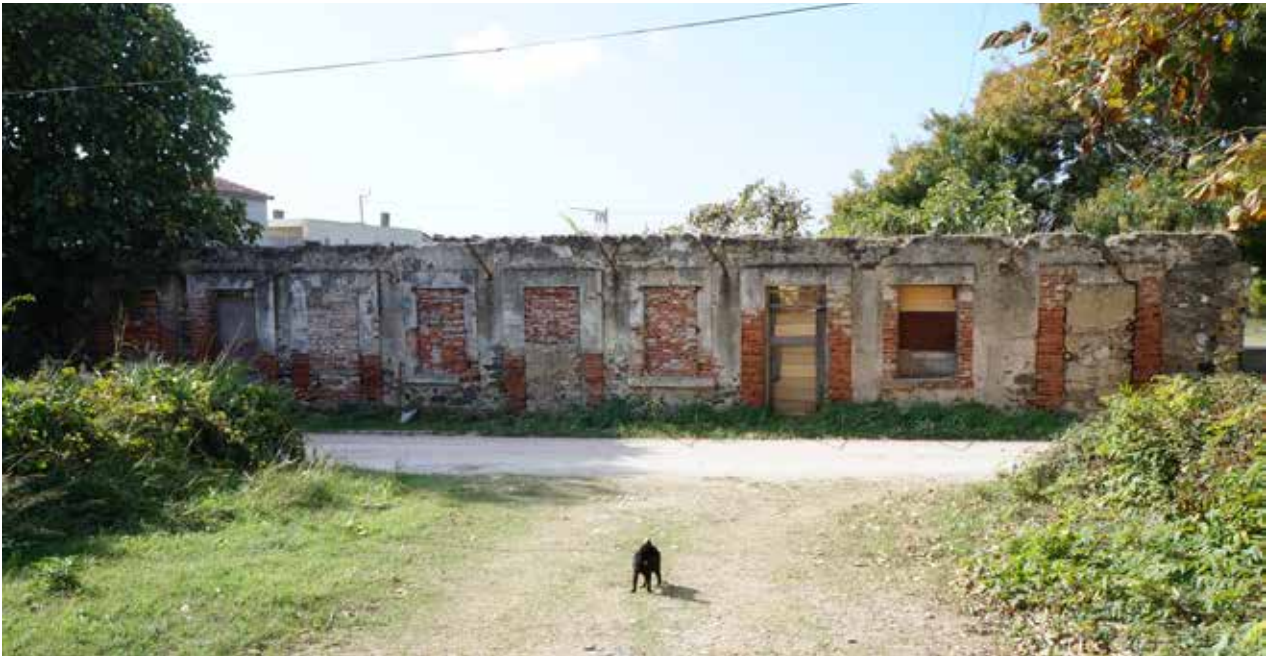
Fig. 9: Eastern façade of the lodging building

The eastern façade, which has a very rhythmic architectural order, has a series of doors and windows starting from the northern corner. One doorway and one window are repeated three times, followed by three doorways and one window, and ending with three doorways (Fig. 9). All the doors on the façade are 1 m wide, with the exception of the 2-m-wide doorway, which is located to the south of the façade leading into the courtyard. The windows are about 90 cm wide.

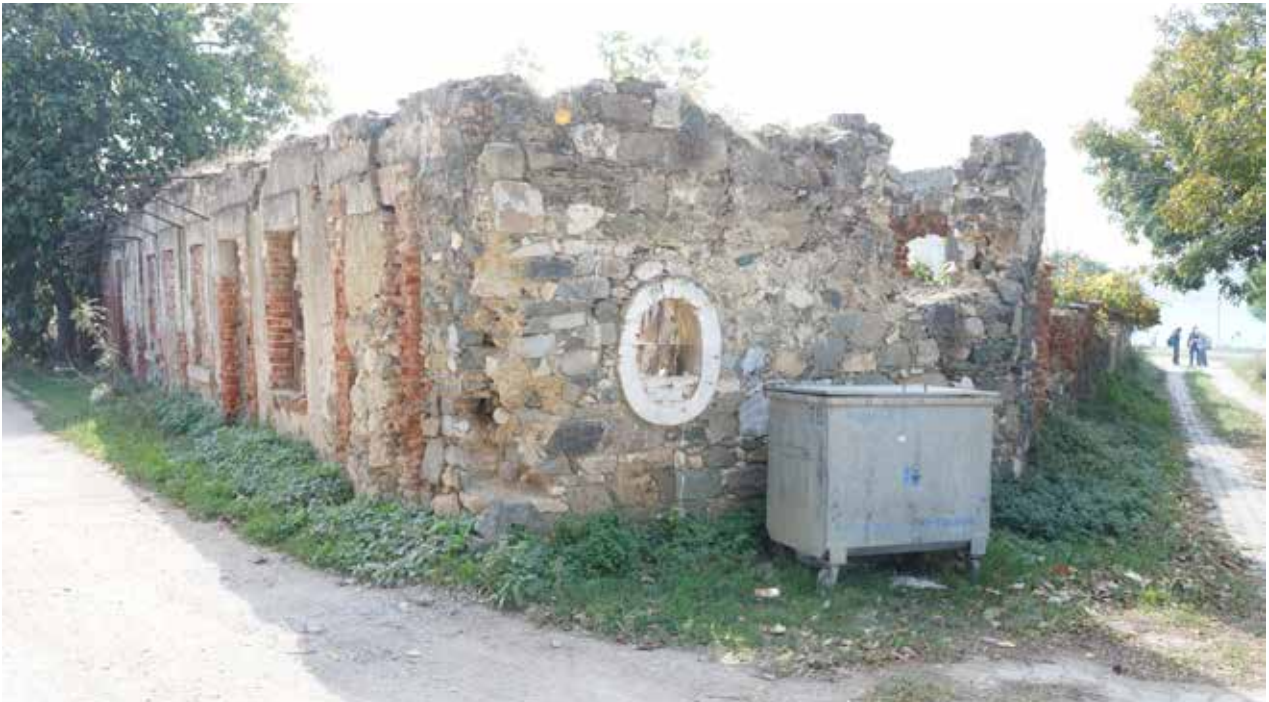
Fig. 10: Northern corner of the lodging building

adjacent garden wall (Fig. 10). The 4-meter-long section of the building wall directly faces north, the wall then slightly shifts and continues southwest for approximately another 2 m, and eventually connects to the courtyard wall with brick eaves. The north-facing wall has a small upright oval window. A half-brick-wide frame runs around the window with iron bars.

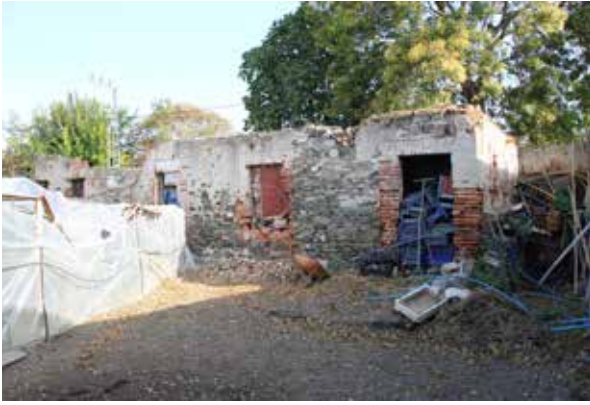
There are seven windows and three doorways on the western façade facing the sea (Fig. 11). The openings have the same character as those on the eastern façade. The iron railings of the now-lost balcony are still at the centre of the façade (Fig. 12). These railings are connected to the masonry wall with cast iron brackets.

Fig. 11: Western façade of the lodging building

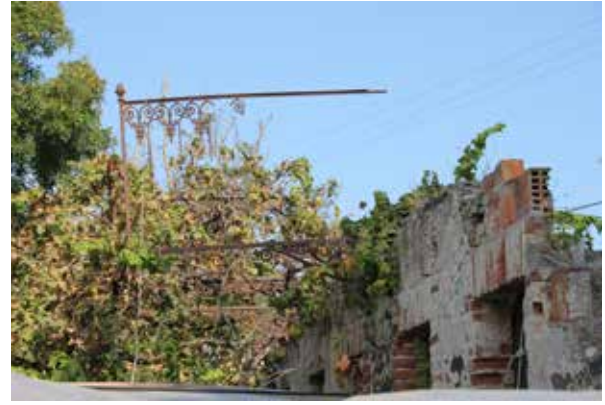
Fig. 12: Balcony railing on the western façade of the lodging building

The perforated iron balustrades of the balcony on the western façade of the lodging building suggest that the first-floor walls were also stone masonry. The iron bar with box profiles sitting on the cast iron brackets at the flooring level and on the railings' upper level connect the balcony to the masonry wall.
