Lighthouse

District of Erdek, Karşiyaka Neighbourhood, Fener Adası Locality	Construction period/date: Second half of the 19th century – Beginning of the 20th century
	Current status: Not in use
GPS: 40°27'42.6"N 28°03'58.9"E	Ownership status: Private ownership
Registration date and number: Unknown

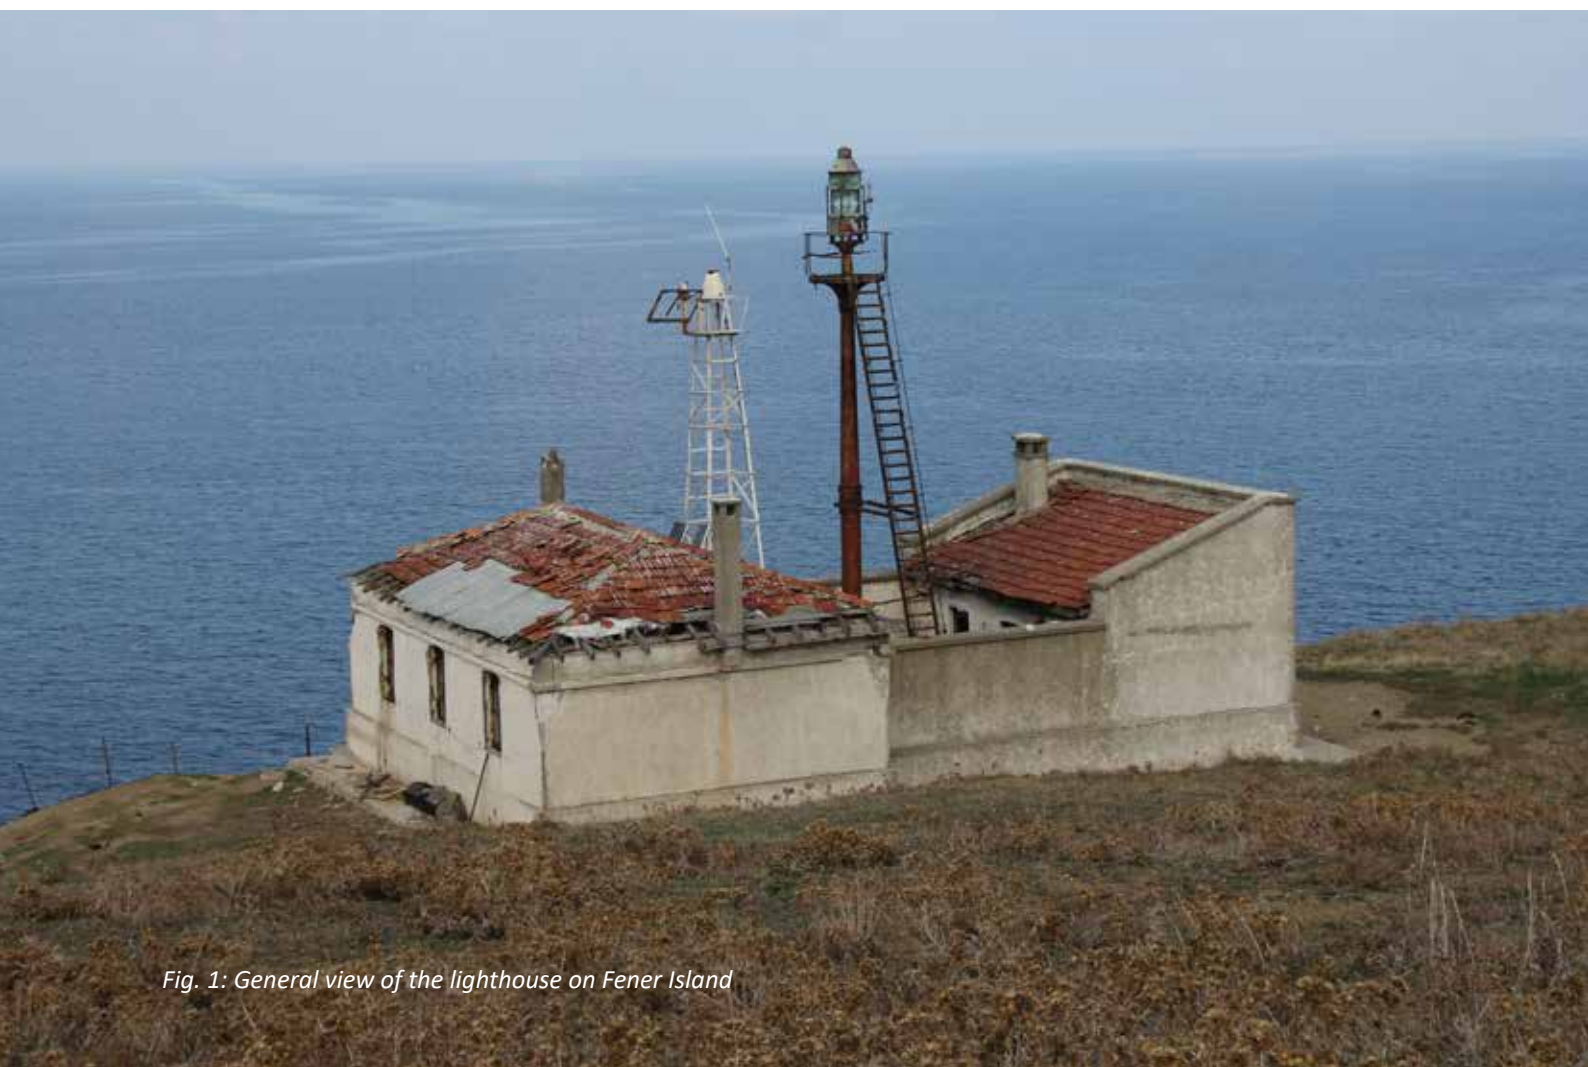
Fig. 1: General view of the lighthouse on Fener Island

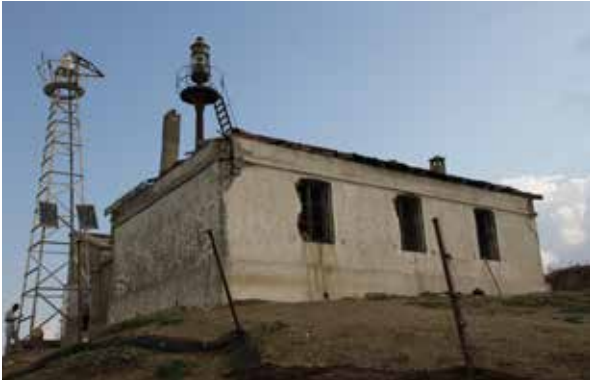
Fig. 2: Southwestern façade

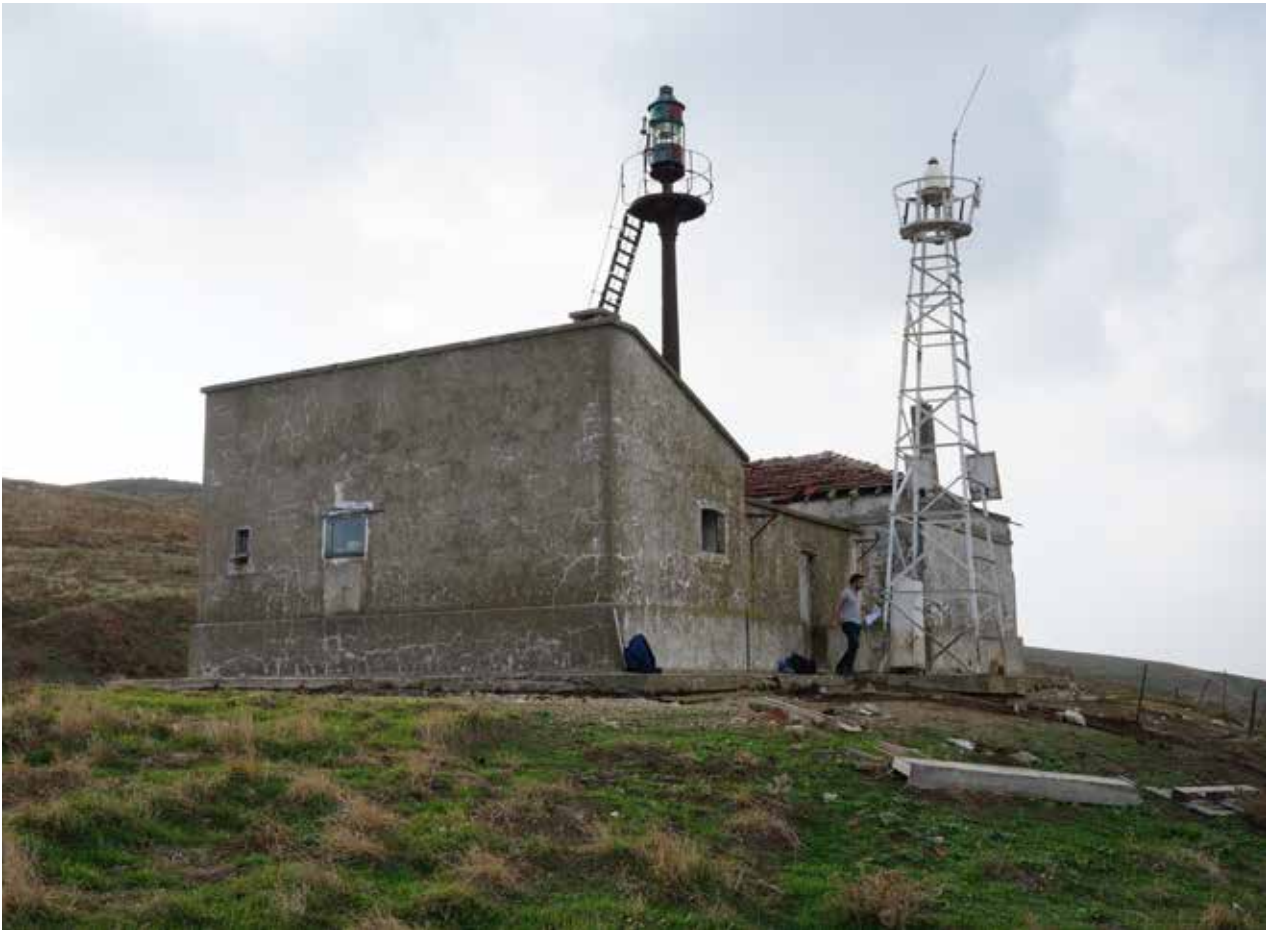
The building's main walls are 50 cm thick and covered with a thick layer of plaster. As it is observed from the damaged area in the western corner, the walls are rubble masonry. The partition walls are 28 cm thick. Solid brick is used in the windows and doors with depressed arches. Continuous iron ties are seen near the level of the eave in the residential section. Ties are fitted to the main walls with anchors. Horizontal cracks seen on the upper parts of the façades and interior walls are caused by the corrosion of the iron ties. The

Fig. 3: Northeastern and southwestern façade

cracks indicate the level at which the ties were placed. The steps and the floor of the corridor are made of terrazzo. The residential part has a timber, hipped roof covered with Marseille tiles. The interior spaces have timber ceilings. The auxiliary units have a timber lean-to roof that is also covered with Marseille tiles. All the window and door joineries are made of timber.

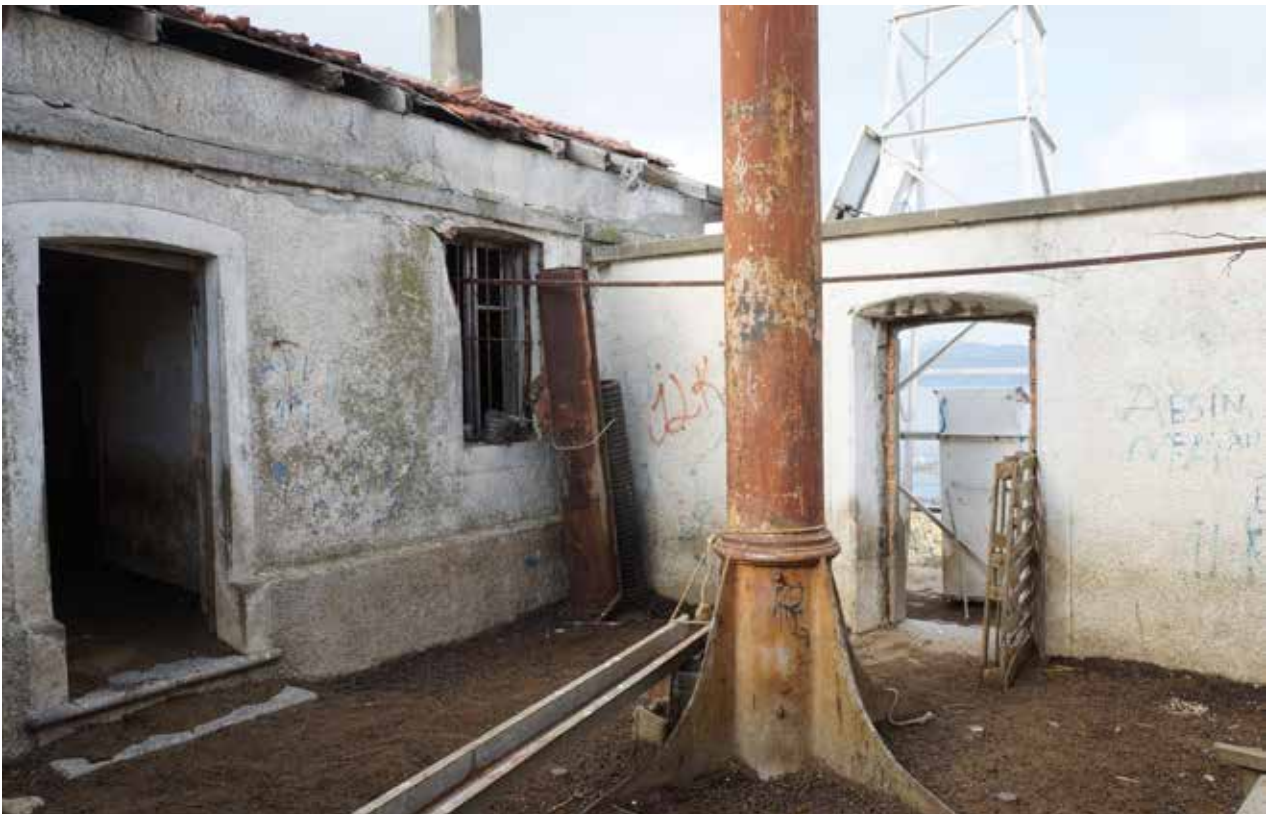
Fig. 4: Courtyard, southwestern façade

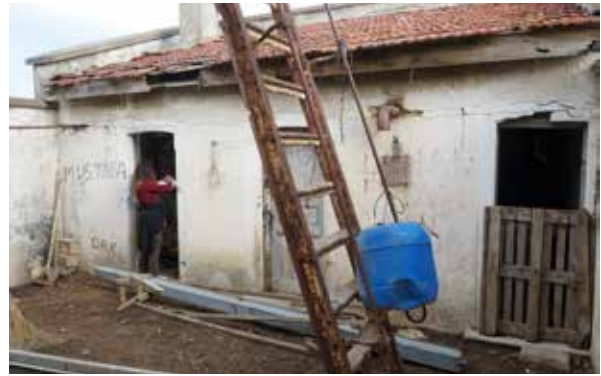
In parallel with the automation of lighthouses and the developments in satellite communication systems, the family that kept the lighthouse abandoned the site, which resulted in the deterioration of the building due to negligence. The light pole preserves its original details to a great extent but it is under the threat of irreversible destruction due to severe corrosion, unless repaired soon. Damages are

Fig. 5: Courtyard, northeastern façade

noted on the masonry walls and timber roofs of the lighthouse structures.

The lighthouse, which partially preserves its original installations, should be considered as industrial heritage due to its historical, technological, and architectural value, and should be protected accordingly. The building, dating between the second half of the 19th century and early 20th century, is of importance since it reflects the French influence in the design and construction of supplementary structures for navigation, especially in maritime transportation. It is quite surprising to see that the projects prepared in the middle of the 19th century were implemented just as they were designed. The architectural quality and the organization of the residential unit are beyond their age. Furthermore, the original light pole is unique; it is among the rare architectural examples of its type that have survived. The iron light pole should urgently be taken under protection.
