Windmills on the Southern Marmara Islands

Gizem Erten, Umut Almaç, Emre Kishalı

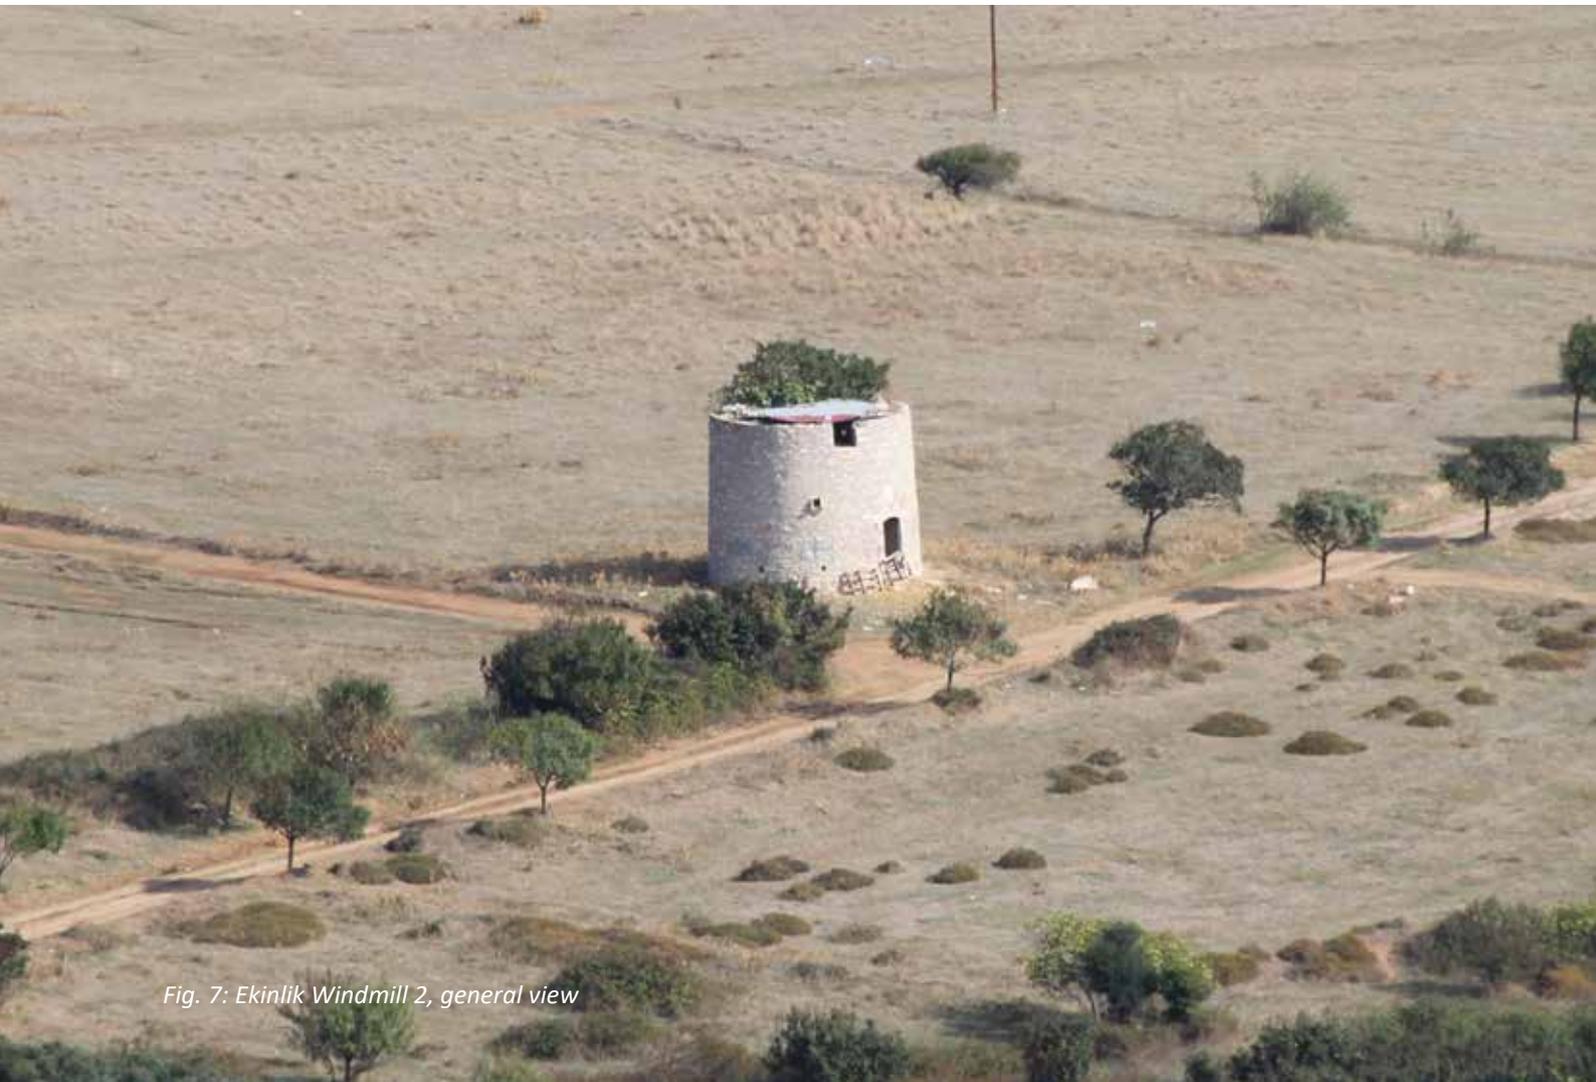
Fig. 7: Ekinlik Windmill 2, general view

Windmill 2 is used as a straw depot and located on a lot of 561.34 m² to the northwest of the harbour of Ekinlik Island. It is approximately 475 m from the harbour as the crow flies (Fig. 7). The main walls, as well as the window and door openings are intact. The circular structure has a perimeter of about 20 m (exterior diameter is approximately 6.50 m) and its entrance is in the south. The inscription "1877" over the entrance supports that the islands' windmills date from the 19th century (Fig. 8). Since the middle part of the stone lintel above the door has a curvilinear form, the opening seems to have the form of a depressed arch. According to the *Marmarina Nea* newspaper, the building belonged to a person called Ntompros before the population exchange (May 1952, 1). There is a rectangular window opening with a width of 45 cm to the west of the entrance, at the level of the inscription. The window jambs protrude by about 18 cm. The structure is currently covered with aluminium sheets. The main walls of the building are rubble masonry. The wall thickness is about 118~120 cm. Lime-based mortar and plaster are noted on the wall surfaces. On the upper levels of the body walls, there are holes for timber beams that carried the flooring. The mechanical parts of the mill sat on this flooring. Due to the bales of straw on the interior, the original features of Windmill 2, such as the extant staircase, could not be investigated in detail.

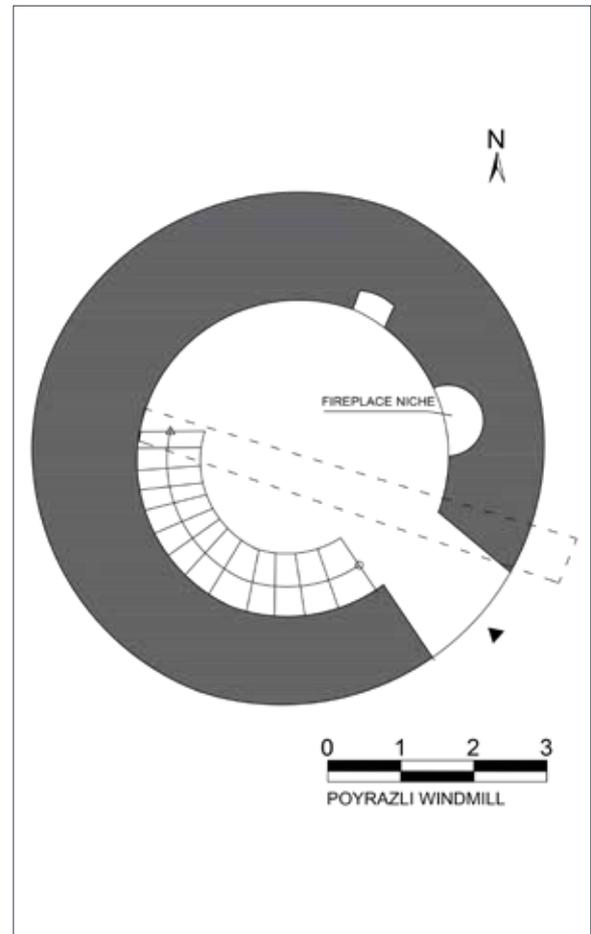
Fig. 1: Poyrazlı Windmill, general view

Poyrazlı Windmill is the most prominent example that has survived with its unique features. It is located on the edge of Poyrazlı Neighbourhood on Paşalimanı Island, to the north of the road leading to the village (Fig. 1). The circular building has an inner diameter of approximately 4.35 m. While its northern façade faces the sea, its gate is on the east. It has a stone-coursed and cylindrical body. Local stones are used as the building material of the cylindrical body wall. The mortar between these stones is the combination of earth, organic additives, and cement-based binder with large amounts of marble and seashells. The cement-based mortar attested on the outer surface of the building must be the result of a later repair. Tension bars are used in the body walls as structural elements. This must be to protect the windmill from natural conditions, especially from strong winds coming from the north.

Poyrazlı Windmill is currently neglected and unprotected because its use ended. The structure is generally preserved in good condition. Some of its significant elements specific to windmills such as the staircase, fireplace, niches, axle, and millstone have survived. Timber bands in the main walls, which are

thought to be original, have survived despite some biological growth; however, they have lost their strength. The loss of the superstructure makes the building susceptible to external factors, accelerates deterioration, and threatens the building's ability to survive for future generations. A large fig tree covers the building's interior to a large extent. Its leaves reach to the upper levels and exterior due to the loss of the superstructure. There are later interventions involving cement-based mortar, lime-based mortar, and iron reinforcement, which are not compatible with the original materials of the building and may mislead the interpretation of its construction techniques. There is cracking and detachment, as well as loss of materials in the main walls of the building. Biological degradation is seen on the stone surfaces of the exterior.

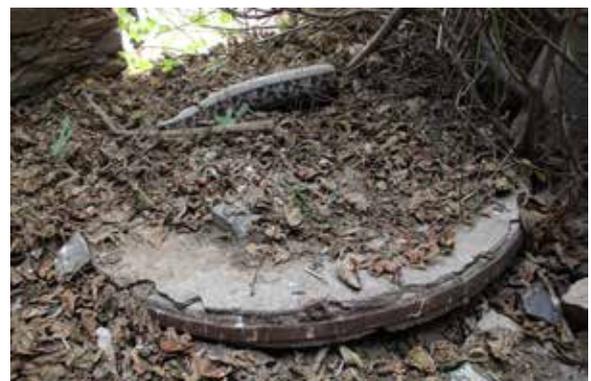
Fig. 2: Poyrazlı Windmill, millstone

The millstone retains its authenticity; however, due to the collapse of the timber beams and flooring carrying the second floor, where it was located, it is currently located downstairs (Fig. 2). The main timber horizontal axle (spindle), which is the main element of the windmill's movement mechanism, has largely been preserved.

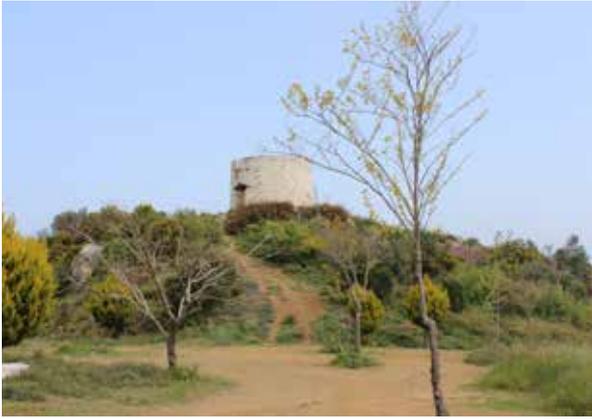
Fig. 3: Saraylar Northern Windmill, general view

The lot, approximately 116 decares, is on the hill to the east of Saraylar Neighbourhood and covers almost the entire slope. The northern windmill dominates over the area and it is about 150 m away from the sea (Fig. 3). The southern windmill is situated atop the slope, about 120 m from the northern one (Fig. 4).

Only the main, masonry walls of these windmills have survived. There are losses of sections and growth of rooted plants on these walls. Unlike the Poyrazlı Windmill and the Ekinlik Windmills 2 and 3, all of the timber structural elements such as the lintels, the timber bands in the walls, and the flooring have been lost. The section of the northern windmill that is defined by the entrance and the window above it is structurally in critical condition. Due to the loss of the doorway's timber lintels, there are losses of the rubble stones in the wall above. Both buildings have debris inside; therefore, the original flooring could not be identified. Similarly, the original roof levels could not be determined. The installations related to the buildings' function have been lost, although the original millstones may be concealed underneath the debris layer on the ground.

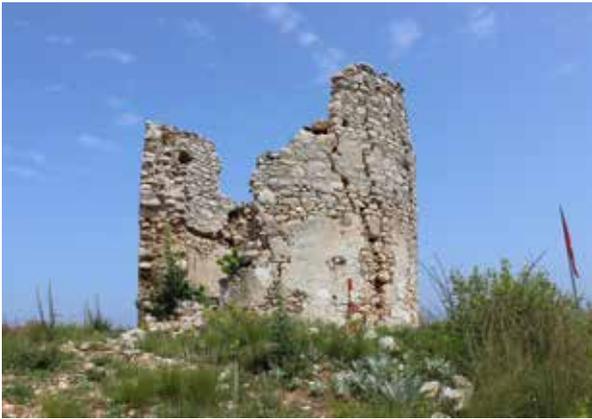
Fig. 4: Saraylar Southern Windmill, general view

The southern windmill is more damaged than the northern one. Apart from its circular main wall, there are not any architectural elements associated with the original function of the structure. The building, which has an approximate inner diameter of 4.0 m, has its entrance in the south. The traces of beam holes on the main wall suggest that it had two floors. The walls, which are about 90 cm thick, are constructed in rubble masonry with timber bands. Lime-based mortar is used to point the façades, while earth-based mortar is used in the core of the wall. Two rows of timber bands (10x10 cm) are used in the walls. These bands are nailed to elements with smaller cross-sections (6x6cm) that are placed transversely throughout the wall thickness for bracing. The walls reach up to a height of 5.20 cm in the east. The walls on the exterior of the ground level protrude approximately 6-7 cm, forming a wall base.

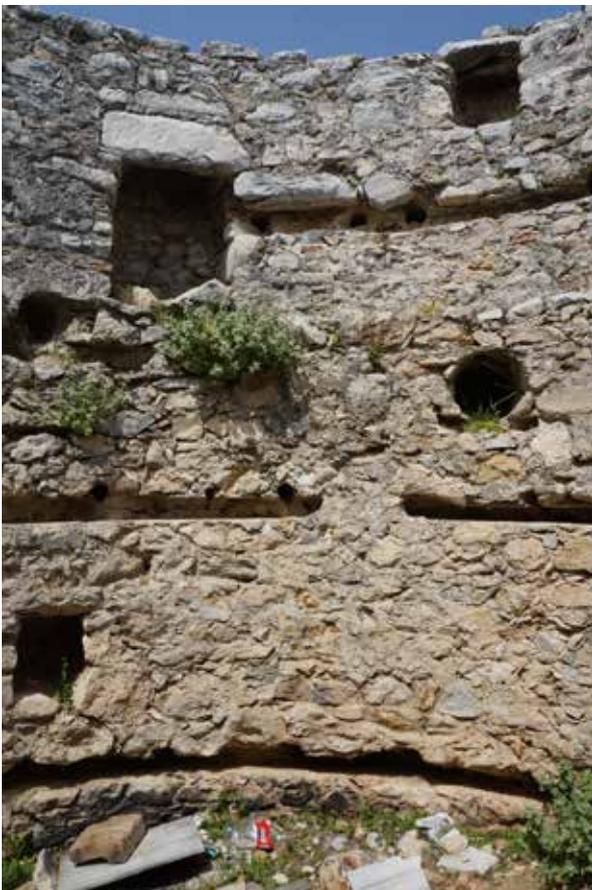
Fig. 5: Saraylar Northern Windmill, interior view

The architectural elements of the northern windmill's original function have not survived, apart from the circular body wall. The circular building, which has an approximate inner diameter of 4.25 m, has an entrance to the west. The beam holes in the main walls suggest that the building was two-storey, similar to that in Poyrazlı. The grinding process was probably carried out on the upper floor, whereas storage and packaging were held on the ground floor; therefore, most of the installations (millstone, flour basin, wheel elements, etc.) that no longer exist must have been upstairs. Unlike the Poyrazlı Windmill, there are not any traces of a staircase connecting the floors on the main walls. There are two rectangular openings, one above the entrance door and the other close to the roof level on the east, for the illumination of the spaces. The fireplace used by the miller is on the upper levels of the main wall. The lintel of the fireplace is monolithic limestone. In the main walls, there are two niches with lintels, one near the fireplace at the upper level, and the other at the ground floor level (Fig. 5).

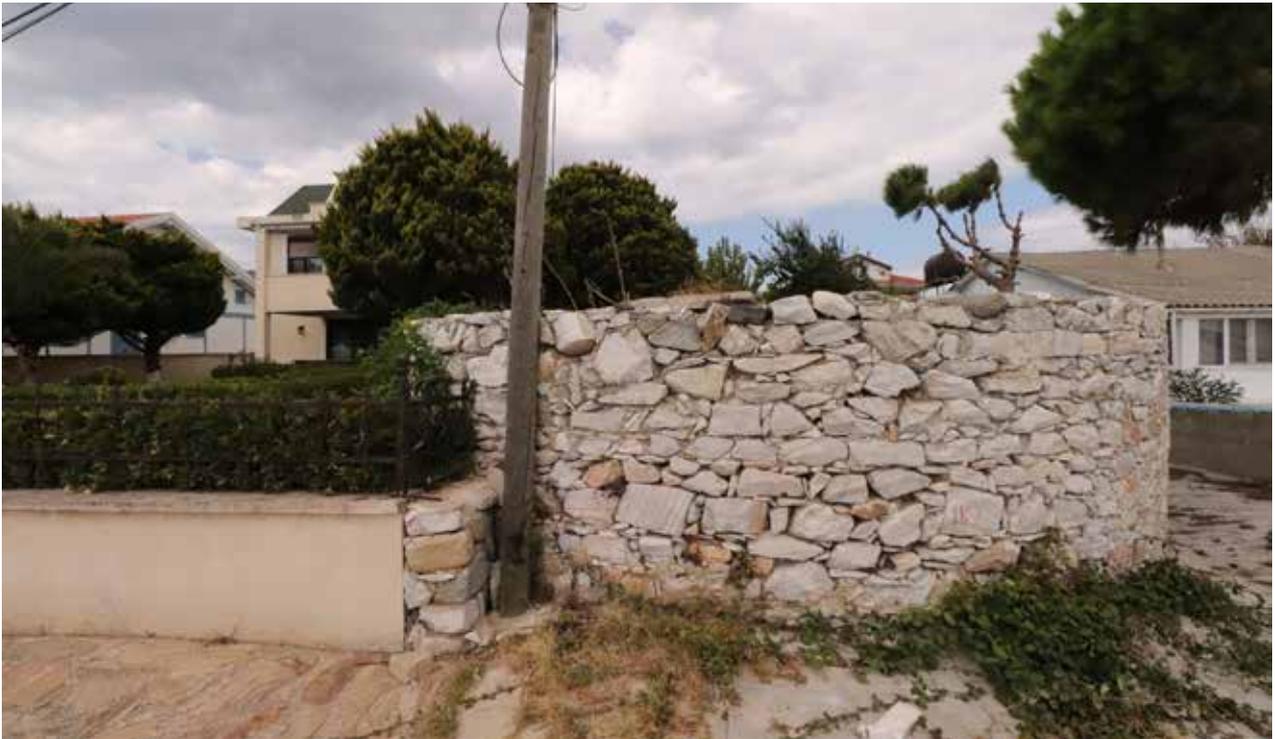
Fig. 6: Ekinlik Windmill 1, general view

Windmill 1 is to the west of the harbour of Ekinlik Island (Pl. IX.39). It is on a 113.92 m² lot that is in the garden of a recently-constructed, residential building (Fig. 6). It is approximately 500 m from the harbour as the crow flies. The remaining sections of the structure are the circular main walls –with an approximate height of 1.85 m– and nine steps

Of Windmill 1, only the main, masonry walls up to a certain height and the staircase are extant. Plant growth is seen in the interior as well as at connections of the floor and main walls. Cement-based mortar is used as binding material.

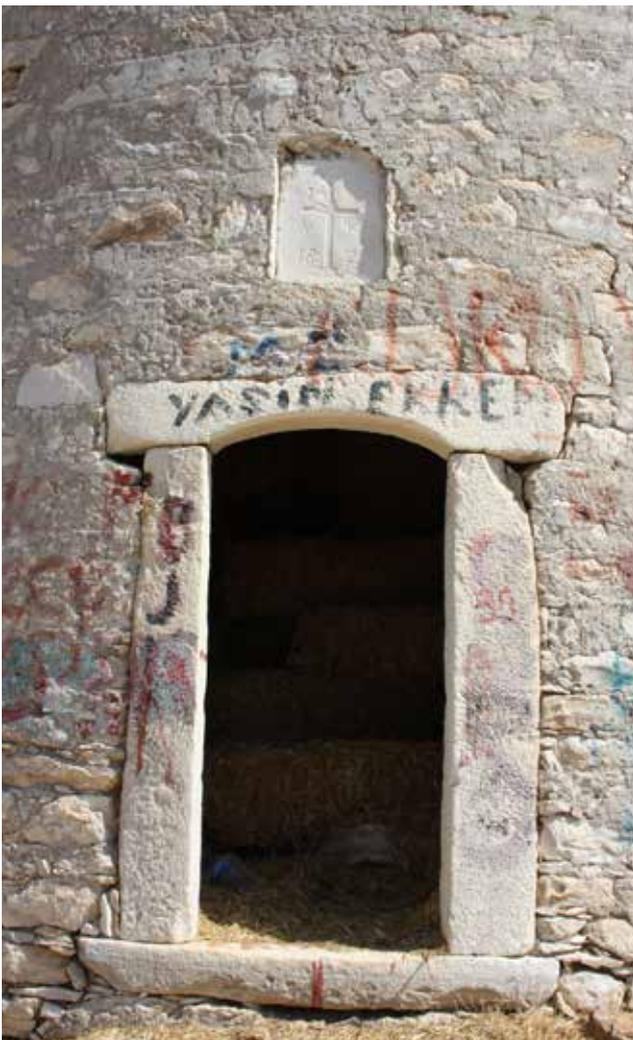
Fig. 8: Ekinlik Windmill 2, entrance door, inscription panel, and vandalism

The main walls as well as the window and door openings of Windmills 2 and 3 have survived. The marble inscription panel in Windmill 2 is noteworthy. Since the interior is

used for hay storage, a detailed examination of the deteriorations could not be made. The area around the door lintel is spray-painted.

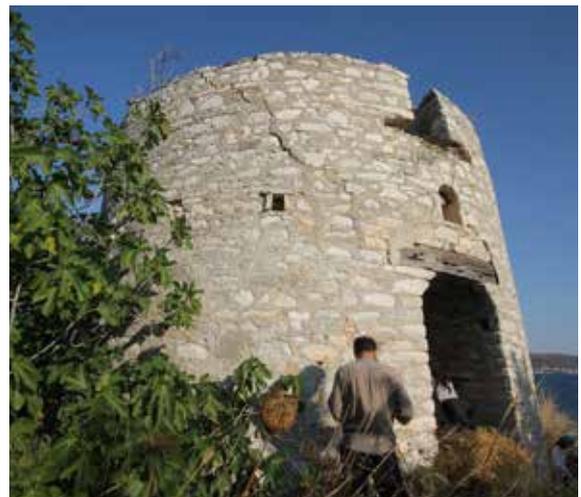
Fig. 9: Ekinlik Windmill 3, western façade and general view

For Windmill 3, apart from the main walls, the staircase and some of the elements carrying the installations of the windmill on the first floor are still *in situ*. There is plant growth (especially a fig tree) in and around the building, similar to the Poyrazlı Mill. There are not any traces about the production mechanism such as the gear wheel, millstone, or axle. The original millstone is probably concealed underneath the debris layer on the ground, like the examples in Marmara Island's Saraylar Neighbourhood. Most of the timber structural elements –such as lintels, bands within the walls, flooring, and roof– of Windmill 3 are still in place. Therefore, it has better architectural quality than the other examples on Ekinlik. There are structural cracks between the level of the lintel and level of the roof on the northern and southern façades of the windmill.
