Agios Georgios Monastery

İnci Türkoğlu, Ioannis Papachristou

District of Marmara, Avşa (Türkeli) Neighbourhood, Manastır Cape	Construction period/date: 1638
GPS: 40°29'55.6"N 27°28'56.5"E	Current status: Archaeological site
	Ownership: Unknown
Registration date and number: Bursa KTVKKBK 18.08.1990 - 1294, Çanakkale KTVKKBK 23.05.2003 - 2014

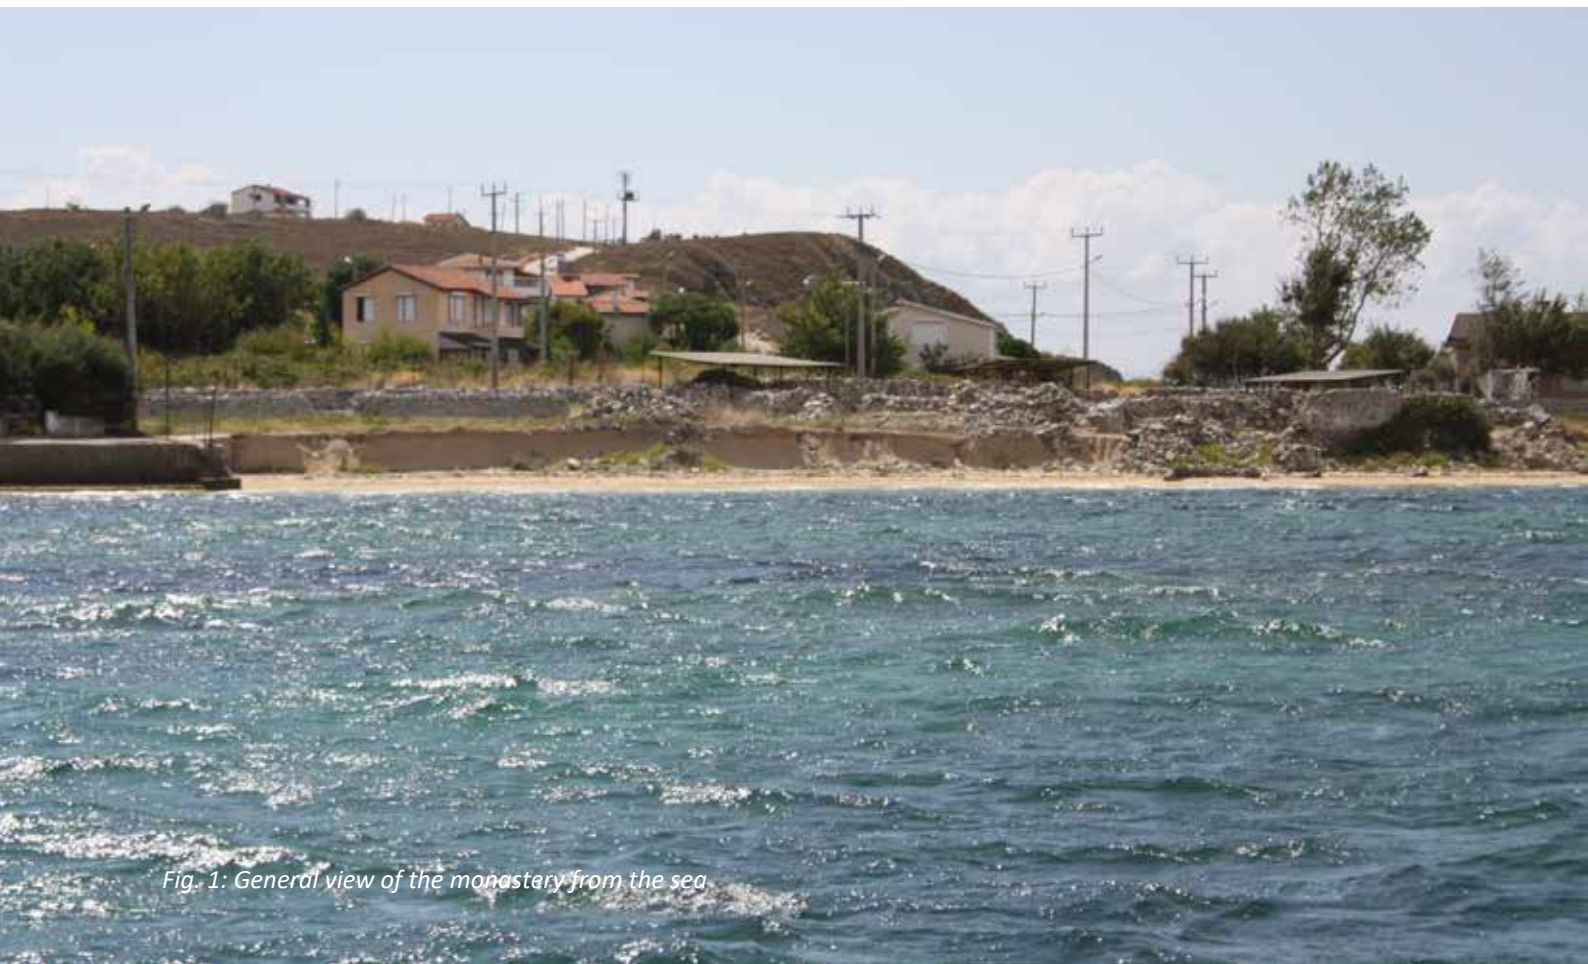
Fig. 1: General view of the monastery from the sea.

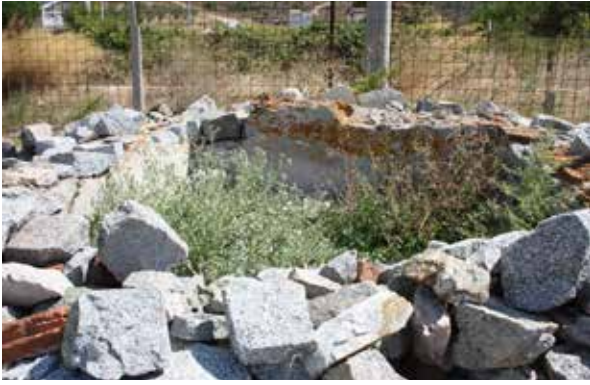
Fig. 2: Water tank in the outer courtyard

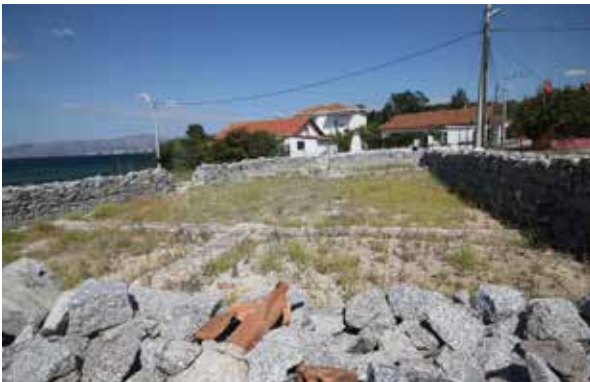
Fig. 3: View of the refectory (trapeza) from the southwest

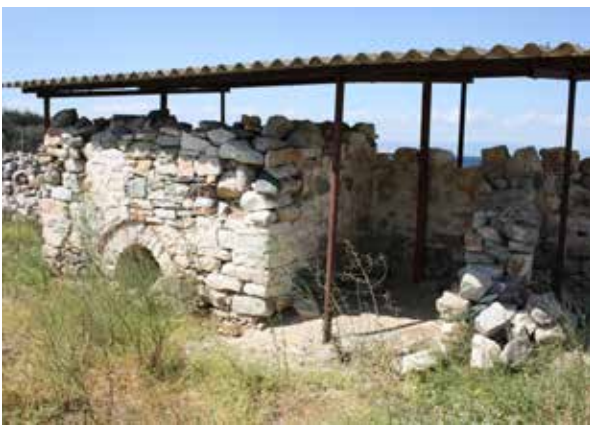
Fig. 4: "Hagiasma?" in the outer courtyard and the wall fragment to its east

A projection from the western part of the southern courtyard wall corresponds to a shorter one extending from the east of the rectangular construction adjoining the southern wall of the main group. These two projections seem to meet and bound the southern area on the west. Also, there is a small wall tongue in poor condition by the southeastern corner of the main group. The rectangular construction (1.94x3.12 m and 1.42 m tall) adjoining the southern wall of the main group has an arch at the bottom of its southern wall. The excavations led to its floor that mildly slopes down toward the arch. Polat proposed it to be a *hagiasma* (p. 209) from the first construction phase; however, there is nothing to confirm this proposal yet (Fig. 4).

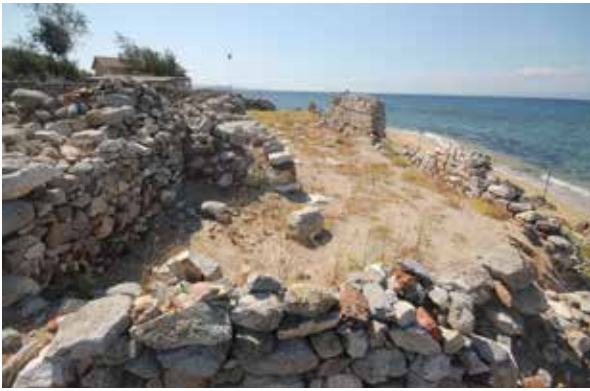
Fig. 5: View of the inner courtyard's northern part and the encircling wall from the east

The main group's encircling wall (Fig. 5) contained baths, a *katholikon*, *hagiasma*, winery, kitchens, workshops, well, monks' cells, cemetery, and more. The baths, entirely in ruins today, are located between the northern encircling wall and the *katholikon* church (Fig. 5). The basins uncovered on the inner and sea sides of the northern encircling wall by Polat (p. 210) are not discernible today. In this part, the outer shell of the stepped *hagiasma* projects from the northern wall of the *katholikon* church. This curving and descending corridor with eight steps leads down to a small basin.

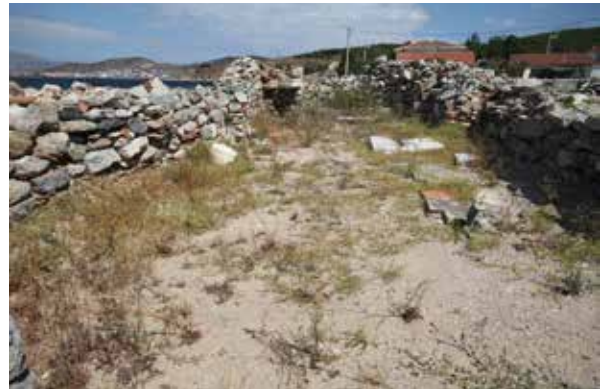
The *katholikon* church is an oblong structure that lies in the east-west direction, with a protruding semicircular apse to the east and a narthex to the west (Fig. 6). It is accessed via a doorway at the southern end of the western wall of the narthex and another doorway at the western end of the southern wall of the naos. The narthex is paved with baked clay bricks and opens into the naos via a doorway in the middle of its eastern wall (Fig. 7). Excavations brought to light numerous fragments of roof tiles and painted Ottoman wares of the 19th century as well as fresco fragments (Polat 2005, 208).

Fig. 6: General view of the *katholikon* church

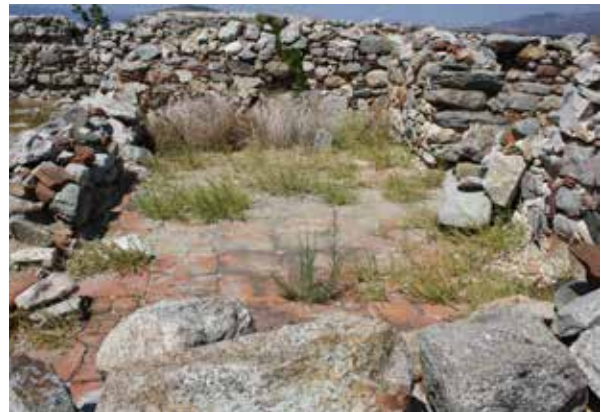
Fig. 7: Narthex

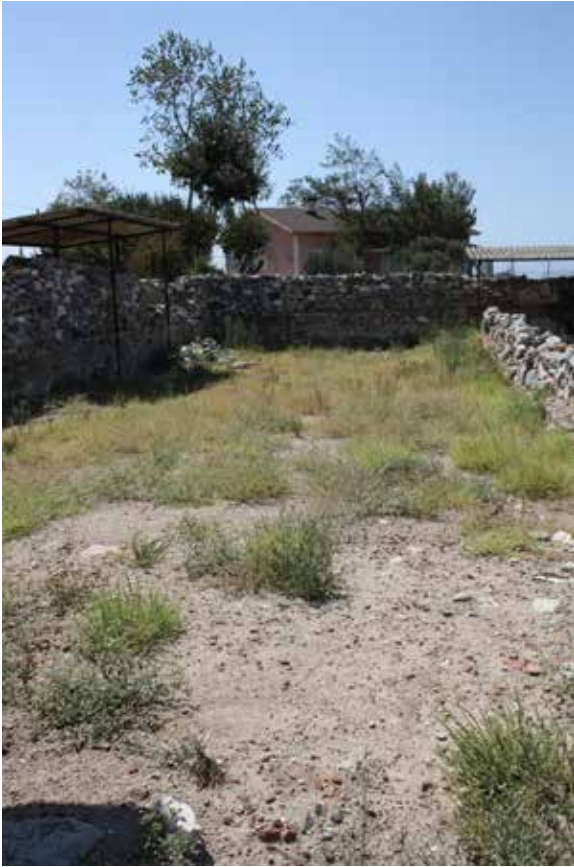
The inner courtyard extending along the southern and western sides of the *katholikon* church is paved with granite and marble blocks. Along the southern side of the inner courtyard extends a large rectangular area housing the work areas and communal kitchen to the east (Fig. 8); on its non-extant, timber upper floor was likely to have been the monks' cells. The communal kitchen still has the lower part of a domed oven (Fig. 9). The area from the oven to the inner courtyard is also paved with stones. This large indoor area is accessed via an opening to the east. At the southwestern corner of the inner courtyard there are the stairs, cooking stove (Fig. 10), winery tank, and discharge basin (Fig. 11); there is a round well (with a diameter of 0.90 m) within a paved square area measuring 1.40x1.40m. to its east (Fig. 12). The cooking stove has bricks marked KII in Greek and the bench in front was built with bricks marked AXMET ΑΛΗ ΠΑΣΣΑ, ΜΥΡΙΟΦΥΤΟΝ, i.e. Ahmet Ali Pasha, Myriofyton (modern Mürefte) (Fig. 13).

Fig.8: Large area housing the communal kitchen and workshops

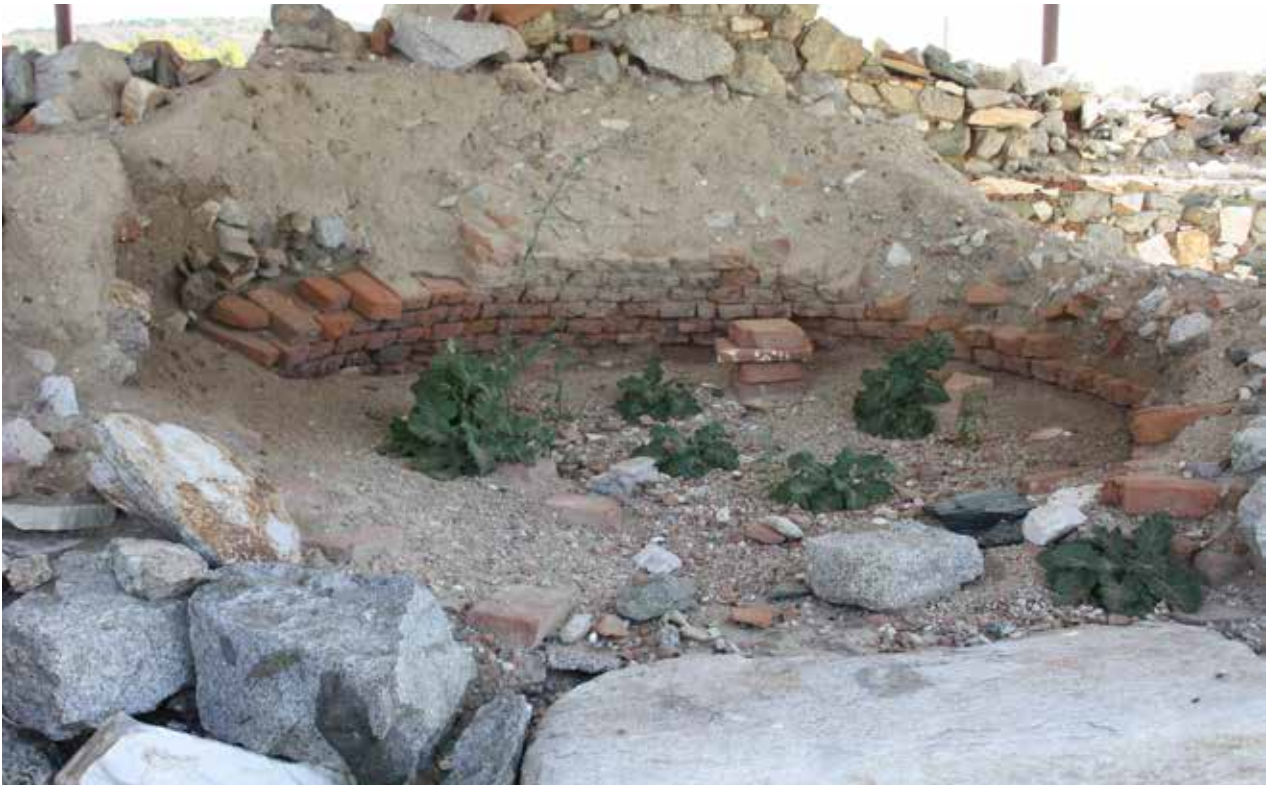
Fig. 9: Domed oven

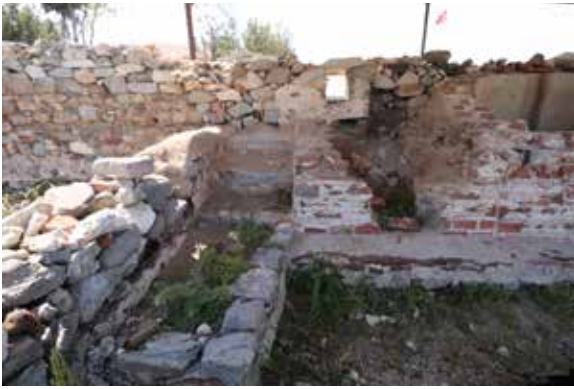
Fig. 10: Stairs and stove

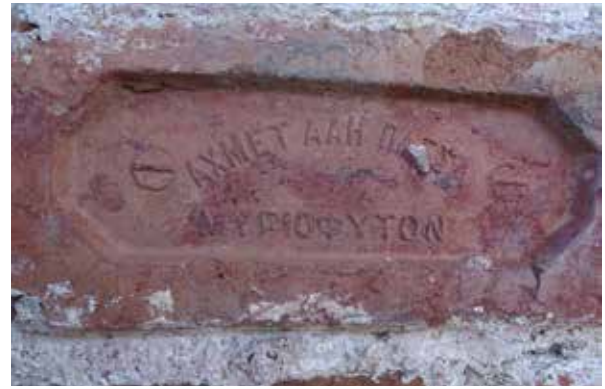
Ahmet Ali Pasha of Mürefte was initially an *armateur*, who eventually went into brick and roof-tile manufacturing. The earliest records of him are from the first decade of the 20th century. Therefore, the construction with his bricks should belong to this decade. On 9 August 1912, a severe earthquake hit the region followed by a tsunami and with WW I, the entire industry was devastated. Fortunately, the region recuperated somewhat after the National War of Independence, but never again reached its former glory, yet Ahmet Ali Pasha remained in the sector (Eldem 2018, 445 Table 17.5). Bricks with KII are not noted in Eldem's study; however, they may be proposed as local, handmade production.

Fig. 13: Bricks inscribed with “Ahmet Ali Pasha Myriophyton”

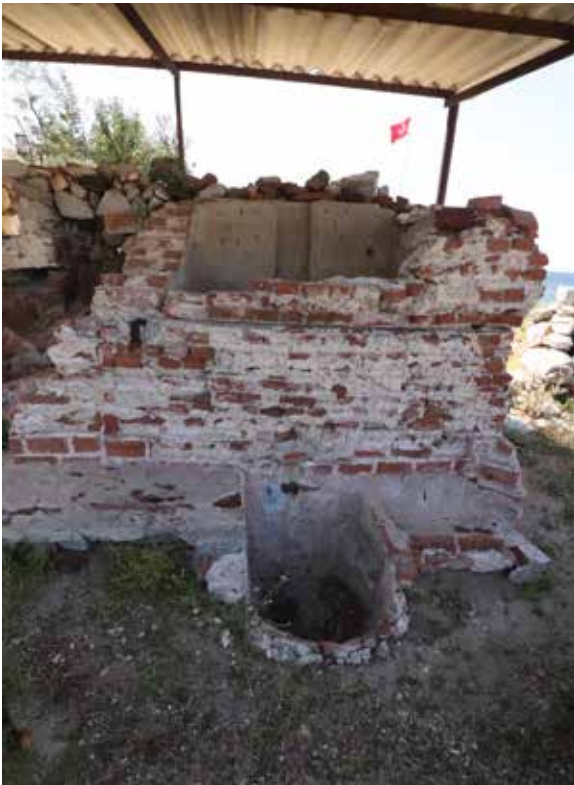
Fig. 11: Winery tank

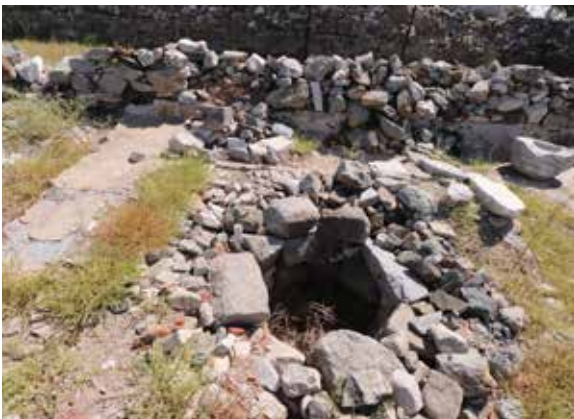
Fig. 12: Well in the inner courtyard
