# Tınaz House

*Mustafa Akçaöz, Emre Kishalı*

District of Marmara, Asmalı (Afthoni) Neighbourhood, Köyiçi Locality	Construction period/date: 1870
	Current status: <b>In use</b>
GPS: 40°36'58.0"N 27°42'17.2"E	Ownership status: <b>Private ownership</b>
Registration date and number: <b>Bursa KTVKBK 15.1.1996 - 4904</b>

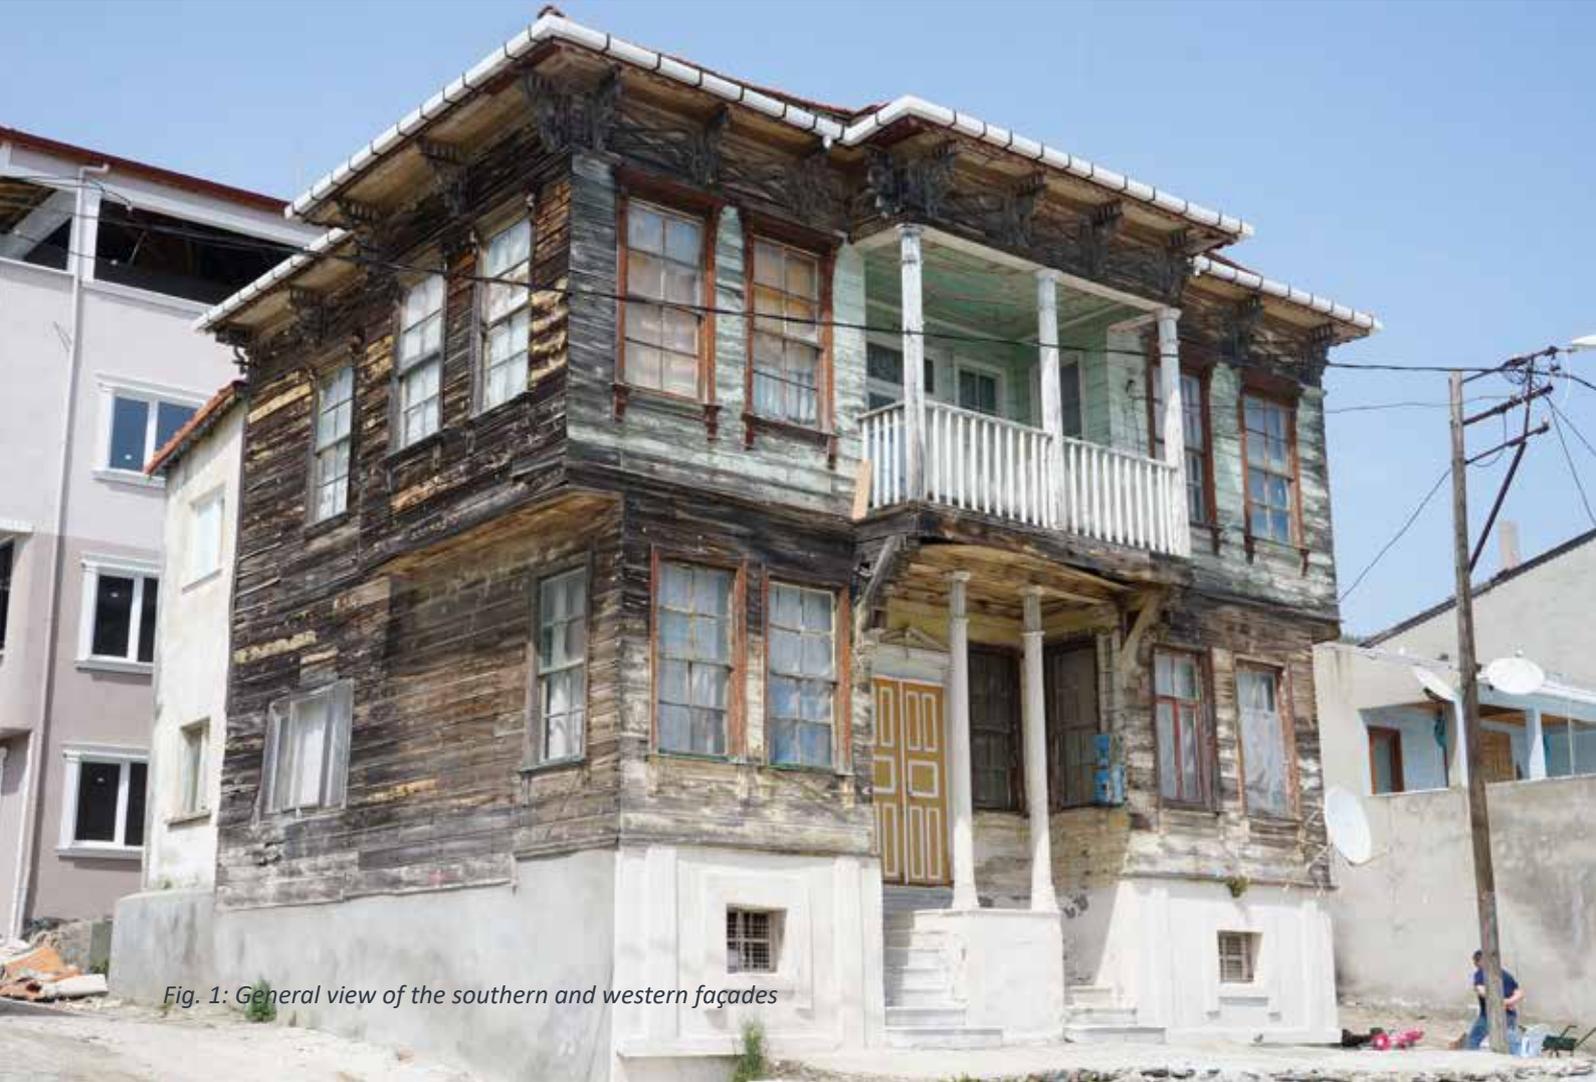
Fig. 1: General view of the southern and western façades

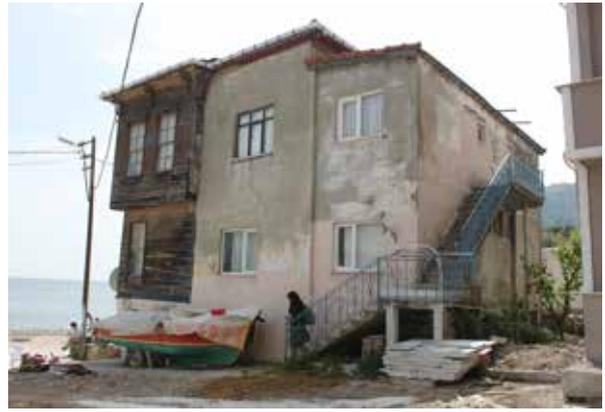
the ground and upper floors are arranged as living spaces. The western façade faces a narrow street. It has a garden to the east and north. The reinforced concrete annex in the north extended the house into the garden (Fig. 2). There are new, reinforced concrete buildings attached to the garden on both sides, but the house has a unique view of the sea to the south. The basement floor is built in rubble masonry and plastered. The ground floor and the southern half of the upper floor are constructed in timber frame with brick in-fill (*humiş*). The building is clad with overlapping timber boards (*yalibaskısı*), except for the northern section of the eastern façade, which is plastered with cement mortar. The projections to the south of the eastern and western façades on the upper floor, as well as the southern façade, are covered with wood laths and not plastered. The hipped roof is covered by over and under tiles.

Fig. 2: Eastern façade and modern northern annex

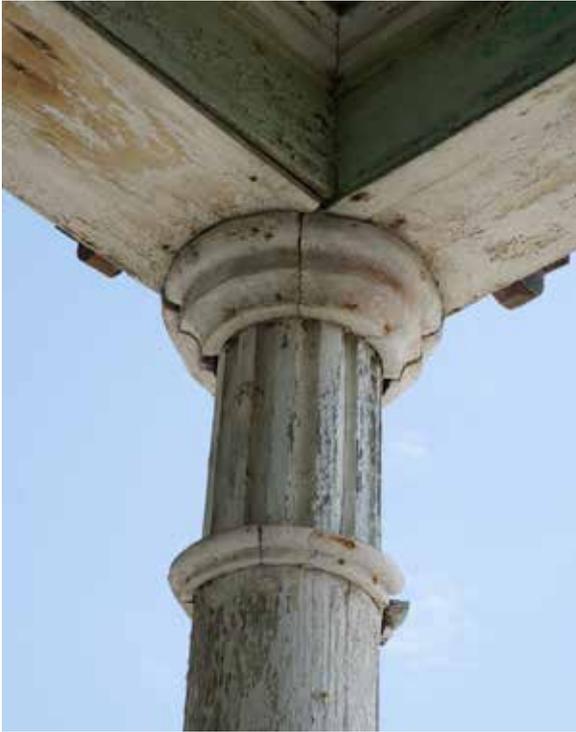
*Fig. 3: Detail of a balcony post*

The northern half of both façades and the basement walls have been plastered with cement-based mortar. Timber sections of the building have deteriorated. There is significant loss of material, particularly in the brackets carrying the projections and the flooring of the balcony. The building has survived with its historic architecture and monumental aspects, despite its modest decorations.

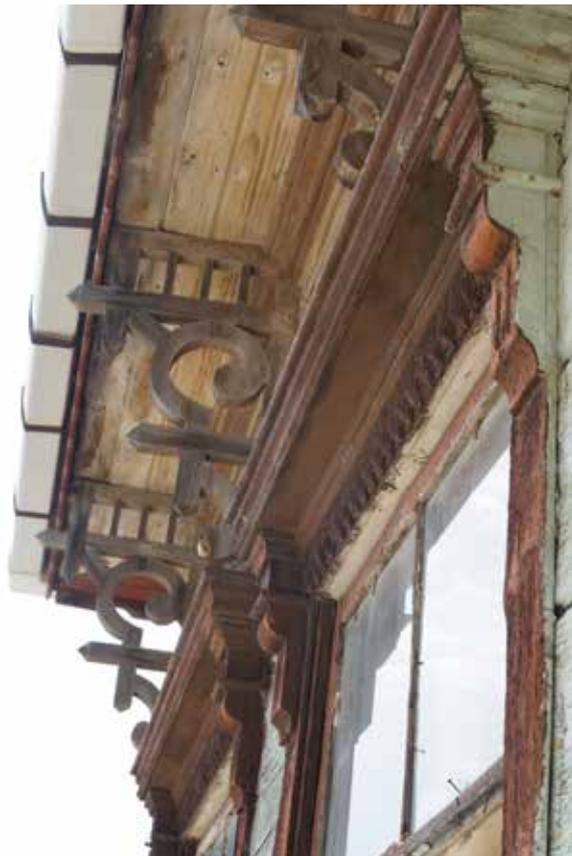
*Fig. 4: Detail of eaves brackets*
