Historic Fountains of the Southern Marmara Islands

İnci Türkoğlu, Umut Almaç, Emre Kışalı, Ioannis Papachristou

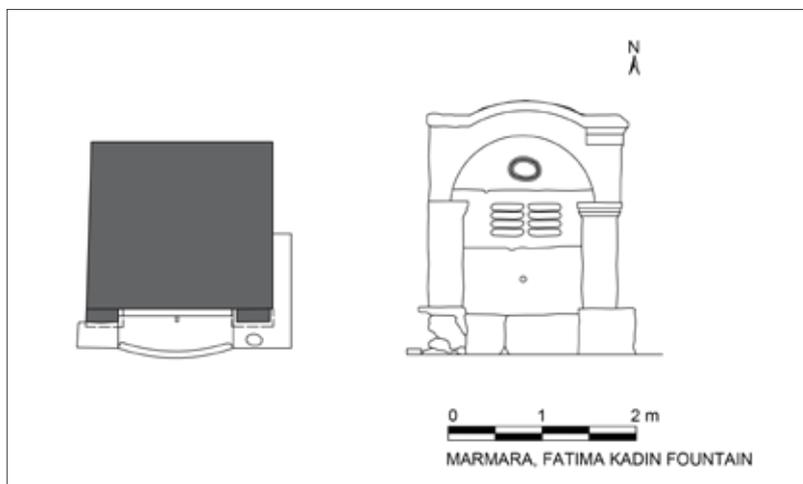
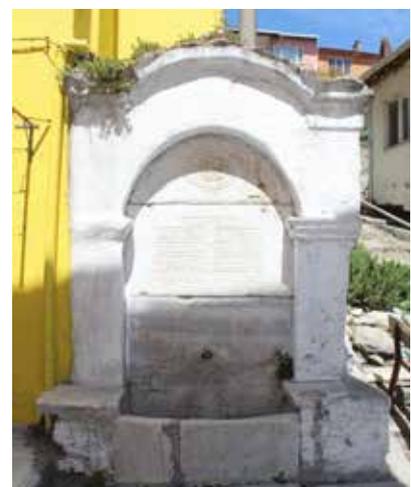
Fig. 1: Marmara Fatima Kadın Fountain

The fountains in Marmara's Merkez Neighbourhood are in better condition than those in Gündoğdu and on Ekinlik; the former underwent small scale alterations in the 1990s. Only the brick vault of the Fatima Kadın Fountain is heavily damaged. The inscriptions on the Fatima Kadın and Ali Beğ Fountains were not translated so the locals do not know anything about them. The water tanks of all the fountains on Marmara have been decommissioned and the taps have been connected to the town's water supply system.

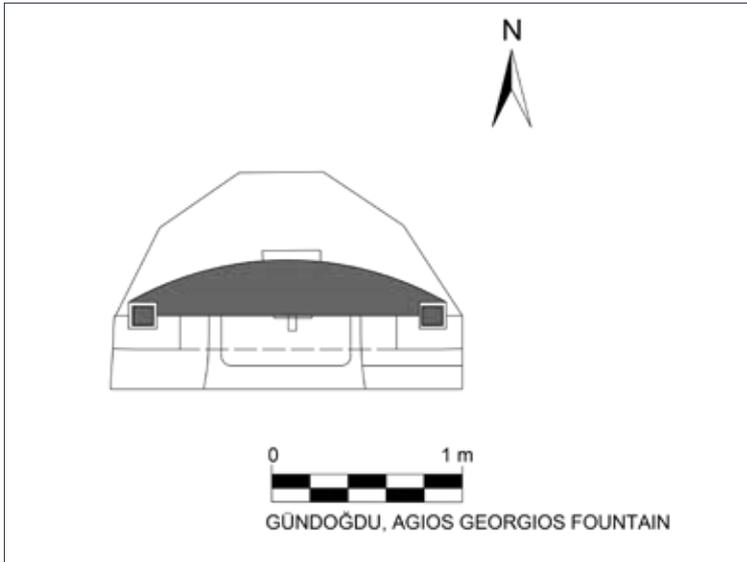
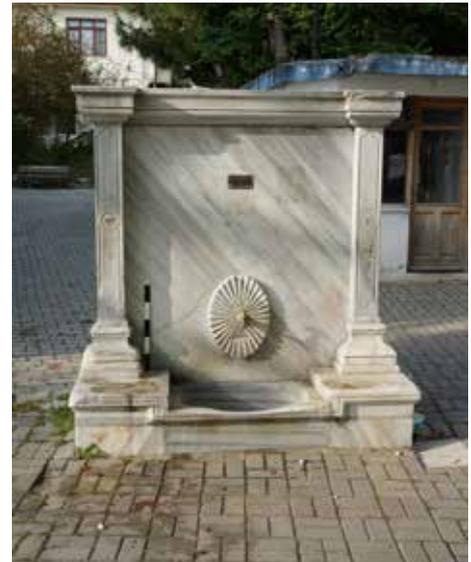
Fig. 4: Gündoğdu Agios Georgios Fountain

The fountains in Gündoğdu have their own issues. Like those in Marmara, these fountains are also connected to the town's water supply system. Agios Georgios Fountain is now somewhat buried as the ground level rose during the landscaping work carried out in recent years. Regarding Pera Fountain, the vault has collapsed partially; furthermore, dense overgrowth is noted on the main walls and the interior of the water tank. Martzoukis

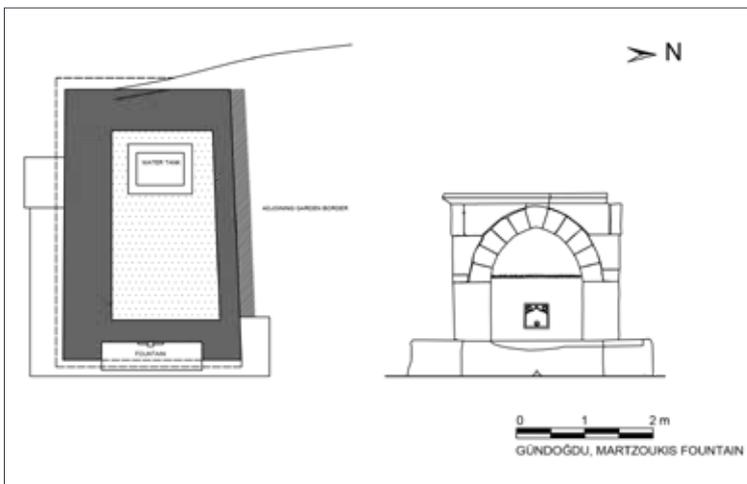
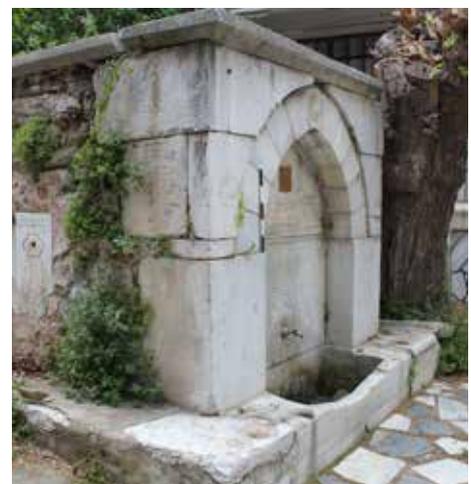
Fig. 6: Gündoğdu Martzoukis Fountain

Fountain has not been maintained for a long time, so it has deteriorated to some extent. Plants are growing in the mortar joints, plaster is lost on the southern façade, marble blocks on the eastern façade are shifting and causing the mortar joints to expand, pieces of moulding are shifting, and some of the clamps are disappearing.

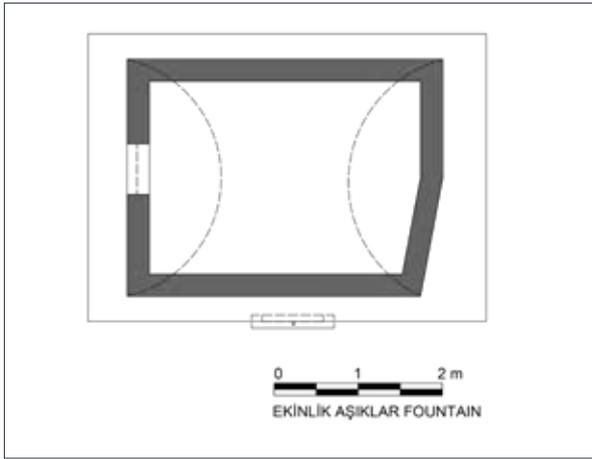
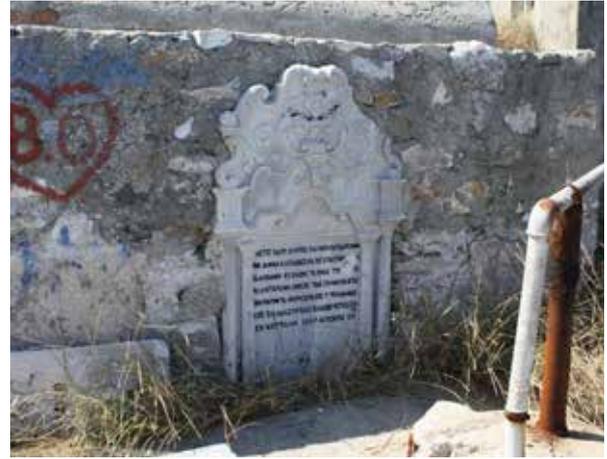
Fig. 7: Ekinlik Aşıklar Fountain

The lower part of the Aşıklar Fountain, which contains the basin and tap, is concealed because of the recent construction of the modern, reinforced concrete tank. The marble plaque bearing the date of 1910 must have been removed from its original place and placed on the side. There is a new construction that appears to house a pump to the southwest of the original water tank, at a higher level. This is one of the two sources supplying the islanders, the other being the one at Ayazma Locality. The tank is vandalised with graffiti. The structure is unprotected and neglected.
