# Panagia Kastrel(l)a Monastery

*İnci Türkoğlu, Ioannis Papachristou*

| District of Marmara,<br>Asmalı Neighbourhood | Construction period/date: <b>Before 1680</b> |

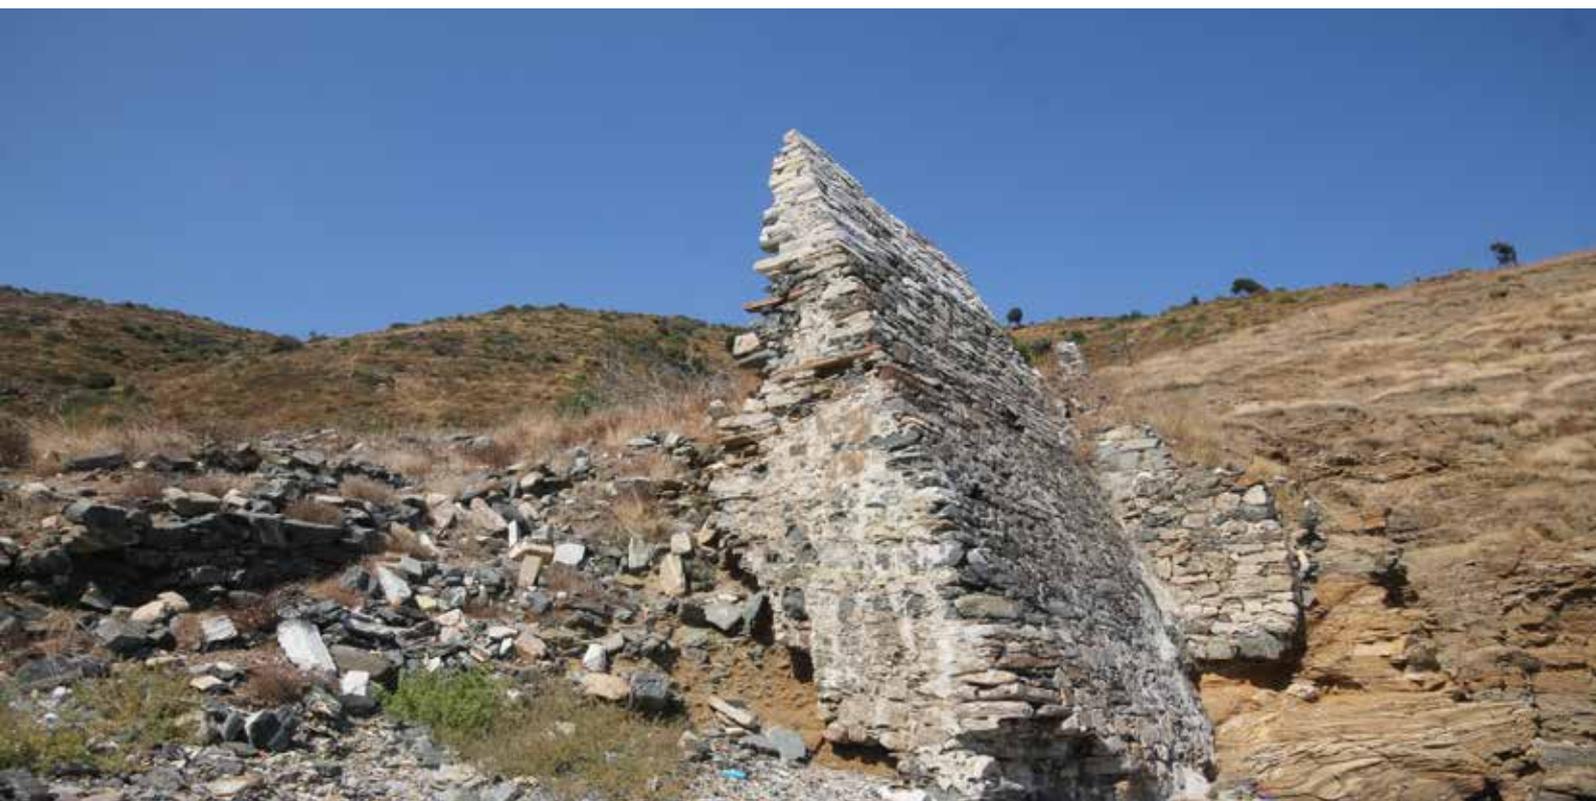
Fig. 1: Southern section of the eastern wall

Panagia Kastrella Monastery complex is located on the shore of a gulf in the northeast of Marmara Island, just west of the Beyaz Burun, known as Aspros Pountos in Greek. The eastern wall facing the sea looks like a castle fortification, hence the name for the monastery. Today, only the foundations of the complex are traceable except for two sections of the eastern wall. The eastern wall makes a corner leading west at its southern tip and leading east at its northern tip (Fig. 1). The northern wall section is linear and stands on top of the rocks rising vertically from the pebbly beach (Fig. 2). The southern wall section rises from the beach and tapers upward. The gap between the two wall sections corresponds to a rocky projection towards the sea. Based on the historical photographs, it seems that the wall went around the projection.

The only surviving walls by the beach are doomed to collapse in an earthquake. Several illicit digs were also noted. Stone pine trees were planted on the surrounding hillsides, which implies that workers will be around the site to pick nuts at certain times of the year in the near future. The site is exposed to the external risks – both of natural causes and of human origin.

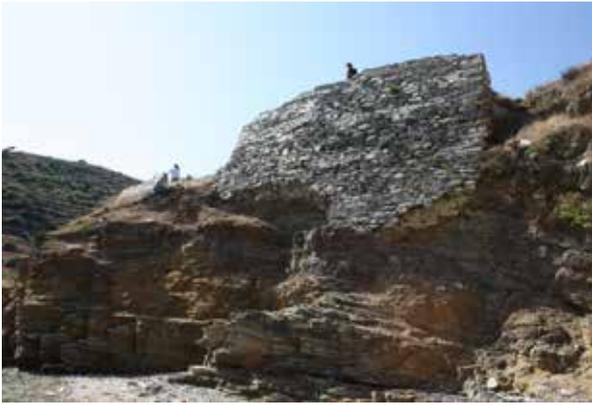
The rest of the building survives only at foundation level. From this, two main sections are discernable amidst overgrowth (Fig. 3). The western wall is 0.80 m thick and reaches a length of about 30 m, while the eastern wall by the sea comprises a southern section that is almost 12 m and a northern section that reaches almost 9 m with a gap of about 6 m in between. The northern wall by the hillside is over 22 m in length and the southern wall by the creek valley measures about 33 m. This quadrangular area is divided in two by a wall

Fig. 2: Northern section of the eastern wall

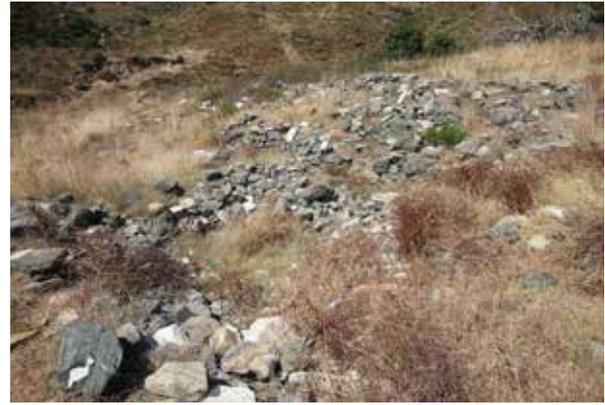
that is about 1 m in thickness and lies in the east-west direction. Amidst the overgrowth and heaps of stones, only one more wall of 0.70 m thickness could be identified in the southern part, closer to the east. Projecting from near the eastern end of the southern wall is a room that is 7x6 m with wall thicknesses of 0.70 and 0.80 m. The walls were built with coursed rubble and lime mortar with brick inserted here and there.

Fig. 3: General view of the foundations

Basic site cleaning and some very basic excavations will certainly yield a lot of information; such activity may be followed by primary protection measures. The site has potential to attract visitors even though access is only by the sea; it should be remembered that on the feast day in September all the Greeks of Asmalı, Saraylar and the other villages of the island used to visit this church for three days.
