Agios Ermolaos Monastery

Emre Kishali, Ioannis Papachristou

District of Marmara, Gündoğdu Neighbourhood, Köyüzeri Locality	Construction period/date: 17th century
	Current state: Abandoned
GPS: 40°35'04.3"N 27°35'50.8"E	Ownership status: State Treasury
Registration date and number: Unknown

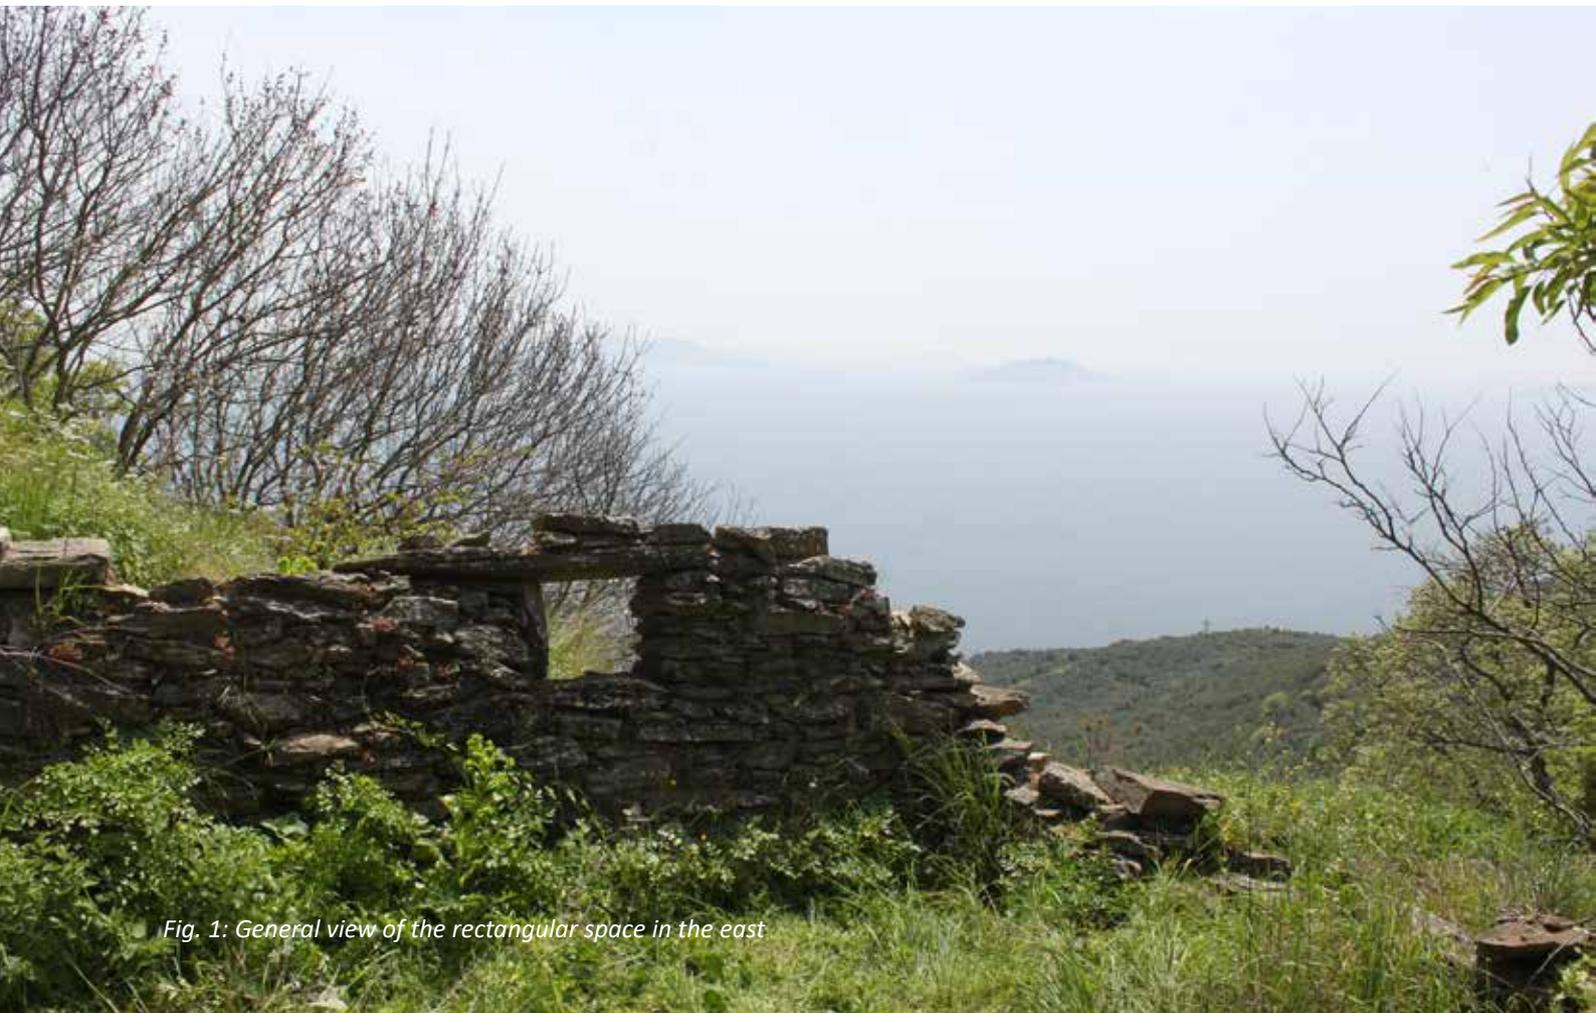
Fig. 1: General view of the rectangular space in the east

provided access to the main volume. There is a rectangular space on the eastern end, which lies outside of the vegetation (Fig. 1). A rectangular window with a flat lintel and a niche in the wall have survived in this space. Moreover, a door that provides passage between spaces is also noted. There is an original stairway on the southern wall of the terrace above that connects different levels.

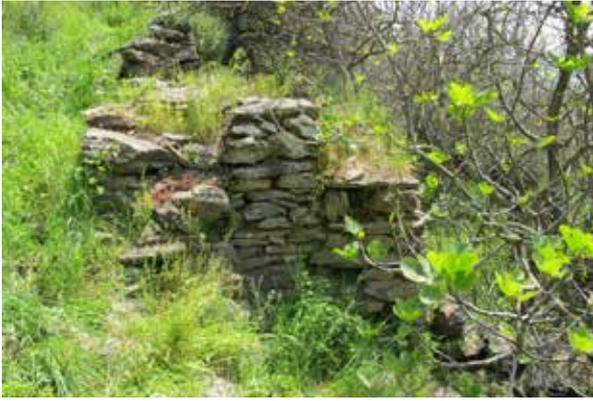
Fig. 2: Remains of the wall

The traceable walls are built in rubble and brick masonry (Fig. 2). Mortar is not noted in the retaining walls of these terraces. However, lime-based mortar is attested in spaces whose plans are discernible.

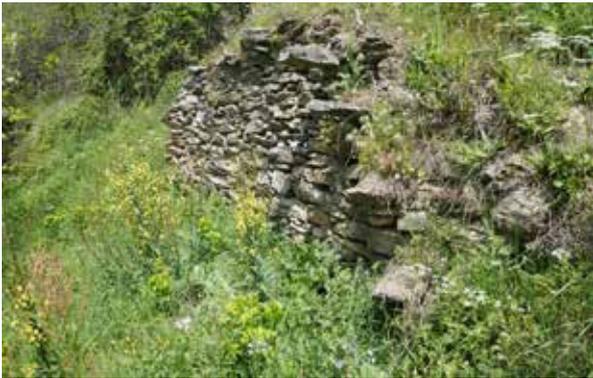
Fig. 3: Stairs (West)

While the thickness of the wall in the remains of the southern terrace is 70~80 cm, the wall thickness of the rectangular space to the east is 110 cm. There are two stairs on the upper terrace (Fig. 3). These are each formed by four stone, cantilever steps supported by rubble

walls. The width and riser heights of the stairs vary. The riser height of the eastern stairs ranges between 26~40 cm. The width narrows down from the wall towards the tips—from 26~30 cm down to 15~20 cm. The thickness of the stones is 6~9 cm. On the other hand, the riser height of the western stairs varies in a wider range, between 17~46 cm. While the width is 23~40 cm near the wall, it decreases to 15~34 cm towards the tip. The thickness of the stones not only vary from step to step but also throughout the length of the stone.
