Agios Timotheos Monastery

Umut Almaç, Ioannis Papachristou

District of Marmara, Topağaç Neighbourhood, Ahtimot Locality	Construction period/date: 17 th century
	Current status: Abandoned
GPS: 40°37'08.1"N 27°37'59.1"E	Ownership status: State Treasury
Registration date and number: Balıkesir KVKBK 17.10.2019 - 1623

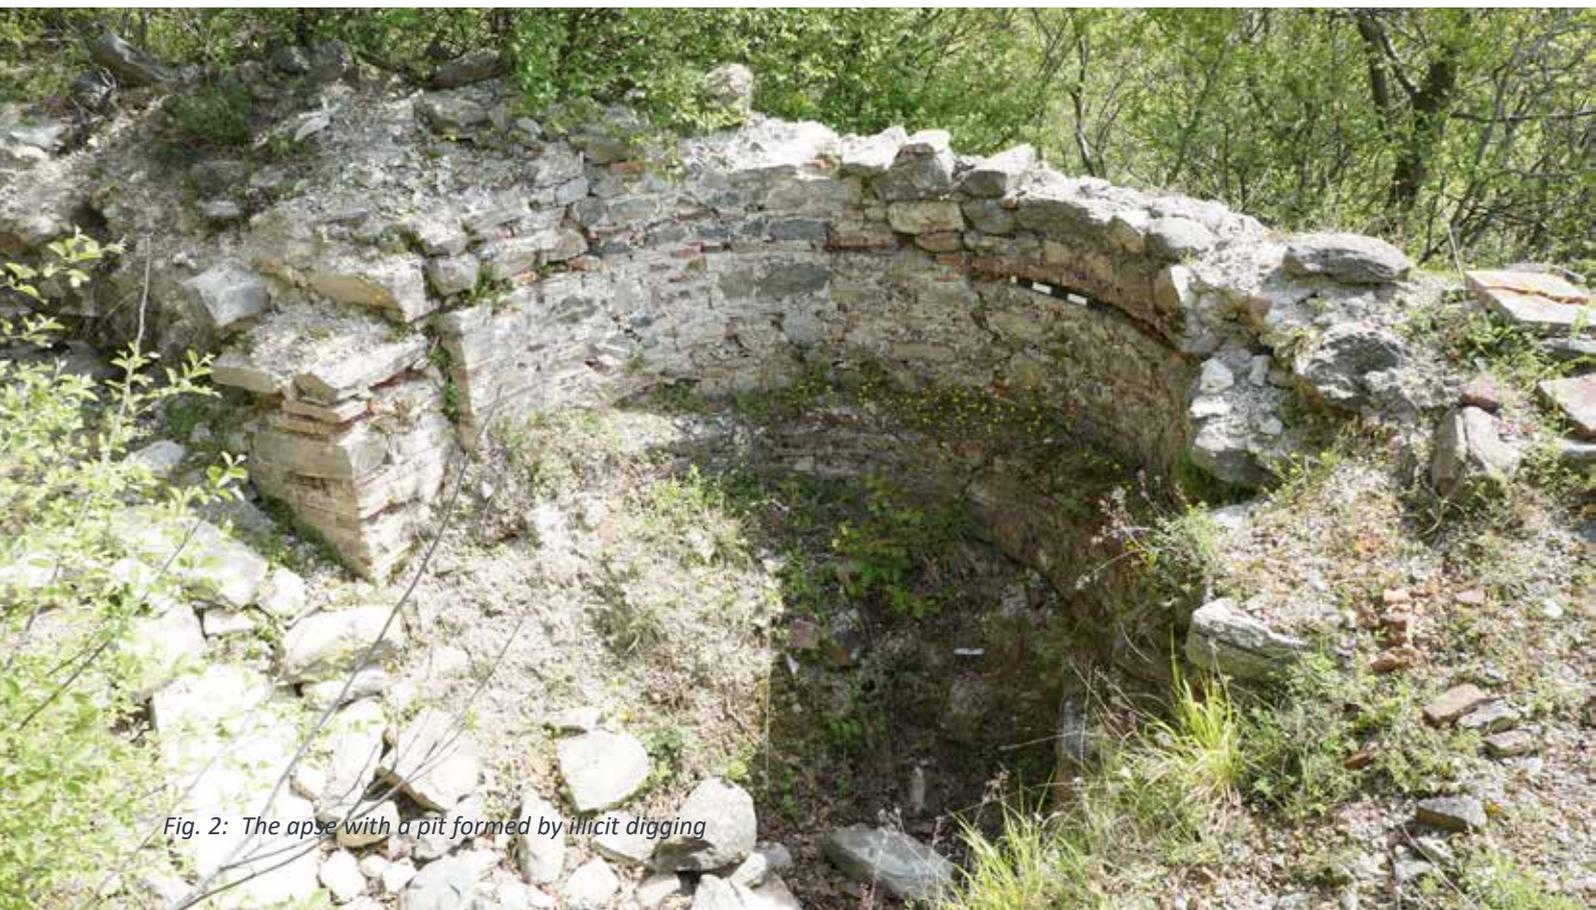
Fig. 2: The apse with a pit formed by illicit digging

The semi-circular apse wall is constructed in rubble masonry. It is 3.10 m wide and 1.50 m deep (Fig. 2). In the centre of the apse where the ground drops to a lower level due to illicit excavations, the 2.70 m-high part of the wall can be seen. The apse wall has encasement on the interior; the wall is 1.55 m above the ground level and protrudes 25 cm from the interior surface. Due to earth infill, similar observations could not be made for the exterior.

The wall at the upper level, which is approximately 75 cm in thickness, is made of irregular series of bricks. These series are generally composed of two rows of bricks that are square-shaped with a thickness of 4-5 cm and a width of 32 cm. The pointing between these bricks is about 4 cm thick. It was noted that a lime-based binding mortar was used in the walls and that there are the traces of brick-powder plaster on the inner surfaces.

It is thought that the building's plan organization can be revealed if excavations are carried out under the supervision of the Ministry of Culture and Tourism. A reliable assessment about the construction period can also be made based on architectural and decorative pieces that may be unearthed. The building elements that are scattered on the ground should be transferred to a safe area under the supervision of the Museum and unauthorized digs should be prevented.

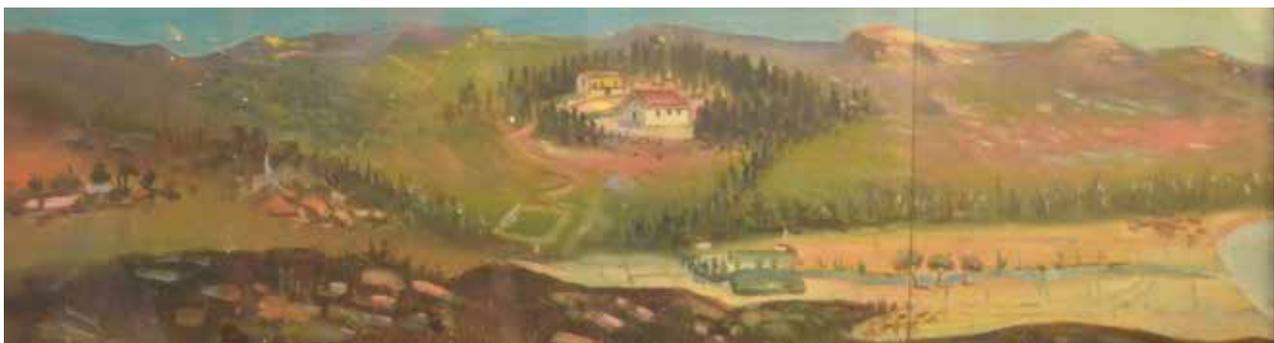
Fig. 1: Detail from St. Timothy's icon at Agios Georgios Karipis Monastery in Burgazada, depicting Topağaç and the Agios Timotheos Monastery (the icon was painted by K. Dimarchopoulos and was offered to Agios Georgios Karipis monastery by Theofanis Theofanidis in 1927)

The feast of Agios Timotheos has been continued by the islanders that settled in Istanbul after 1922 (Papachristou 2019b). Since 1927, descendants of Christians from the Marmara Islands gather at the Monastery of Agios Georgios Karipis in Burgazada on August 1 to celebrate the name day of Agios Timotheos, the so-called Bishop of Proconnesus and patron saint of Marmara Island (Fig. 1).

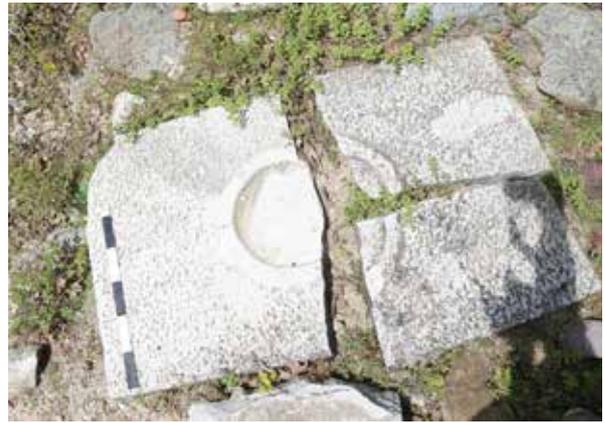
Damaged architectural fragments are scattered in the immediate vicinity of the building. 4-5 m to the southwest of the apse, there is a marble panel on the ground that is 9 cm thick (Fig. 3). The rectangular plaque measuring 78x120 cm was broken into three pieces. The surface of this plaque is roughly worked; the simple raised circle in the middle has a diameter of 30 cm, a width of 5 cm and a smooth interior. This marble plaque is thought to be a parapet fragment.

Fig. 3: Fragment of marble parapet panel

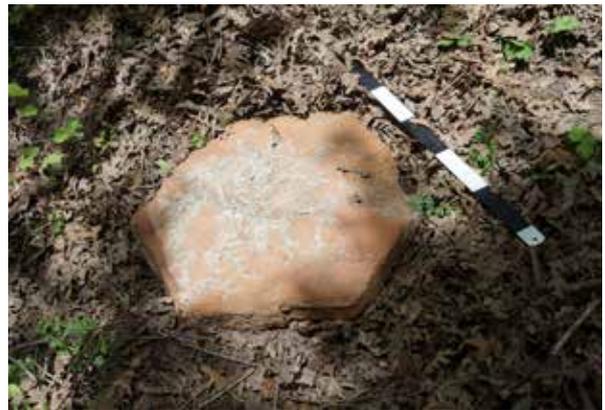
Around the church there were two hexagonal bricks, one of which was intact (Fig. 4). Although it was understood that these were

Fig. 4: Hexagonal brick

used as flooring, their period of installation and position within the building could not be identified. These bricks have a thickness of 4.5 cm and an edge length of 22.5 cm.
