Church of Taxiarches

Emre Kishali, Ioannis Papachristou

District of Marmara, Merkez Neighbourhood	Construction period/date: 1884-1889
	Current status: Abandoned
GPS: 40°35'10.7" N 27°33'25.8" E	Ownership status: Private ownership
Registration date and number: Bursa KTVKKBK 15.1.1996 - 4904, 28.11.2015 - 5175 KGB-1

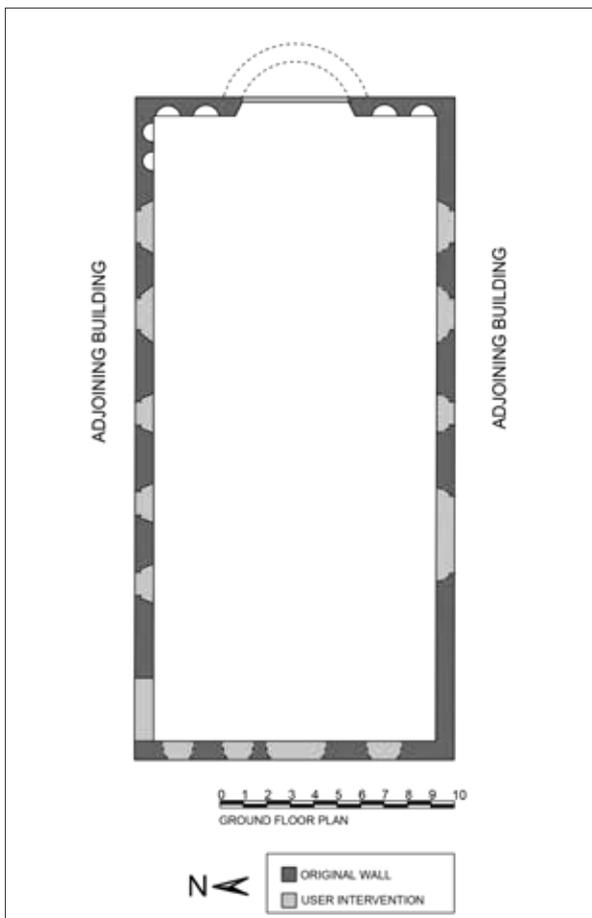
Fig. 1: Western Façade

The building's south façade was damaged due to the adjacent hotel structure. There is an annex close to the north corner of the western façade (Fig. 1). The annex has a timber double-winged door with a top window, as well as a timber window on the upper floor. The older sections of the façade contain door and window openings that were later closed. Since the walls are not plastered, the building materials are visible. Different building elements such as rubble, lime mortar with brick powder (*khōrasan*), brick, marble and a reinforced concrete beam were observed on the western façade. The marble inscription panel, which denotes the construction date of the building, is in the southern part of this façade (Fig. 2). The arched opening under the inscription panel was closed off. The marble moulding in this section of the eave provides clues about the original entrance of the building. The arched
