Church of Agios Nikolaos

Umut Almaç, Emre Kishalı, Ioannis Papachristou

District of Marmara, Abroz Neighbourhood, Yana Locality	Construction period/date: repaired in the 19th century
GPS: 40°38'56.5"N 27°42'10.2"E	Current status: Abandoned
	Ownership status: Unknown
Registration date and number: Bursa KTVKBK 18.08.1990 - 1293

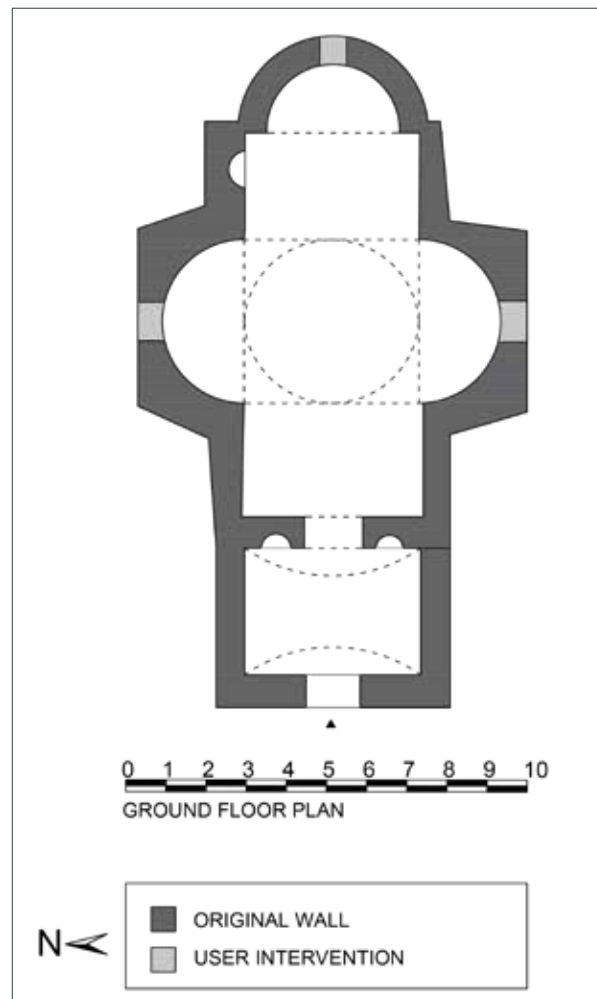
covering these sections at +5.00 m, and the narthex and apse sections rising up to +4.00 m are seen from the outside (Figs. 2, 3). Three different sections of the building are perceptible on the western façade (Fig. 3). At the foremost is the narthex section, which is plastered over, with the entranceway in the centre and crowned by a triangular pediment. Further behind is the gable that rises from the superstructure of the narthex and separates it from the western arm of the church. In the middle of this gable is a concrete panel added after the 1954 repairs. The octagonal drum of the dome covering the main space is seen at the back. The northern facade includes the narthex, the western arm of the cruciform, the transept, the bema and the apse (Fig. 2). The northern façade does not have any openings except the transept’s arched window, which was later closed. On the eastern façade are the semi-circular apse wall, the gable of the bema wall, the protruding northern and southern transepts, and the dome’s drum visible (Figs. 1-2). The apse wall has a circular window, which
