Koyun Island Chapel

Emre Kishalı, Ioannis Papachristou

District of Erdek, Paşalimanı Neighbourhood, Koyun Adası Locality	Construction period/date: 18th century
	Current status: Ruinous
GPS: 40°29'48.5"N 27°34'29.2"E	Ownership status: Private ownership
Registration date and number: Unregistered.

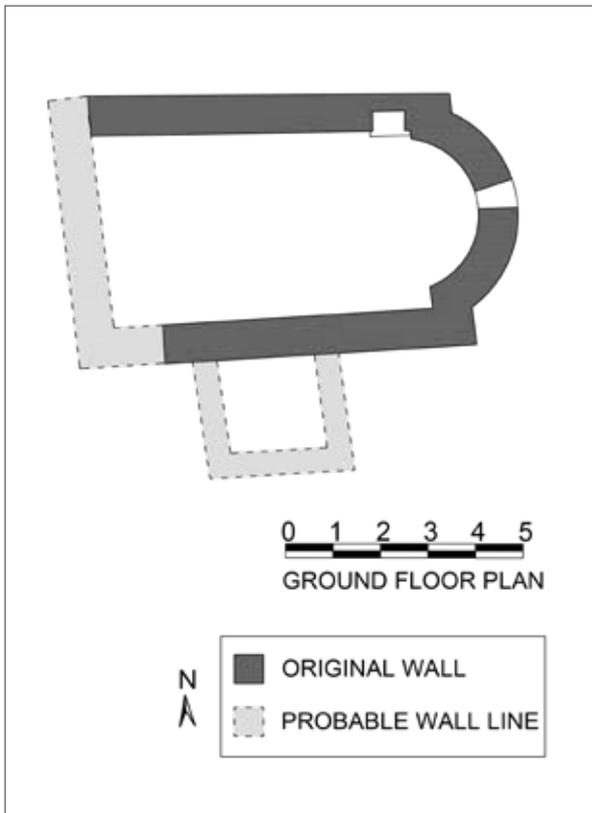
Fig. 1: General view

Although the plan organization of the building can be identified, its spatial properties cannot be estimated (Fig. 1). The eastern part of the building, which is located on an area descending westward, remains concealed up to a certain level (Fig. 2). The building is currently accessed through the collapsed western wall. There are not any traces of the superstructure of the building. The northern wall of the chapel is 7.55 m long, while the length of the southern wall is 6.05 m. The curvilinear wall on the eastern façade, where the apse is located, is 5.58 m long. There are wall remains of about 2.50x3.00 m adjacent to the southern wall of the building, which must be related to the chapel. The

The walls of rubble masonry with brick fragments resting on rubble foundations constitute the overall construction technique. The inner cavity of the double-faced rubble masonry is filled with stone and earth (Fig. 1). The wall thickness is measured 78-81 cm at upper levels that could be reached. Spolia materials are noted in the wall. Earth and adobe were used as the binding material. Traces of both rough and fine lime-based plaster were found on the interior surfaces of the main walls.

The entire western wall of the building, certain sections of its northern and southern walls, and its superstructure have been lost. While the eastern façade still stands, the other masonry walls have largely collapsed. Loss of materials, vegetation, and surface deterioration are noted on the southern and northern façades. Access to the building is not controlled and there is no information panel on the site. During the fieldwork, it was observed that the area to the south had been recently destroyed by dynamite (Fig. 3). It was discovered that this destruction was deliberate in order to procure stones for the construction of Yiğitler Port. The inscription panel and column capital seen in the historical photographs, which were located in the west of the chapel, are currently found in the area destroyed by dynamite (Fig. 4). Moreover, traces of damage caused by illicit digging were found within the building.

Although structural cracks are not observed in the building, there is loss of material on the wall surfaces. In addition, plants grow in the joints of the main walls due to earth-based binding material. These decays, which affect the strength of the materials and the building's integrity, should be taken under control.

The original construction technique and materials that have survived should be preserved through consolidation. The vegetation in the main walls that will cause further deterioration should be removed in a controlled manner. Currently, there are not any attempts for the

building to continue its function; therefore, it should be repaired in its present state, without the reconstruction of its lost western wall or superstructure, by consolidating the existing materials. The structure should also be continuously maintained and repaired afterwards.
