Agios Andreas Monastery

District of Erdek, Karşıyaka Neighbourhood, Fener Adası Locality	Construction period/date: Beginning of the 20th century
GPS: 40°27'30.0"N 28°04'23.6"E	Current status: Abandoned
	Ownership status: Private ownership
Registration date and number: Bursa KTVKKBK 08.10.2009 - 5080

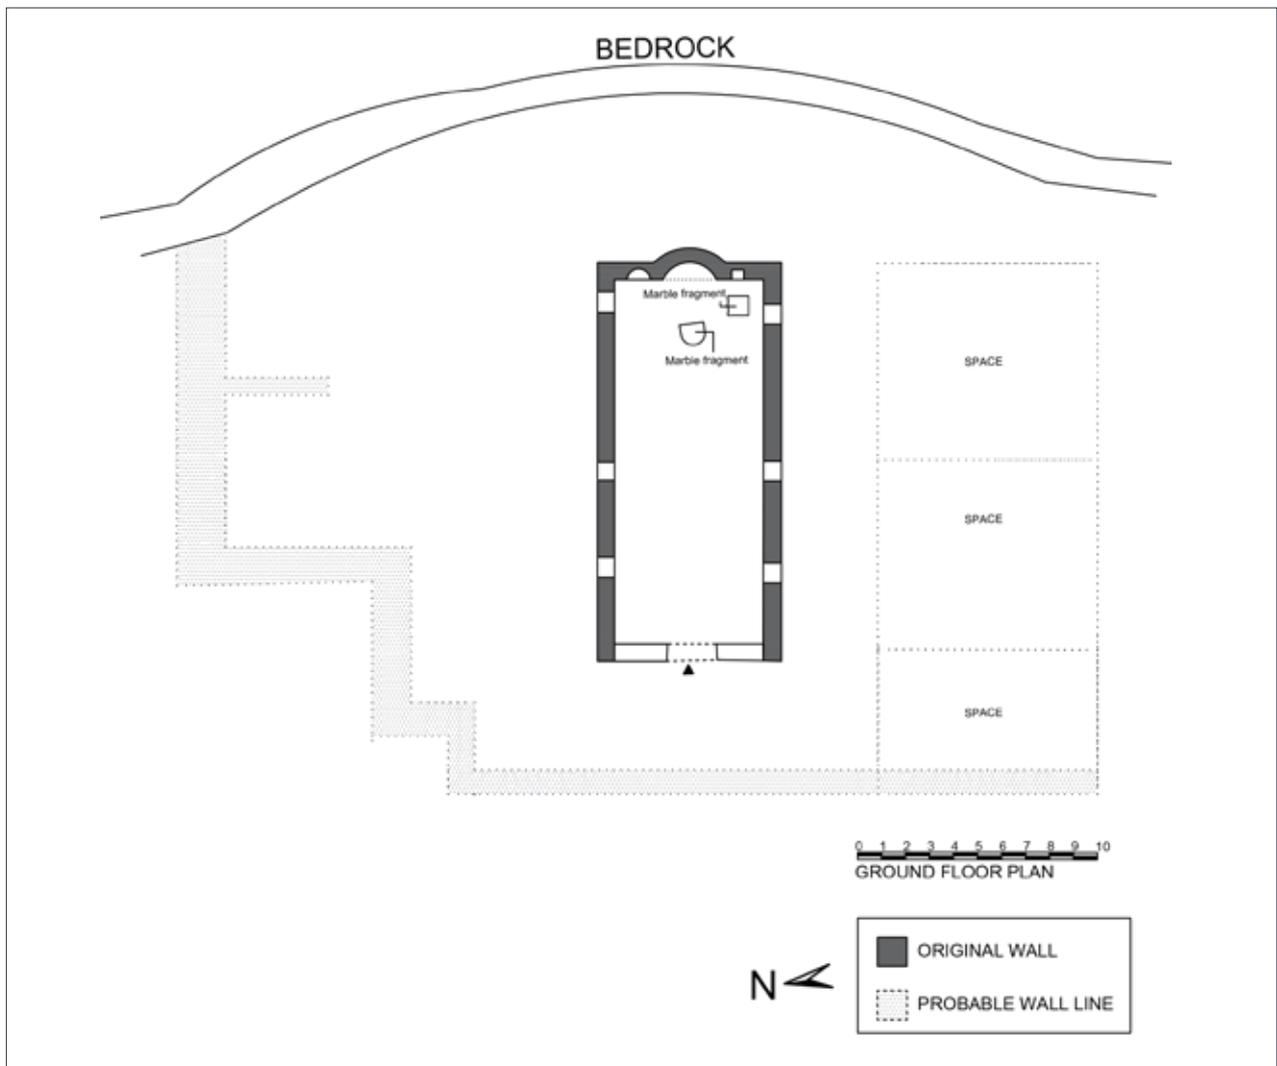
Fig. 1: General view

The plan organization of the church on the second terrace can be traced because its main walls have survived (Fig. 1). The western wall of the church, where the entrance was located, has completely collapsed. There are three round, arched windows on the southern and northern walls. The curving niche covered by an arch of solid bricks on the eastern wall is the apse (Fig. 2). There is a square niche with a lintel to the south of the apse and another niche with a round arch to its north. The apse is not attested on the exterior. The roof has not survived, but the triangular pediment on the eastern wall indicates that it was a gable roof (Fig. 3).

The building's main western wall and roof have not survived. Loss of materials and surface weathering are observed on its extant southern and northern façades. Access to the structure is not controlled and there are no information panels in the surrounding area. There are pits indicating illicit digs by treasure hunters near the apse of the building, which is completely neglected.

Although there are not any structural cracks attested in the building, loss of material is noted on the main wall surfaces and window openings. This issue must be taken under control since it affects the integrity of the building. Moreover, the original construction technique and materials that have survived should be preserved through consolidation.
