Kartal House ('Yılanlı' House)

District of Marmara, Asmalı Neighbourhood, Köyiçi Locality	Construction period/date: Late 19 th century
GPS: 40°37'02.2"N 27°42'22.0"E	Current status: Abandoned
	Ownership status: Private ownership
Registration date and number: Bursa KVKBK 18.08.1990 - 1295

Kartal House ('Yılanlı' House): Conservation Report of Wall Paintings

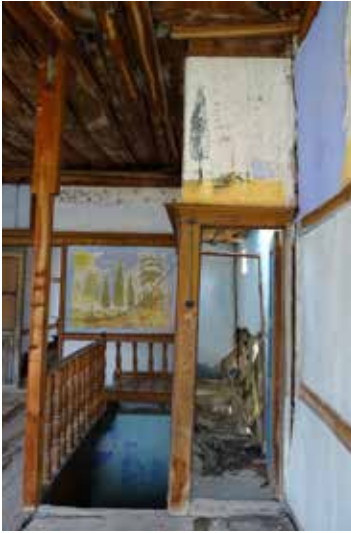
Fig.3: Top of the stairs, facing east

The stairs starting from the kitchen door extend southward and turn west to provide access to the upper floor (Fig. 3). Here, there are two rooms to the east of the L-shaped *sofa* and one room to the northwest. The western wall and the superstructure of the western wing of the *sofa* have fallen (Fig. 4). The north-south hall that connects these rooms is considered part of the *sofa* and called *vliakos* in Greek (βλιακός; ηλιακός, derived from the word 'sun'). These rooms are illuminated with plenty of windows, providing a very commodious space. Their wooden doors are double-winged

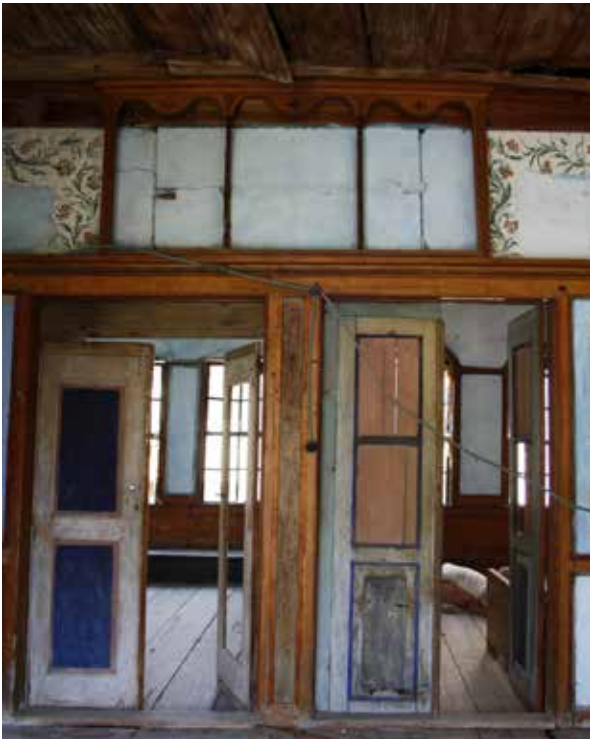
Fig.7: Doors opening to the rooms to the east of the sofa and the iconostasion on top

There is a tri-partite wooden frame (*iconostasion*) above the doors on the eastern wall of the *sofa* (Fig. 7). According to tradition, an icon of the Virgin Mary or Jesus is placed in the middle, while the side frames house icons of the saints. It can be observed that the wooden mouldings separating the doors from the *iconostasion* were also ornamented. Since they were painted over, only traces of this decoration remain; however, it is also composed of S-shaped branches with leaves and floral motifs of different sizes at their ends. The wooden frame is articulated by a row of small, alternating semi-circular arches in the upper part. A cross is carved on each semi-circular arch coinciding with the middle of one of the three panels.

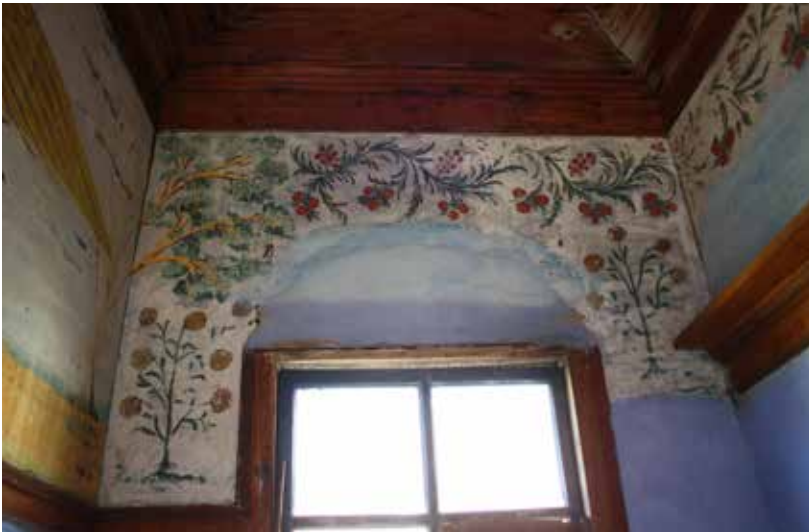
Fig.8: General view of sofa's north wall

On the northern wall of the sofa's northern wing is a floral composition featuring trees and flowers (Fig. 8). These decorations are organized in a semicircle around the window's blind arch, such that they frame the panel later covered with blue wash. There are large red flowers with green leaves diverging from a single green branch on both sides of the blind arch. The branches of the tree framing the eagle on the western wall of the northern wing extend from the upper part to the northern wall. Tree branches have leaves in different shades of green to provide a light-shadow effect that resembles free brushstrokes. A thin S-shaped branch extends from the end of the tree branches and continues to the sofa's eastern wall. There are numerous elongated leaves on each fold of the branch, between which hang triple red pomegranates, with bunches of red grapes above.

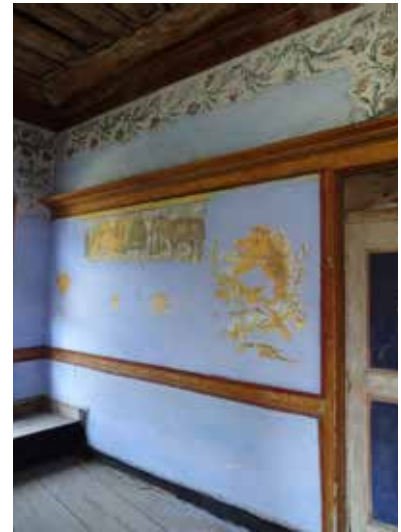
Fig.9: The eastern wall of sofa's north wing

Figures of camel and deer in nature are depicted in the upper part of the *sofa's* eastern wall towards the north (Fig. 9). These paintings may refer to the antique name of the island, derived from a deer species named *prokos*. The camel and deer are depicted in profile, facing each other on a green ground and under a grey sky. There are trees with green leaves and brown trunks in the background. The camel is light brown and has one hump. The deer is dark brown with dark spots and has four antlers on each side. The

Below and to the south of this panel is a painted scene depicting the struggle between a very large lion and a gopher serpent (Fig. 9). Although the composition is discernible, the head of the serpent, among other parts, have been plastered over. The lion is light brown, close to yellow, and portrayed with its tongue open and eyes out. His mane stands on end and its front limbs are in the air. The serpent, depicted to the finest detail with its scales, has entwined the lion twice. Although the head remains under the plaster, it is discerned that it faces the lion.
