# Tahsin Tutucu House

District of Marmara, Ekinlik Neighbourhood	Construction period/date: <b>19<sup>th</sup> century</b>
	Current function: <b>Abandoned</b>
GPS: 40°32'50.2"N 27°29'22.3"E	Ownership status: <b>Private ownership</b>
Registration date and number: <b>Bursa KTVKKBK 18.8.1990 - 1297</b>

# Tahsin Tutucu House: Conservation Report of Wall Paintings

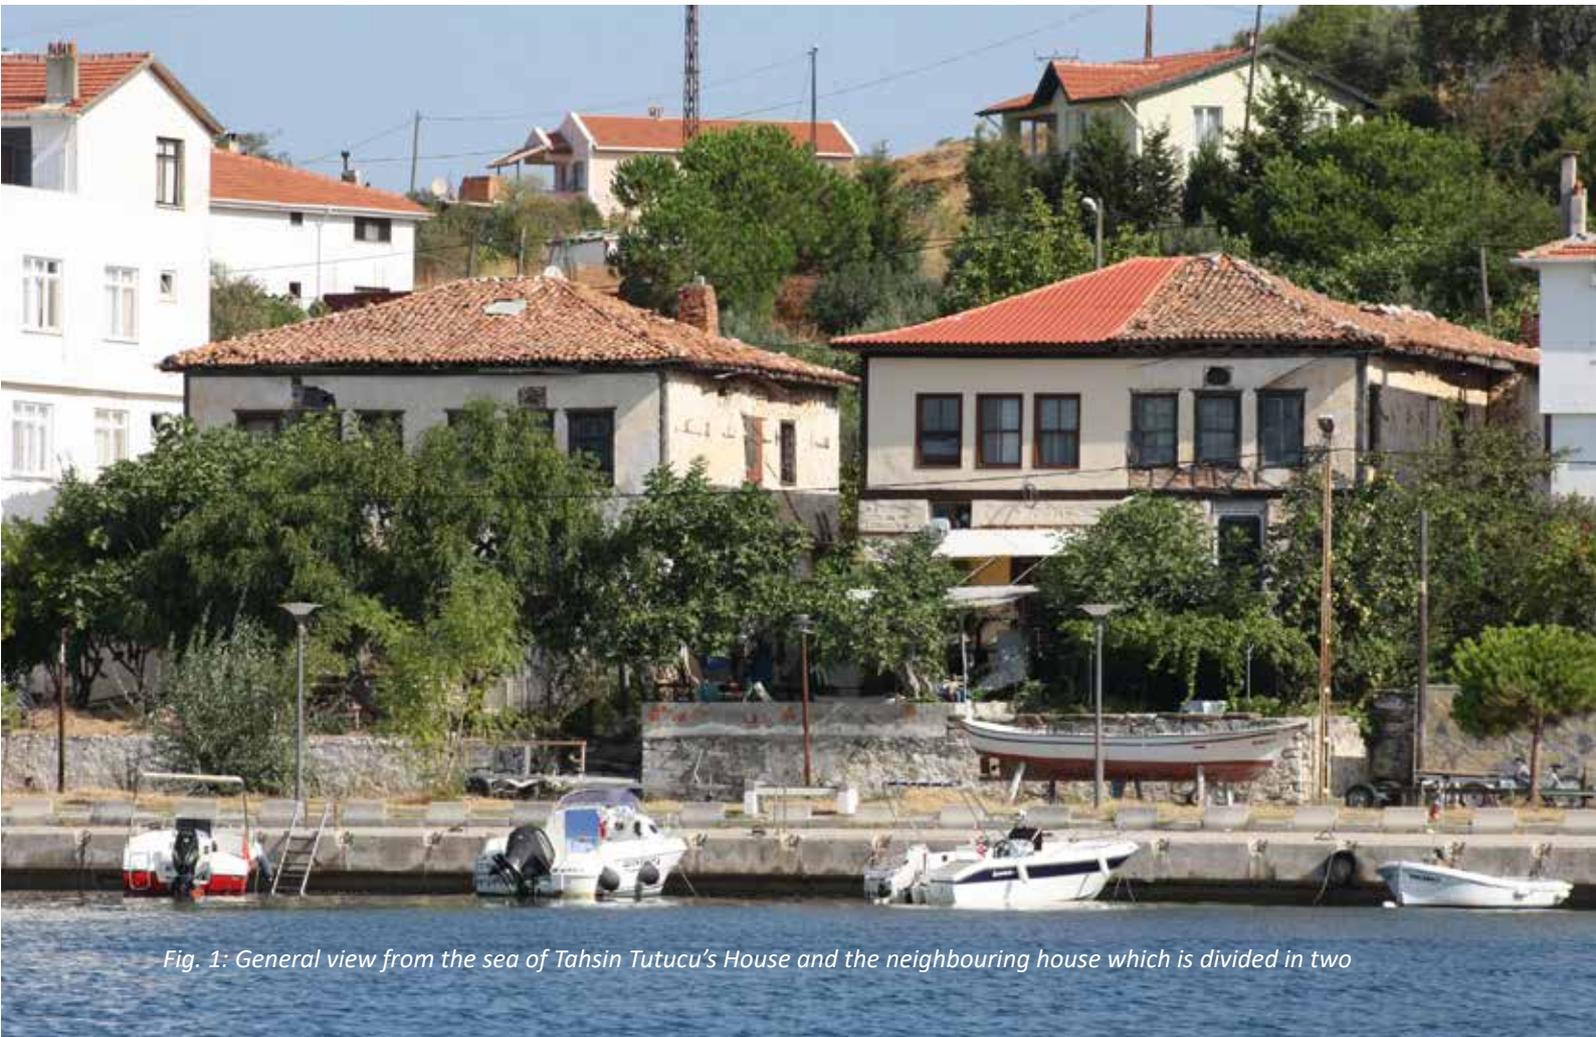
Fig. 1: General view from the sea of Tahsin Tutucu's House and the neighbouring house which is divided in two

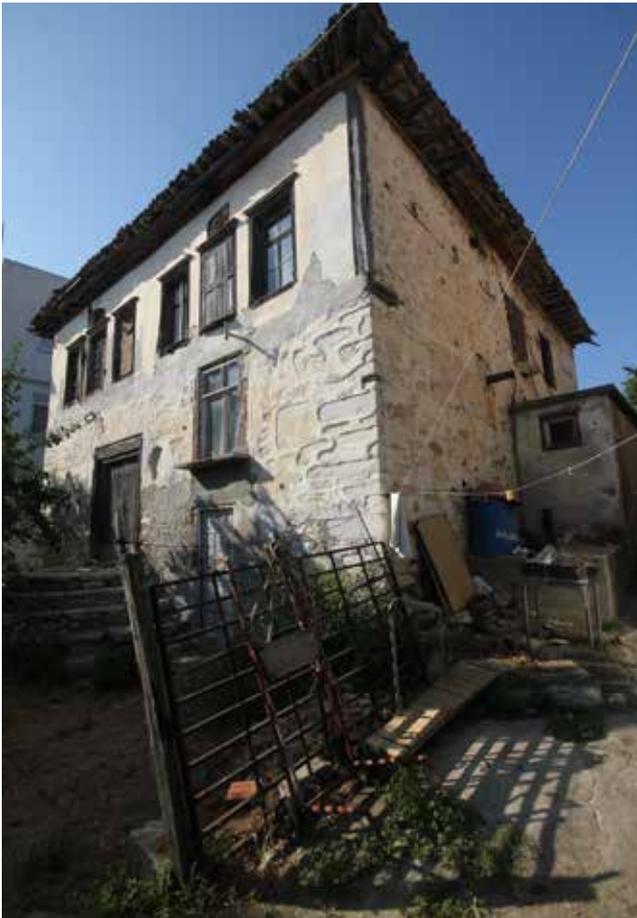
*Fig. 2: South and east façades*

The eastern façade (Fig. 2) has a toilet mass later attached to its northern section on the ground floor. The ground floor of the façade is blind except for a window opening to the north of the toilet mass. On the upper floor, there are two windows on the northern side and a drainpipe for the sink, which was added later according to information obtained from the owners.

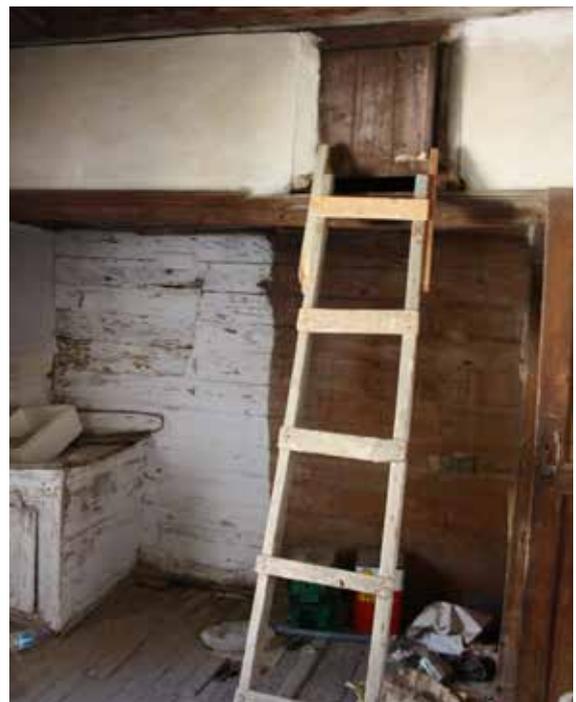
*Fig. 6: The southern wall in the northeastern room on the upper floor*

a pipe. The space is separated from the room to its south by a timber construction (Fig. 6). The western end of this wall is bevelled and arranged as a cupboard. There is also a cupboard at a higher level, close to the ceiling.

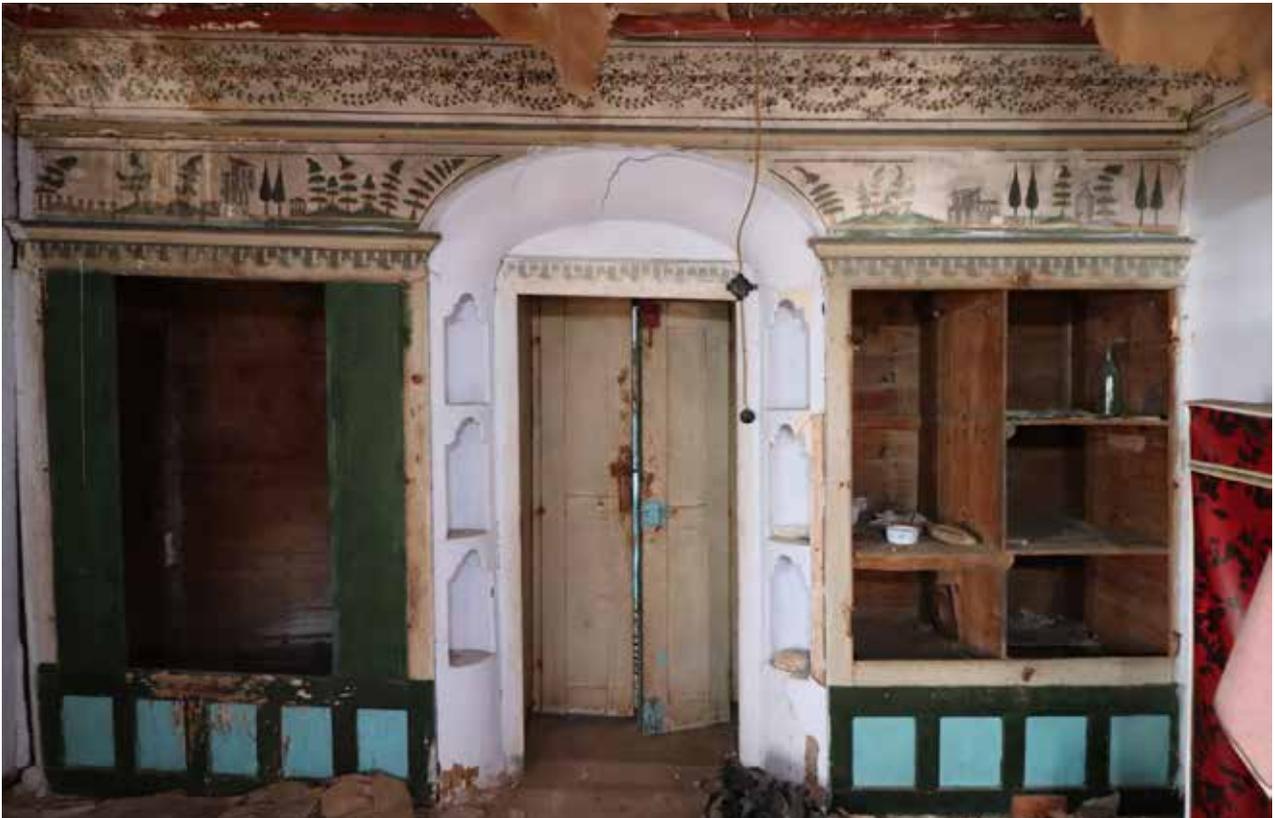
Fig. 8: Closets and the painted panels of the southwestern room on the upper floor

The southwestern room on the upper floor of Tahsin Tutucu's House is decorated with authentic wall paintings. There are examples of wall paintings on the upper sections of the timber closet arrangement on the northern wall (Fig. 8), on the lintels of the three windows on the southern wall (Fig. 9, 12), and the concave ceiling plinths running along the four walls of the room. Another remarkable feature of the room is the ceiling decoration with wood laths (*çitakâri*) (Fig. 9, 13).

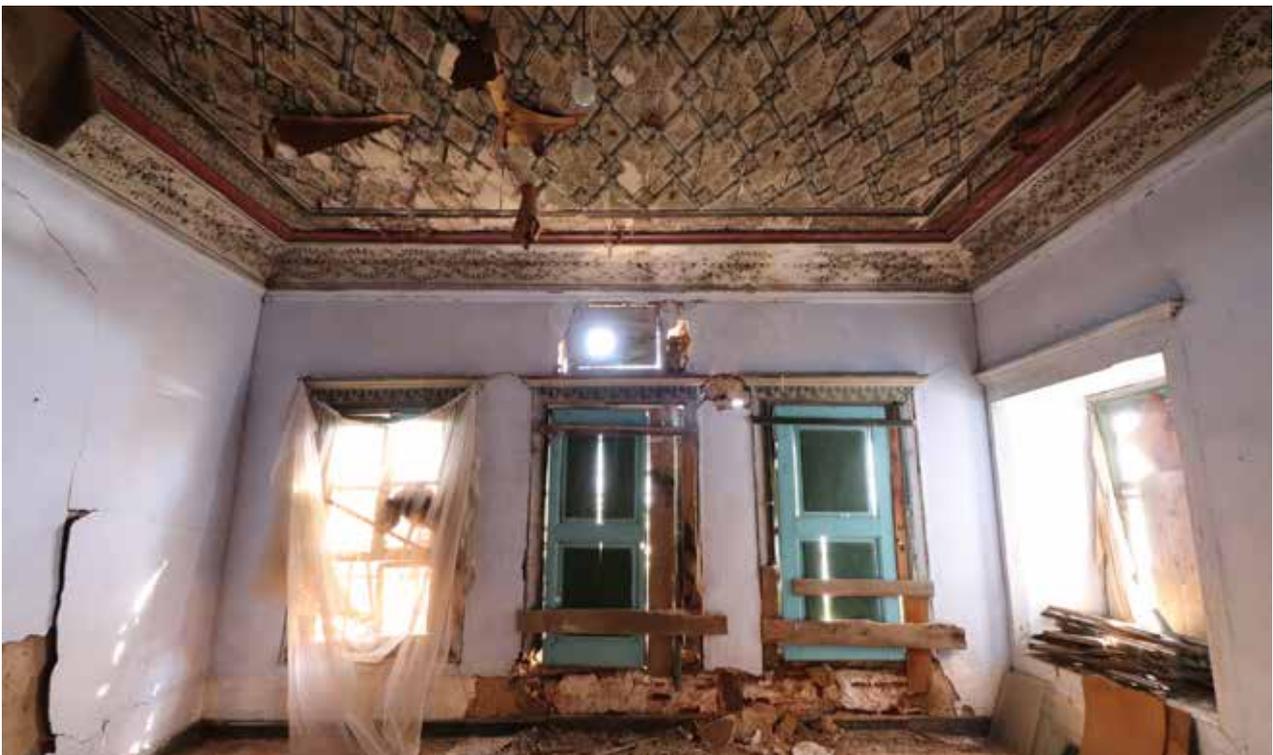
Fig. 9: General view of the south wall of the southwestern room on the upper

running along the walls, the baroque decoration on the window lintels in the southern wall, and other ornamentations on the windows, which were later painted over (Fig. 12). In addition to these decorations, there is ceiling lath-work (*çıtakari*) as other important decorative elements of the room (Figs. 9, 13). However, it is noted that water leakage caused by the superstructure has had a significant effect on the ceiling decorations. Therefore, loss of paint, loss of fragments, loss of original decoration, humidity problems, intense dry deposits and loss of timber durability are observed in some parts of the ceiling decoration. The surface of the ceiling decoration was covered with paper in the past. This wallpaper was attached to the timber ceiling, which is thought to be original, with the help of iron staples. During this process, iron staples reacted with water and oxidized, causing the exposure of the ornamented surface to deterioration due to the corrosion of iron.
