Metin Doğantimur House

District of Marmara, Merkez Neighbourhood	Construction period/date: 19 th century
	Current status: Abandoned
GPS: 40°35'06.4"N 27°33'11.7"E	Ownership status: Private ownership
Registration date and number: Bursa KTVKKBK 15.1.1996 - 4904

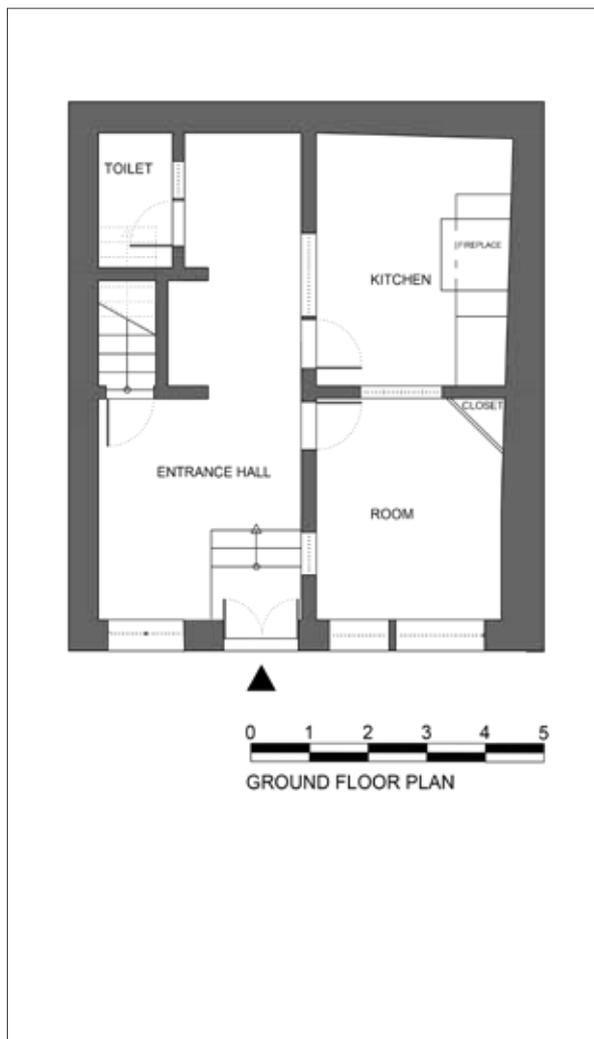
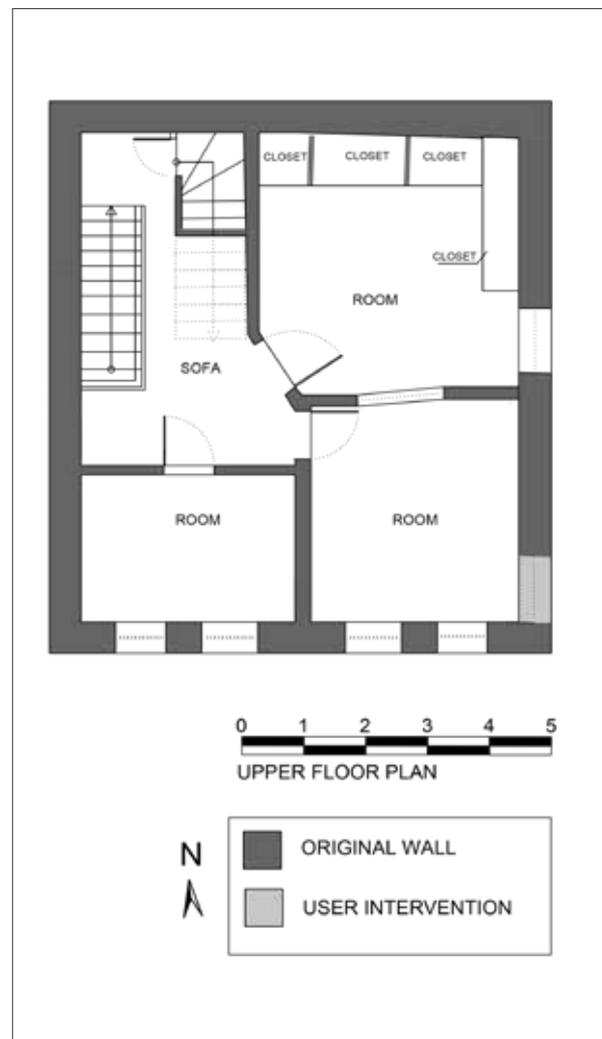
provide access to the first floor (Fig. 3). There are three rooms opening onto an outer *sofa* on the first floor. The dimensions of the rooms are approximately 3-3.5x3.5-4 m. Two of the rooms on the first floor are on the south.

The stairs leading to the second floor are separated from the space by a timber door, similar to the arrangement on the ground floor. The first and second floors have the same layout. Since the roof was heavily damaged and has partially collapsed, the plan layout of the second floor could not be measured but was only examined by visual observation (Fig. 4).
