# Kamil Kanat House

*Gamze Özmertyurt*

District of Marmara, Asmalı Neighbourhood, Köyiçi Locality	Construction period/date: <b>Late 19<sup>th</sup> century</b>
	Current status: <b>Abandoned</b>
GPS: 40°37'02.9"N 27°42'25.1"E	Ownership status: <b>Private ownership</b>
Registration date and number: <b>Bursa KTVKBK 15.01.1996 - 4904</b>

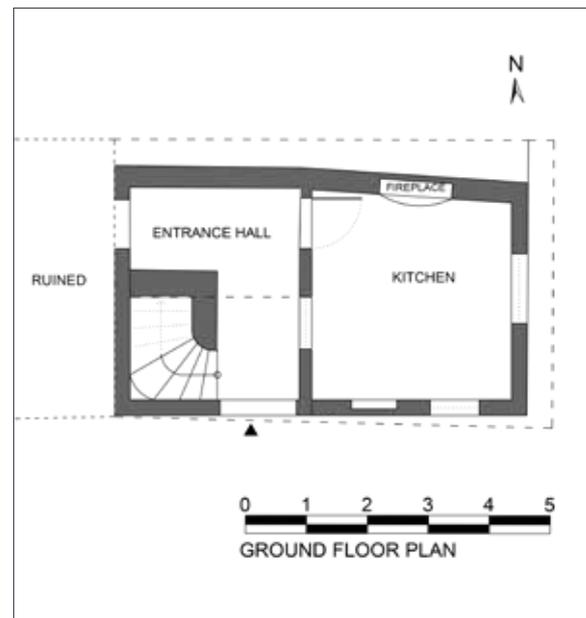
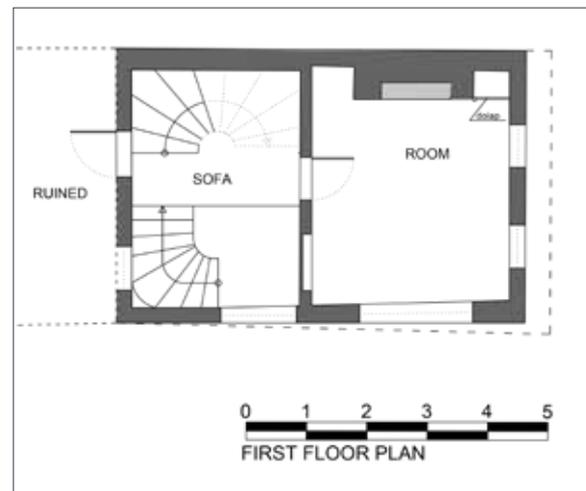
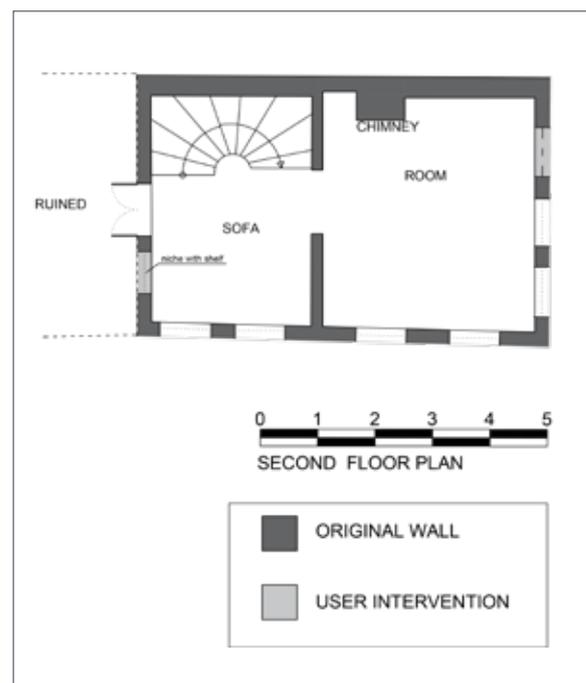
Fig. 2: Entrance hall on the ground floor, kitchen on the right and sofa of the first floor above

It corresponds to the L-shaped entrance hall (Fig. 2). According to the former residents, this space was used to process olives. The kitchen, accessed through a door from the entrance hall, is located on the eastern wing of the ground floor. It has a fireplace that is covered by a timber hood. Since the floor is entirely covered by earth, it is not clear whether there was a staircase going downstairs. There are also pits resulting from illicit digging that have damaged the floor. The timber ceiling of the kitchen has wooden beams. The walls are mainly plastered with lime, although certain sections are covered with modern ceramic tiles. The kitchen counter extends along the southern wall.
