# Tınaz House

*Mustafa Akçaöz, Emre Kishalı*

District of Marmara, Asmalı (Afthoni) Neighbourhood, Köyiçi Locality	Construction period/date: 1870
	Current status: <b>In use</b>
GPS: 40°36'58.0"N 27°42'17.2"E	Ownership status: <b>Private ownership</b>
Registration date and number: <b>Bursa KTVKBK 15.1.1996 - 4904</b>

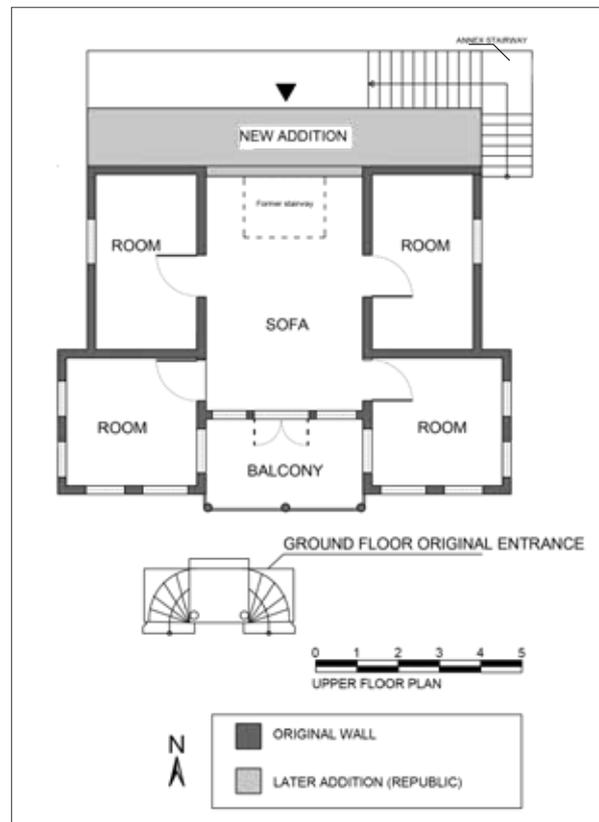
Like all the other façades of the structure, which has a cubic mass, the southern façade also has a symmetrical arrangement. The entrance on the central axis of the southern façade is arranged as a high *iwan* that covers the height of both the basement and the ground floor. The double-sided, curving staircase reaches a square landing. The double-winged door, elevated from the landing with a single step, is the main entrance of the house. There is a triangular pediment above the door. Timber posts are placed on the outer corners of the landing to carry the balcony on the upper floor. The posts, placed on bases, are separated from their uppermost section by a ring. The part above this ring resembles a fluted capital (Fig. 3). The three posts on the balcony are in the same style as those on the ground floor. The balcony is carried by timber brackets covered with wood laths and has a 0,50 m tall railing. The timber ceiling of this outer space is decorated by wood laths

(*çitakâri*). The ornamentation is composed of a rhombus in the centre with wood laths extending from two of its sides to form rectangles at the corners.
