Ekinlik Greek School for Girls

Emre Kishalı, Ioannis Papachristou

District of Marmara, Ekinlik Neighbourhood	Construction period/date: 1911
	Current status: Ruinous
GPS: 40°32'46.1"N 27°29'08.9"E	Ownership status: State Treasury
Registration date and number: Bursa KTVKKBK 18.08.1990 - 1297

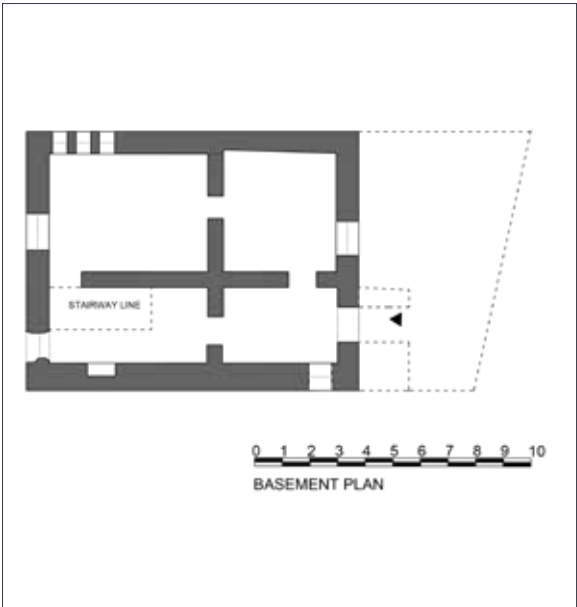
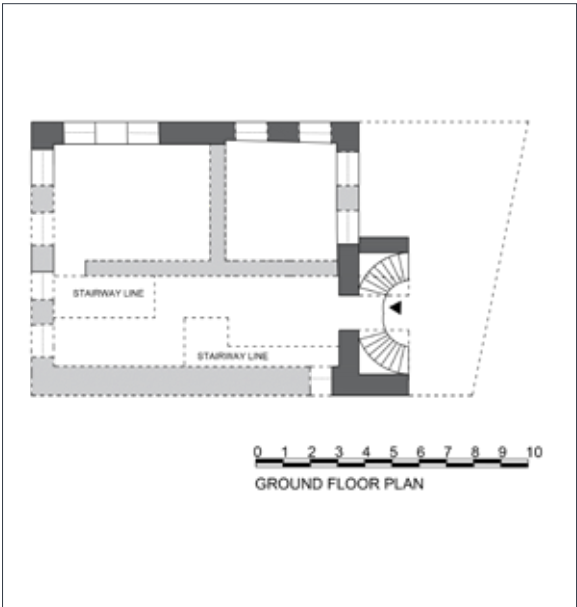
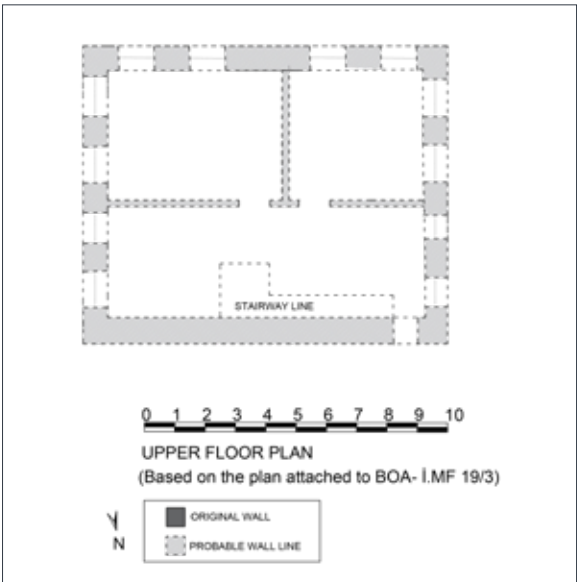
The main walls of the first floor, flooring, and roof structure of the historic building have not survived. Although the southern façade of the ground floor still stands, the walls of the other façades have largely fallen. The main and partition walls of the basement are extant. Loss of materials and structural cracks are attested on the southern façade. Access to the building is not controlled, and there is no information panel. Plant growth is seen in the building, especially in the basement, and around it.

other and the structure will behave like a box. However, since only the southern façade of the ground floor has survived with no connection to the others, it carries increased risk of damage. The deep cracks and loss of material attested on this façade are indicators that the brick walls deteriorate day by day. The southern façade of the basement is adjacent to the Marmara Sea, reducing the durability of the materials here. That the rubble walls are exposed to exterior conditions poses a risk for the structure.

Consolidation work is recommended for the surviving parts of the building. ICOMOS Turkey Charter for the Conservation of

Architectural Heritage defines consolidation as ‘the prevention/slowing down of cultural asset’s deterioration process by increasing the durability of its material and/or structural system, and improvement of its existing physical and mechanical properties.’ The reintegration of structures whose building elements have been largely lost is controversial. The conservation/design problem of the building is to re-establish the box behaviour of the southern façade, which is highly vulnerable, by integrating it with original material.
