Marmara Greek School for Girls (Pantelidia)

Umut Almaç, Mustafa Akçaöz, Ioannis Papachristou

District of Marmara, Merkez Neighbourhood	Construction period/date: 1912-1914
	Current status: Recently abandoned, planned reuse as a museum.
GPS: 40°35'09.9"N 27°33'34.9"E	Ownership status: State Treasury
Registration date and number: GEEAYK 20.12.1975 - 8791 / TKTVYK 27.02.1987 - 3045 / Bursa KVTKBK 15.01.1996 - 4904

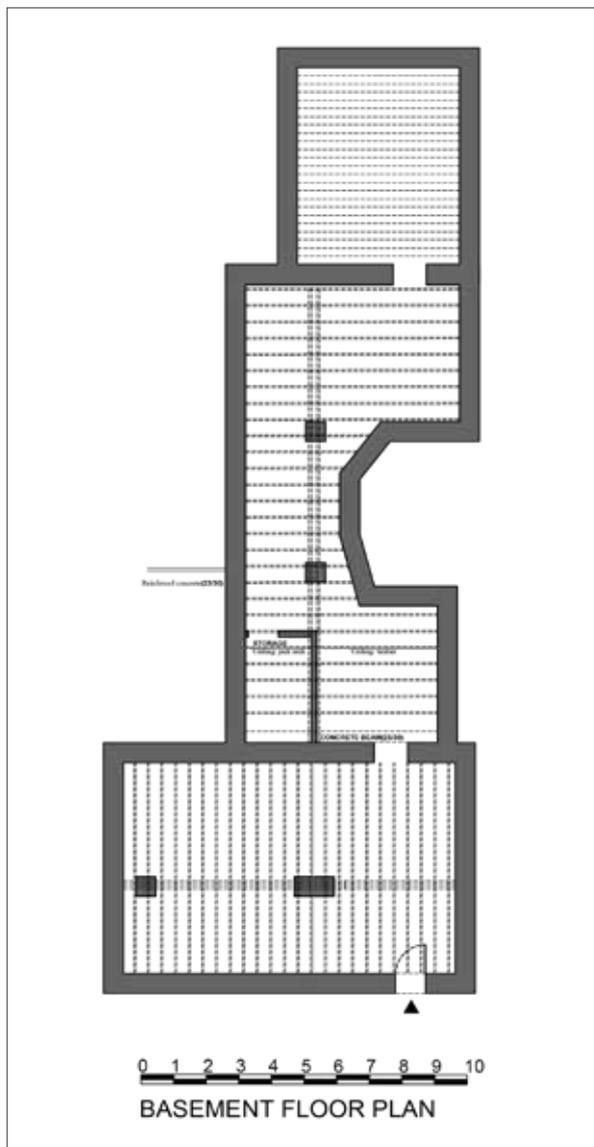
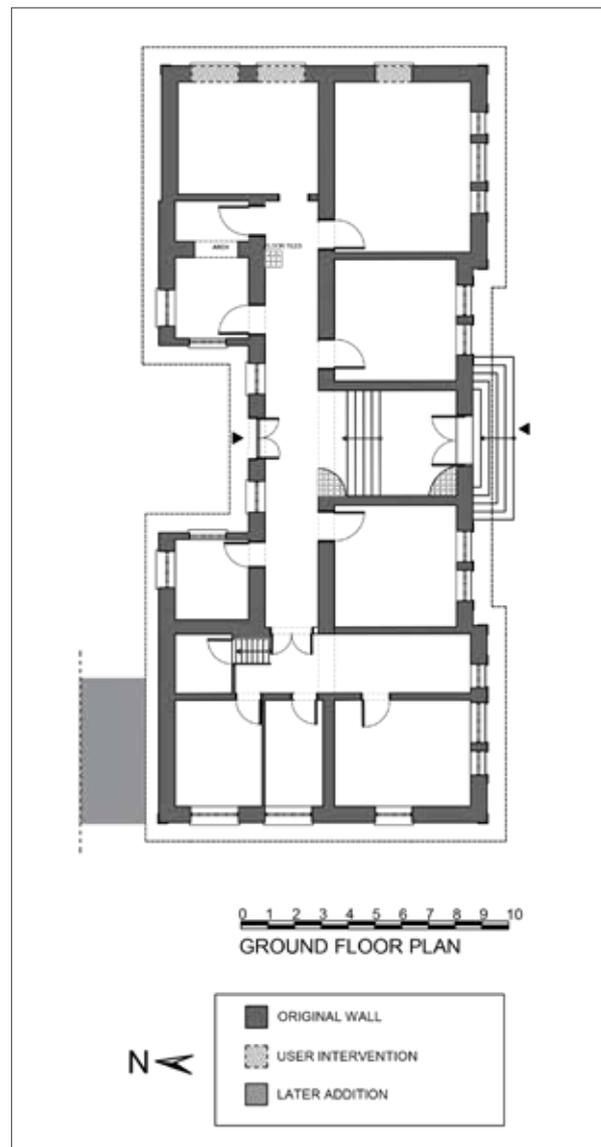
The building's ground floor is accessed from the southern façade, while the basement has an entrance on the western façade. The two-meter level difference between the northern and southern sides of the lot is balanced by the stairs between the garden and the building, and those in the building's entrance hall. The landing of the main entrance on the southern façade is reached from the garden by a five-step marble staircase. After entering the building through a double-winged, iron door, there is the entrance hall and a corridor on the east-west axis, elevated from the hall by five steps. The corridor is 2 m wide and 15.5 m long. It is covered by a jack-arched system and has a floor covered by terrazzo tiles (Fig. 3). The spaces on the ground floor open into this corridor. On the middle axis, opposite the main entrance, there is a double-winged door with a lintel that allows access to the backyard to the north. There are two spaces, facing south, on either side of the entrance hall. The corridor connects to two spaces in the eastern wing of the building. In the western wing, there is a second corridor in the north-south direction with three spaces opening into it. The wings protrude on the northern façade as well as on the southern one and have two windows each (Fig. 2).
