# Marmara Greek School for Boys (Kyriakidia)

*Emre Kishalı, Mustafa Akçaöz, Ioannis Papachristou*

District of Marmara, Merkez Neighbourhood	Construction period/date: 1910
	Current status: <b>Public Education Centre</b>
GPS: 40°35'11.9"N 27°33'30.4"E	Ownership status: <b>State Treasury</b>
Registration date and number: GEEAYK 20.12.1975 – 8791, TKTVYK 27.02.1987 – 3045, Bursa KTVKBK 15.01.1996 – 4904

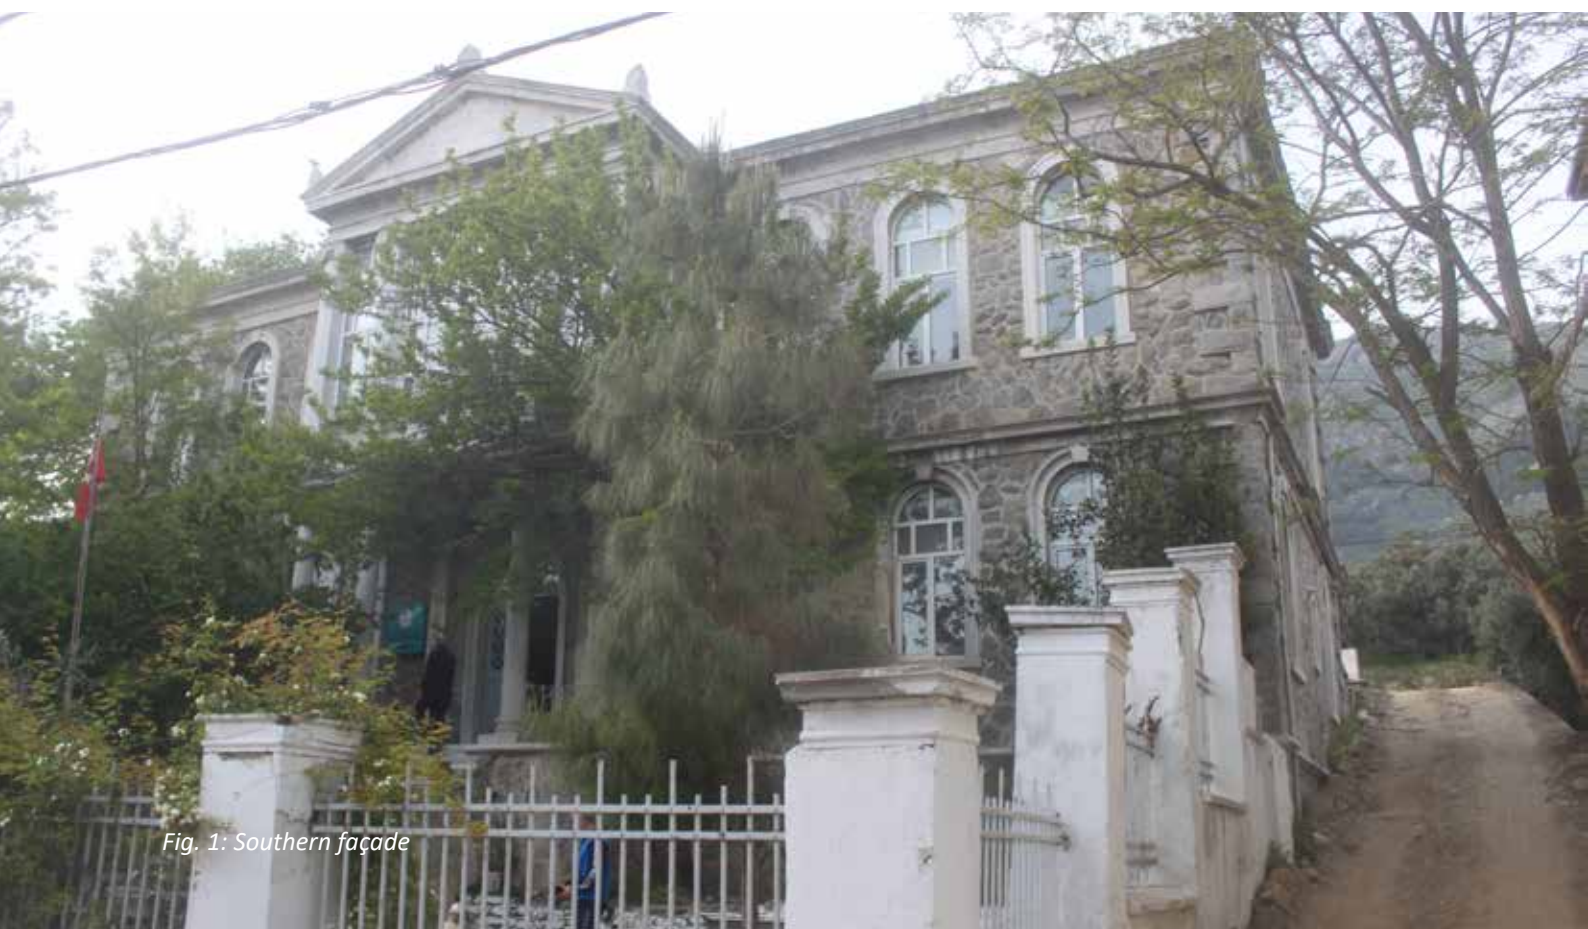
Fig. 1: Southern façade

The southern façade, which is the main entrance, was deliberately constructed to be more impressive and decorated than the others (Fig. 1). The yard on this side leads to an intermediary landing via eight steps, then the ground-floor entrance landing via five more steps. Above this landing, at the centre of the symmetry axis, rises the projected first floor. This projection is supported by four columns with Ionic capitals (Fig. 3). Behind the columns are pilasters with Doric-like capitals, forming a two-row load-bearing system. Above the Ionic capitals is the architrave with the inscription reading *Kyriakidia* and the architect's name. The columns, which carry the projection on the ground floor, continue on the first floor in the same style. The arrangement of the southern façade's upper floor is composed of windows between engaged columns with Ionic capitals, and marble blocks atop the columns that form the architrave. Above the entablature on the southern façade, there is a triangular pediment crowned with

The southern façade is approximately 23 m long. Its walls are rubble masonry without plaster, except the entrance section (Fig. 1). The parts flanking the main doorway are embellished with stucco marble. The arched door has two wings. There are six windows with round arches on the ground and first floors, to the east and west of the entrance section. The arches on the doors and windows are accentuated with keystone ornamentations. The profiled floor and roof mouldings are among other decorations of the school building. While there are not any openings on the eastern side of the basement of the southern façade, the western side has two small rectangular ones.

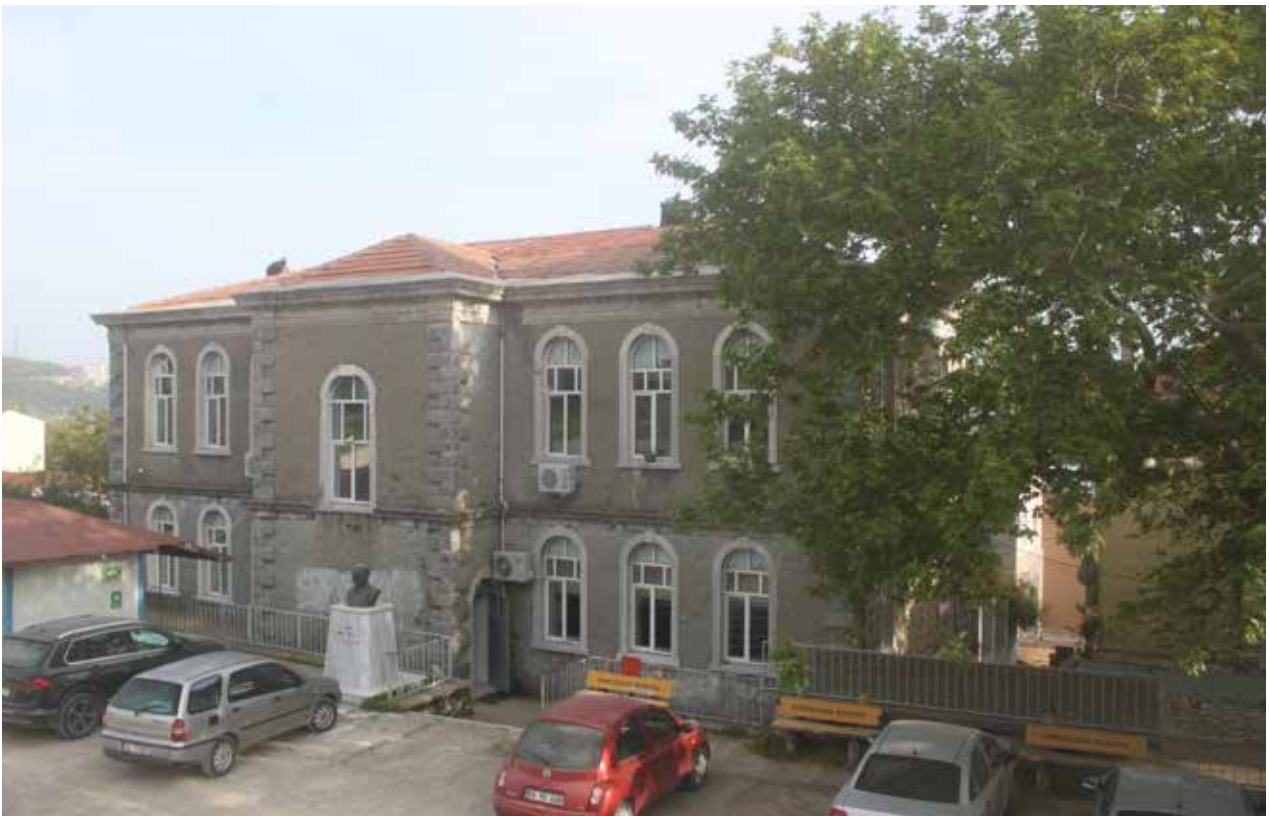
Fig. 2: Northern façade

All the walls on this side of the structure are plastered (Fig. 2). Unlike the projection on the southern façade where the first floor covers the entrance landing, the northern entrance protrudes on both the ground and first floor. This section houses a staircase that provides vertical circulation in the building. The middle section has an arched opening on the first floor, while the eastern and western sections of the façade have six windows with round arches, three on each floor.
