Windmills on the Southern Marmara Islands

Gizem Erten, Umut Almaç, Emre Kishalı

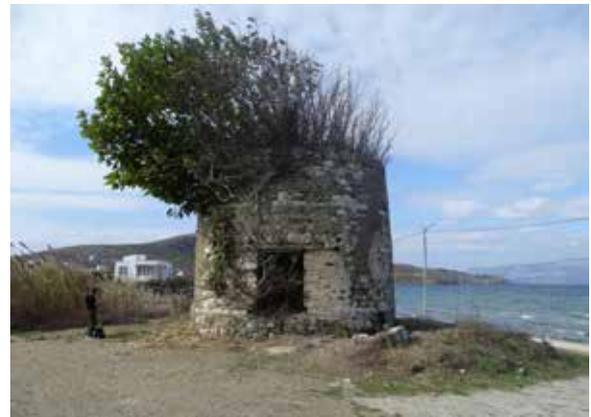
Fig. 1: Poyrazlı Windmill, general view

Poyrazlı Windmill is the most prominent example that has survived with its unique features. It is located on the edge of Poyrazlı Neighbourhood on Paşalimanı Island, to the north of the road leading to the village (Fig. 1). The circular building has an inner diameter of approximately 4.35 m. While its northern façade faces the sea, its gate is on the east. It has a stone-coursed and cylindrical body. Local stones are used as the building material of the cylindrical body wall. The mortar between these stones is the combination of earth, organic additives, and cement-based binder with large amounts of marble and seashells. The cement-based mortar attested on the outer surface of the building must be the result of a later repair. Tension bars are used in the body walls as structural elements. This must be to protect the windmill from natural conditions, especially from strong winds coming from the north.

Poyrazlı Windmill is currently neglected and unprotected because its use ended. The structure is generally preserved in good condition. Some of its significant elements specific to windmills such as the staircase, fireplace, niches, axle, and millstone have survived. Timber bands in the main walls, which are

thought to be original, have survived despite some biological growth; however, they have lost their strength. The loss of the superstructure makes the building susceptible to external factors, accelerates deterioration, and threatens the building's ability to survive for future generations. A large fig tree covers the building's interior to a large extent. Its leaves reach to the upper levels and exterior due to the loss of the superstructure. There are later interventions involving cement-based mortar, lime-based mortar, and iron reinforcement, which are not compatible with the original materials of the building and may mislead the interpretation of its construction techniques. There is cracking and detachment, as well as loss of materials in the main walls of the building. Biological degradation is seen on the stone surfaces of the exterior.

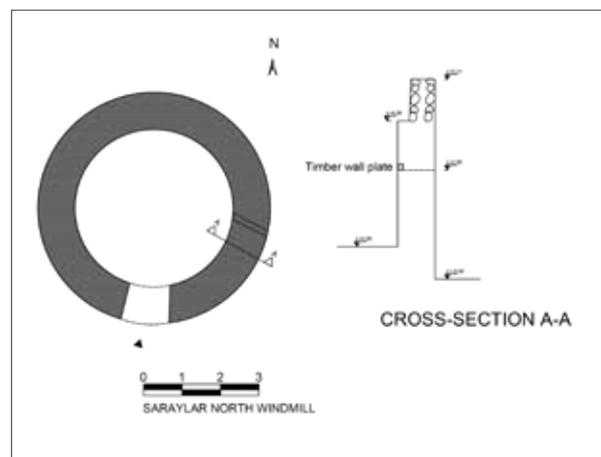
Fig. 3: Saraylar Northern Windmill, general view

The lot, approximately 116 decares, is on the hill to the east of Saraylar Neighbourhood and covers almost the entire slope. The northern windmill dominates over the area and it is about 150 m away from the sea (Fig. 3). The southern windmill is situated atop the slope, about 120 m from the northern one (Fig. 4).

Only the main, masonry walls of these windmills have survived. There are losses of sections and growth of rooted plants on these walls. Unlike the Poyrazlı Windmill and the Ekinlik Windmills 2 and 3, all of the timber structural elements such as the lintels, the timber bands in the walls, and the flooring have been lost. The section of the northern windmill that is defined by the entrance and the window above it is structurally in critical condition. Due to the loss of the doorway's timber lintels, there are losses of the rubble stones in the wall above. Both buildings have debris inside; therefore, the original flooring could not be identified. Similarly, the original roof levels could not be determined. The installations related to the buildings' function have been lost, although the original millstones may be concealed underneath the debris layer on the ground.

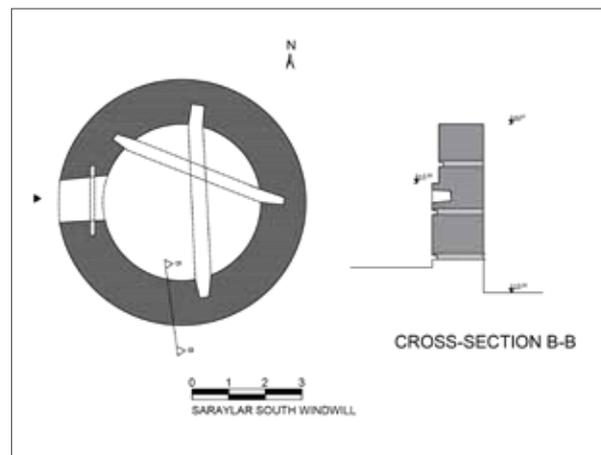
Fig. 4: Saraylar Southern Windmill, general view

The southern windmill is more damaged than the northern one. Apart from its circular main wall, there are not any architectural elements associated with the original function of the structure. The building, which has an approximate inner diameter of 4.0 m, has its entrance in the south. The traces of beam holes on the main wall suggest that it had two floors. The walls, which are about 90 cm thick, are constructed in rubble masonry with timber bands. Lime-based mortar is used to point the façades, while earth-based mortar is used in the core of the wall. Two rows of timber bands (10x10 cm) are used in the walls. These bands are nailed to elements with smaller cross-sections (6x6cm) that are placed transversely throughout the wall thickness for bracing. The walls reach up to a height of 5.20 cm in the east. The walls on the exterior of the ground level protrude approximately 6-7 cm, forming a wall base.

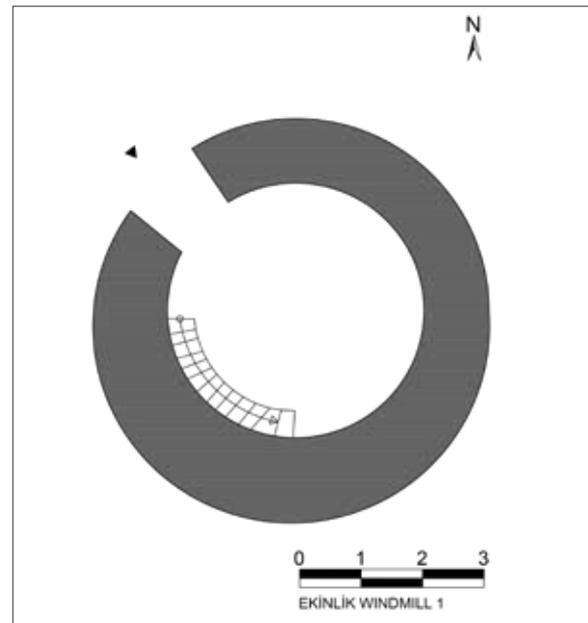
Fig. 6: Ekinlik Windmill 1, general view

Windmill 1 is to the west of the harbour of Ekinlik Island (Pl. IX.39). It is on a 113.92 m² lot that is in the garden of a recently-constructed, residential building (Fig. 6). It is approximately 500 m from the harbour as the crow flies. The remaining sections of the structure are the circular main walls –with an approximate height of 1.85 m– and nine steps

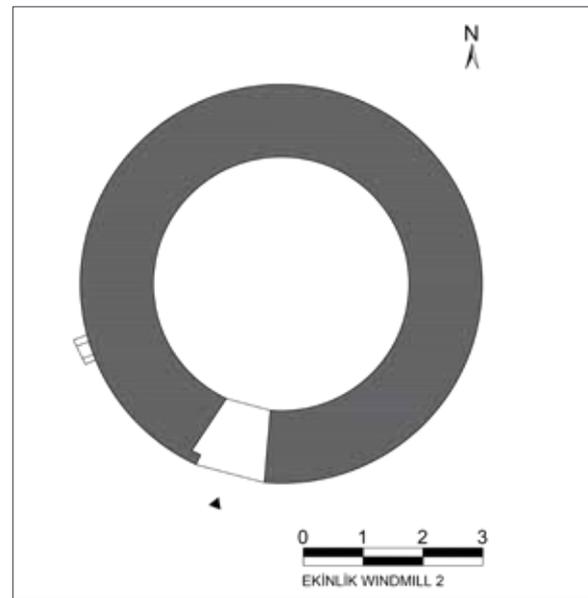
Fig. 7: Ekinlik Windmill 2, general view

Windmill 2 is used as a straw depot and located on a lot of 561.34 m² to the northwest of the harbour of Ekinlik Island. It is approximately 475 m from the harbour as the crow flies (Fig. 7). The main walls, as well as the window and door openings are intact. The circular structure has a perimeter of about 20 m (exterior diameter is approximately 6.50 m) and its entrance is in the south. The inscription "1877" over the entrance supports that the islands' windmills date from the 19th century (Fig. 8). Since the middle part of the stone lintel above the door has a curvilinear form, the opening seems to have the form of a depressed arch. According to the *Marmarina Nea* newspaper, the building belonged to a person called Ntompros before the population exchange (May 1952, 1). There is a rectangular window opening with a width of 45 cm to the west of the entrance, at the level of the inscription. The window jambs protrude by about 18 cm. The structure is currently covered with aluminium sheets. The main walls of the building are rubble masonry. The wall thickness is about 118~120 cm. Lime-based mortar and plaster are noted on the wall surfaces. On the upper levels of the body walls, there are holes for timber beams that carried the flooring. The mechanical parts of the mill sat on this flooring. Due to the bales of straw on the interior, the original features of Windmill 2, such as the extant staircase, could not be investigated in detail.

used for hay storage, a detailed examination of the deteriorations could not be made. The area around the door lintel is spray-painted.
